Report: TAB Report
Function: Test, Adjust, & Balance
Date: 11/12/2025
Completed By: National TAB

PROJECT
01-26-26 QT #0492 BUCKEYE, AZ

Project: 01-26-26 QT #0492 BUCKEYE, AZ

Project Summary

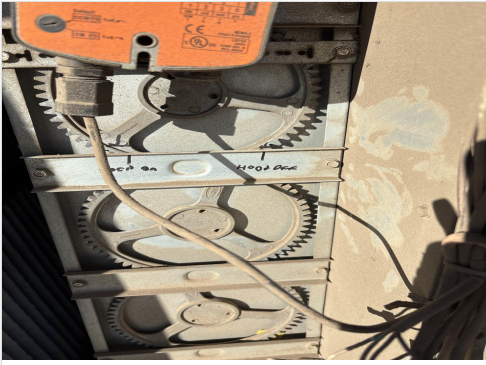
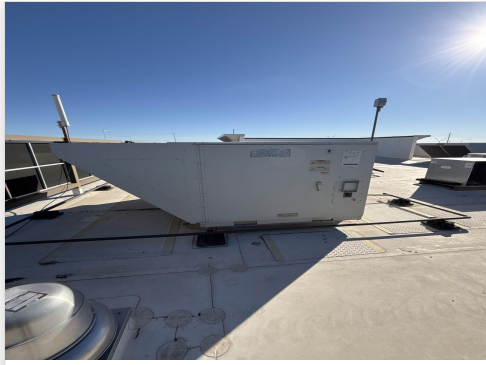
Unit Data - PHOTO LOG

Unit Data	
	Actual
MFG	AAON
Serial Num	201211-ANEK07379
Model Num	RN-013-8-0-EA0A-152
Num OA Filters 1	1
OA Filter Size 1	45X22.5
Num Final Filter 1	2
Final Filter Size 1	44X20

Test Data		
	Design	Actual
SF CFM	4200	4351
SF RPM	-	1232
OA CFM (Hoods On)	800	831
OA CFM (Hoods Off)	350	358
RL Voltage	-	136@VFD
RL Amperage	-	8.7@VFD
VFD Max SetPt	-	42HZ
VFD Min SetPt	-	24HZ
OA Damper Position (Hoods On)	-	46%
OA Damper Position (Hoods Off)	-	24%
