**Report: TAB Report**  
**Function: Test, Adjust, & Balance**  
**Date: 11/12/2025**  
**Completed By: National TAB**

**PROJECT**  
**01-26-26 QT #0492 BUCKEYE, AZ**

1850 SOUTH MILLER RD

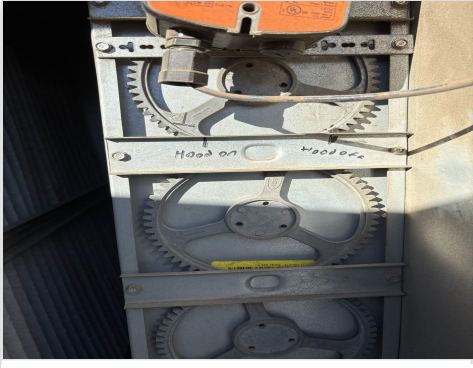
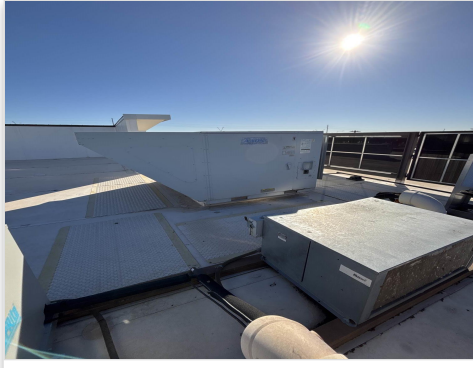
Asset: RT-1

Test Data		
	Design	Actual
SF CFM	4200	4365
SF RPM	-	1173
OA CFM (Hoods On)	800	821
OA CFM (Hoods Off)	350	351
RL Voltage	-	115@VFD
RL Amperage	-	9.0@VFD
VFD Max SetPt	-	40HZ
VFD Min SetPt	-	24HZ
OA Damper Position (Hoods On)	-	46%
OA Damper Position (Hoods Off)	-	22%

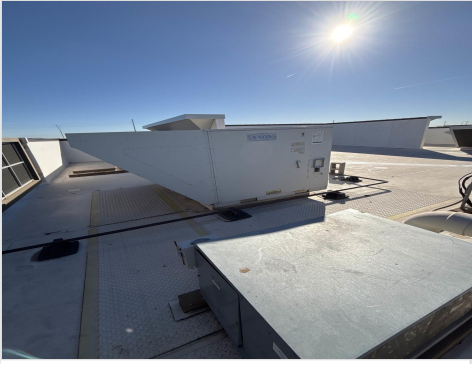
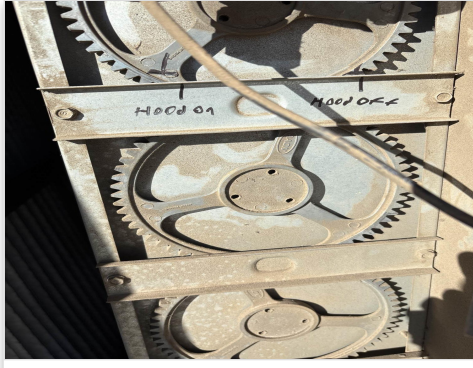
Asset: RT-2

Test Data		
	Design	Actual
SF CFM	4200	4288
SF RPM	-	1114
OA CFM (Hoods On)	800	811
OA CFM (Hoods Off)	350	358
RL Voltage	-	103@VFD
RL Amperage	-	9.0@VFD
VFD Max SetPt	-	38HZ
VFD Min SetPt	-	24HZ
OA Damper Position (Hoods On)	-	46%
OA Damper Position (Hoods Off)	-	26%

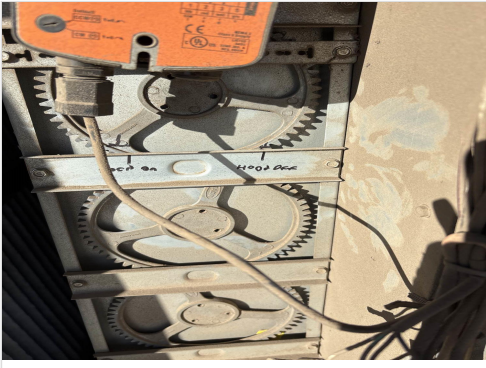
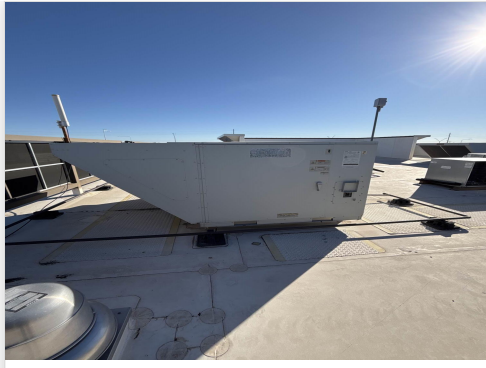
Asset: RT-3

Test Data		
	Design	Actual
SF CFM	4200	4351
SF RPM	-	1232
OA CFM (Hoods On)	800	831
OA CFM (Hoods Off)	350	358
RL Voltage	-	136@VFD
RL Amperage	-	8.7@VFD
VFD Max SetPt	-	42HZ
VFD Min SetPt	-	24HZ
OA Damper Position (Hoods On)	-	46%
OA Damper Position (Hoods Off)	-	24%

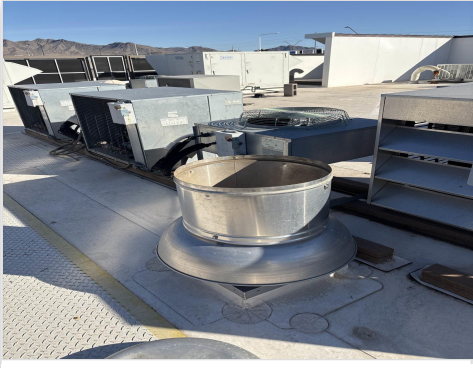
Asset: EF1

Test Data		
	Design	Actual
CFM	225	234
Fan RPM	-	NA
Fan Rotation	-	CCW
Motor RPM	-	NA
System SetPt	-	LOW
RL Voltage	-	NA
RL Amperage	-	NA
Total ESP	-	0.15"
Fan Inlet SP	-	-0.15"
Fan Discharge SP	-	ATMS

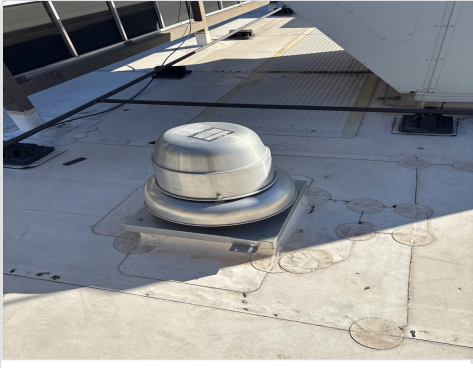
Asset: EF2

Test Data		
	Design	Actual
CFM	525	531
Fan RPM	-	NA
Fan Rotation	-	CCW
Motor RPM	-	NA
System SetPt	-	HI
RL Voltage	-	115
RL Amperage	-	0.88
Total ESP	-	0.23"
Fan Inlet SP	-	-0.23"
Fan Discharge SP	-	ATMS

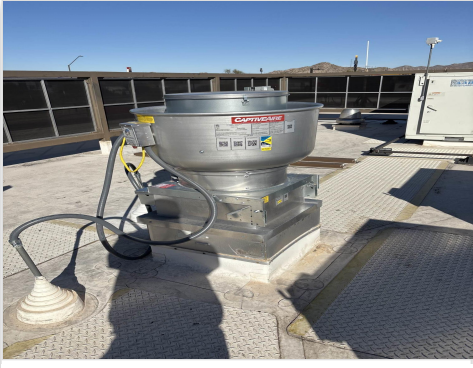
Asset: EF3

Test Data		
	Design	Actual
CFM	1350	1397
Fan RPM	-	1165
Fan Rotation	-	CCW
Motor RPM	-	1165
System SetPt	-	49.8 HZ
RL Voltage	-	210
RL Amperage	-	2.1
Total ESP	-	0.62
Fan Inlet SP	-	0.62"
Fan Discharge SP	-	ATMS

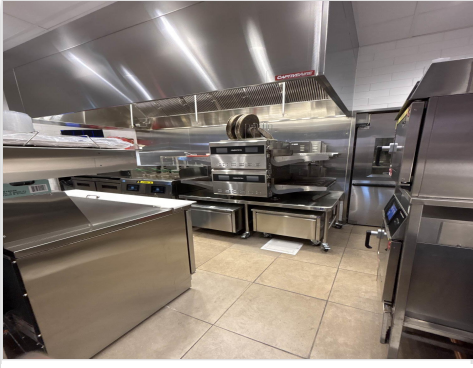
Asset: HD1

Design	Actual
Filter Type	-	BAFFLE
Filter Size 1	-	16X20
Filter Qty 1	-	6
Filter AK factor size 1	-	2.08
Filter Total AK Area	-	12.48
Filter1 FPM	-	119
Filter2 FPM	-	110
Filter3 FPM	-	109
Filter4 FPM	-	123
Filter5 FPM	-	108
Filter6 FPM	-	106
Filter Ave FPM(corr)	-	112
CFM	1350	1397
