Report: TAB Report
Function: Test, Adjust, & Balance
Date: 07/09/2024

07-08-24 ULTA #1708 HARTSDALE, NY

Rectenwald Brothers Construction

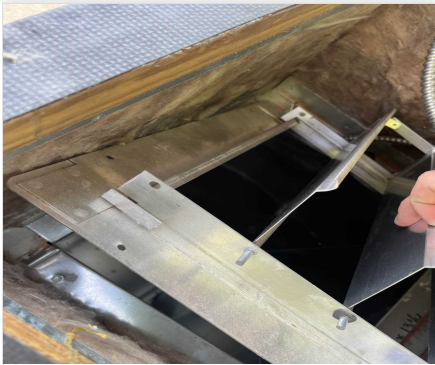
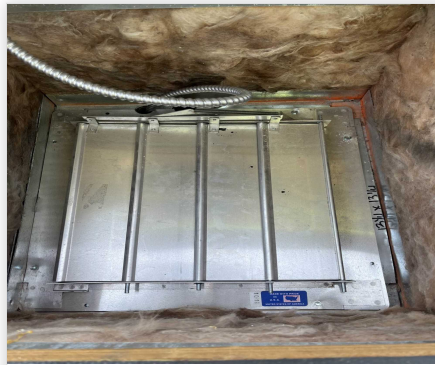
Issue Name : EF-1 BACKDRAFT DAMPER
Description : EF-1 Backdraft damper was found sitting crooked and loose in the curb of the fan. NTi secured it with sheet metal screws to resolve the issue.
Created By : National TAB **Assigned To :** National TAB - Tyler Youells
Status : Closed
Priority : High **Asset Tag :**
Originated Date : 07/09/2024 - Tyler Youells - National TAB

NTi Found the backdraft damper sitting crooked and loosely in the curb. NTi secured the backdraft damper with screws to prevent it from moving.

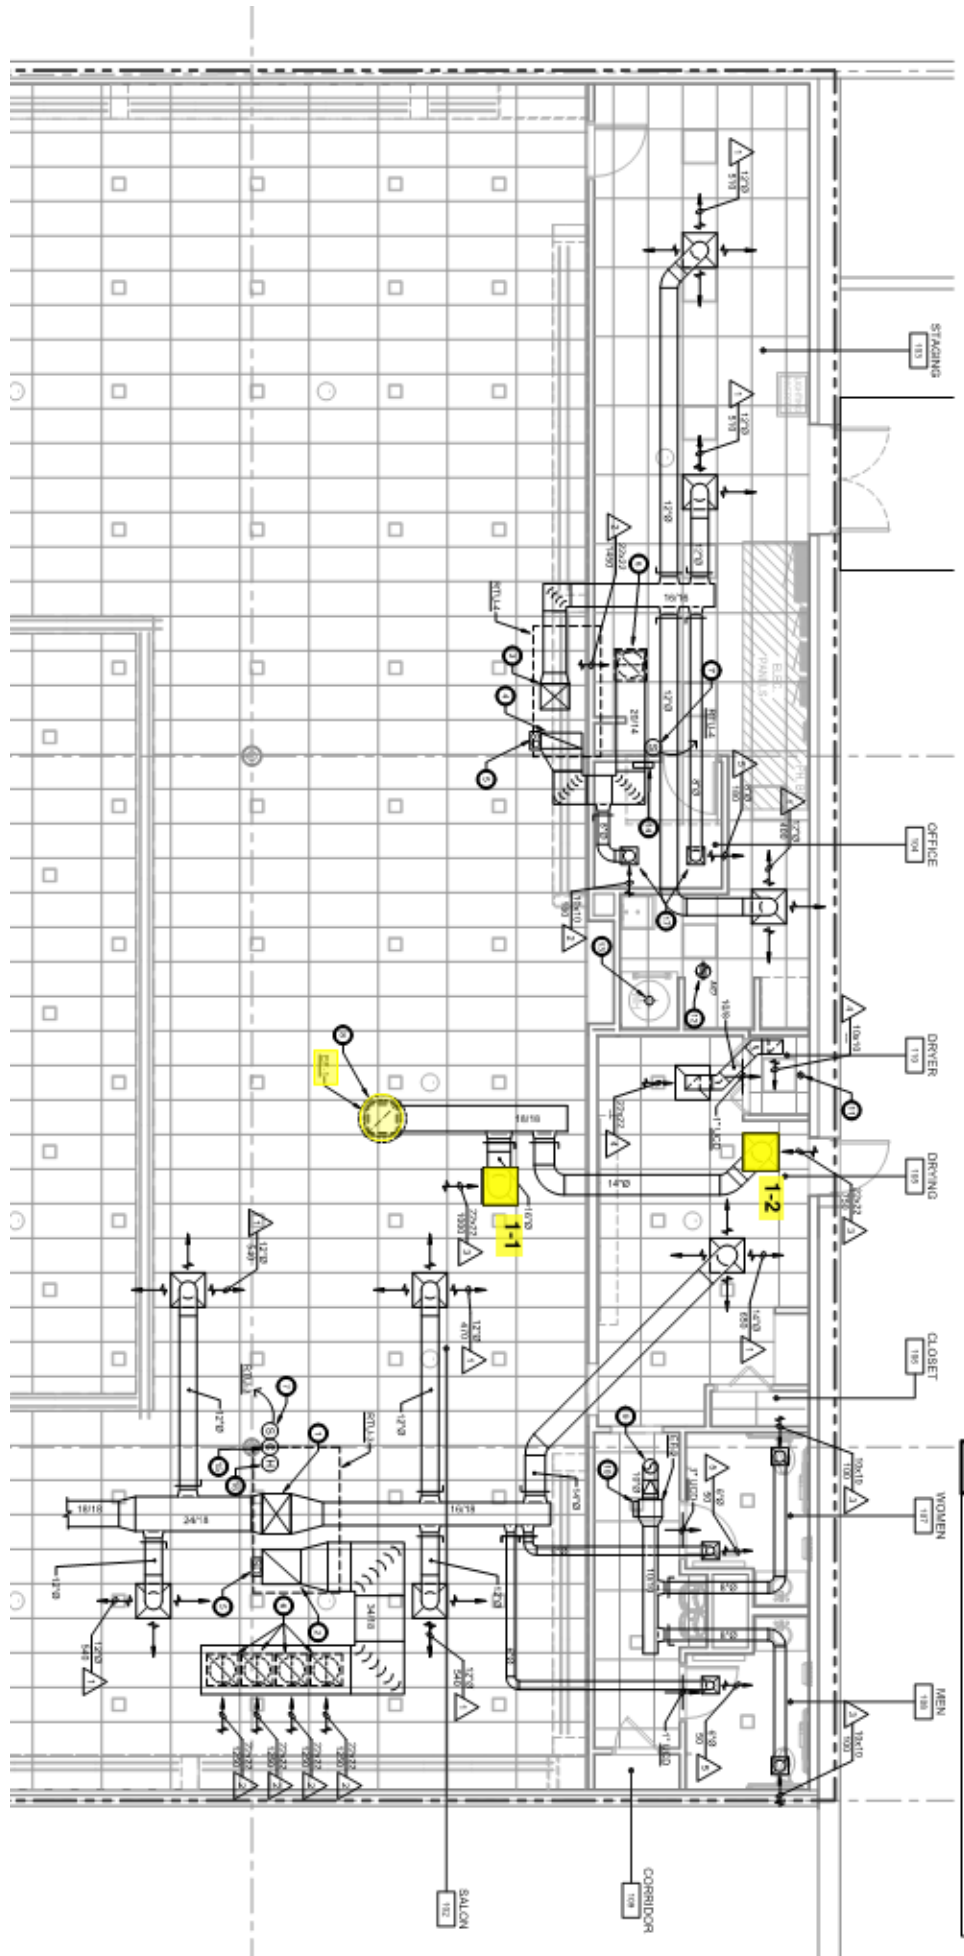
Diffuser Ret/Exh (GRD)

Asset									
Asset Name	Location	Type	Size	DESIGN CFM	AK	CFM(1)	CFM(2)	FINAL CFM	% to design
EF1-EGRD1	SALON	3	16	1000	1	1001	1001	1001	100.1
EF1-EGRD2	HAIR WASH	3	14	750	1	747	747	747	99.6
Total				1750		1748	1748	1748	99.89%
