Report: TAB REPORT
Function: Test, Adjust, & Balance
Date: 08/09/2023

**07-31-23 FIVE GUYS #0501 - HAGERSTOWN,
MD**

18007 GARLAND GROH BLVD

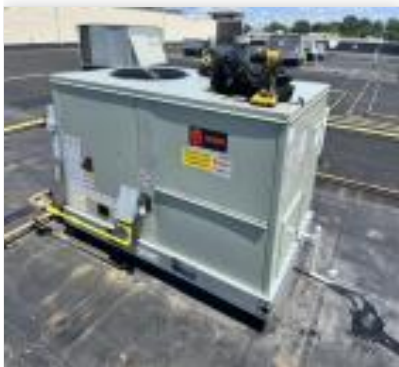
RTU-2(1)
08/07/2023

Test Data		
	Design	Actual
SF CFM	2000	1640
SF RPM	-	1124
RA CFM	1600	1262
OA CFM	400	378
RL Voltage	-	208/208/208
RL Amperage	-	2.6/2.5/2.6
SF Rotation	-	CW
RA Damper Position	-	Marked
Min OA Damper Position	-	Marked
Min OA Damper Type	-	SBD
OA Enthalpy Setpt	-	E

Unable to speed up fan speed setting. Recommend a pulley change to get to suggested design flow of 2000 CFM.

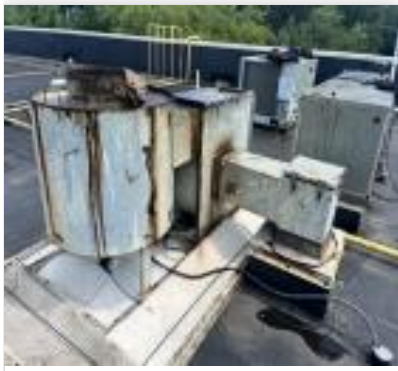
KEF-1
08/07/2023

Test Data		
	Design	Actual
CFM	-	4005
Fan RPM	-	1376
Fan Rotation	-	CCW
Motor RPM	-	1731
RL Voltage	-	208/208/208
RL Amperage	-	10.6/10.9/11.0
Suction ESP	-	-2.20"
Discharge ESP	-	ATM
Total ESP	-	2.20"

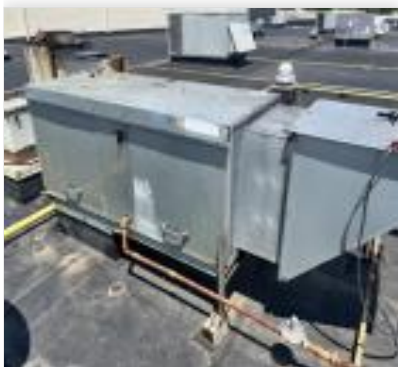
MUA-1
08/07/2023

Notes:
Intake filters were very dirty. Readings were taken without filters.

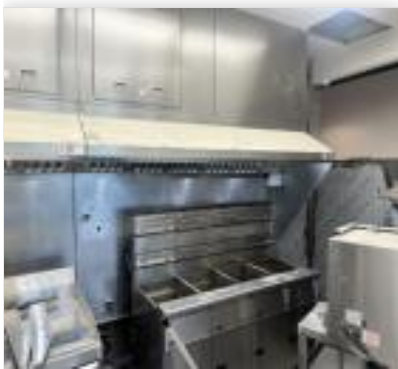
Hood-2
08/07/2023

Test Data Exhaust		
	Design	Actual
Filter Type	-	Baffle
Filter Size 1	-	16X16
Filter Qty 1	-	6
Filter AK factor size 1	-	1.62
Filter Total AK Area	-	9.72
Filter1 FPM	-	193
Filter2 FPM	-	244
Filter3 FPM	-	229
Filter4 FPM	-	230
Filter5 FPM	-	197
Filter6 FPM	-	195
Filter Ave FPM(corr)	-	215
CFM	-	2090
