Report: TAB REPORT
Function: Test, Adjust, & Balance
Date: 08/09/2023

**07-31-23 FIVE GUYS #0501 - HAGERSTOWN,
MD**

AIR BALANCE SCHEDULE

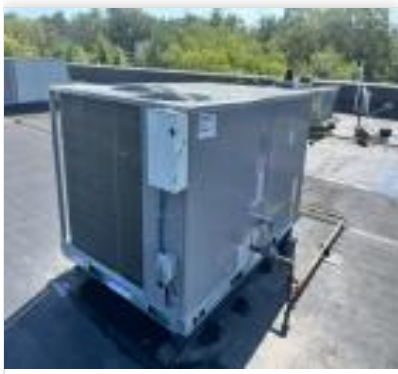
RTU-1
08/07/2023

Test Data		
	Design	Actual
SF CFM	4000	3885
SF RPM	-	1984
RA CFM	3200	3059
OA CFM	800	826
RL Voltage	-	208/208/208
RL Amperage	-	6.4/5.6/6.3
SF Rotation	-	CCW
RA Damper Position	-	100%
Min OA Damper Position	-	0%
Min OA Damper Type	-	SBD
OA Enthalpy Setpt	-	NA

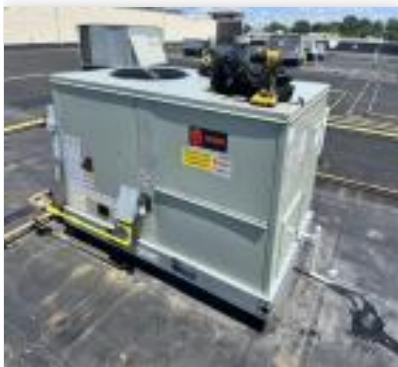
RTU-2(1)
08/07/2023

Test Data		
	Design	Actual
SF CFM	2000	1640
SF RPM	-	1124
RA CFM	1600	1262
OA CFM	400	378
RL Voltage	-	208/208/208
RL Amperage	-	2.6/2.5/2.6
SF Rotation	-	CW
RA Damper Position	-	Marked
Min OA Damper Position	-	Marked
Min OA Damper Type	-	SBD
OA Enthalpy Setpt	-	E

Unable to speed up fan speed setting. Recommend a pulley change to get to suggested design flow of 2000 CFM.
