Report: TAB Report
Function: Test, Adjust, & Balance
Date: 10/08/2024
Completed By: National TAB

PROJECT
10-14-24 FREDDYS - CINNAMINSON, NJ

Project: 10-14-24 FREDDYS - CINNAMINSON, NJ

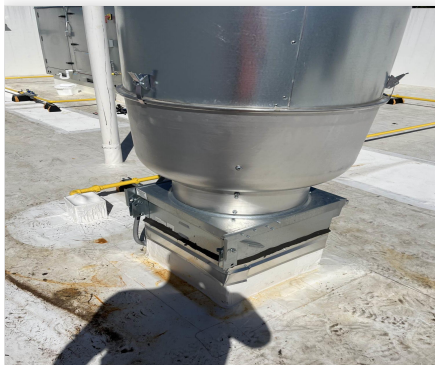
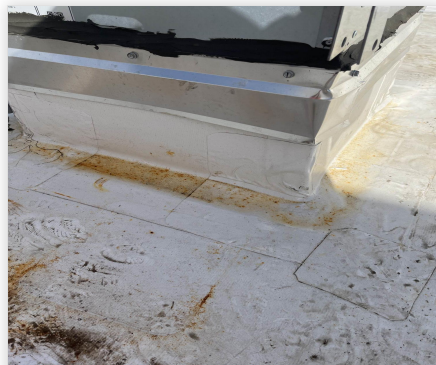
Issue Name : KEF-2 Shaking
Description : KEF-1 shakes when running. Shaking seems to be coming from the curb connection at the roof and is exacerbated by the heavy grease flue on the fan. Talking with Tom, GC will add more securement screws to the curb and reseal the roof membrane.
Created By : National TAB **Assigned To :** National TAB - Tyler Youells
Status : Open
Priority : Medium **Asset Tag :**
Originated Date : 10/08/2024 - Tyler Youells - National TAB

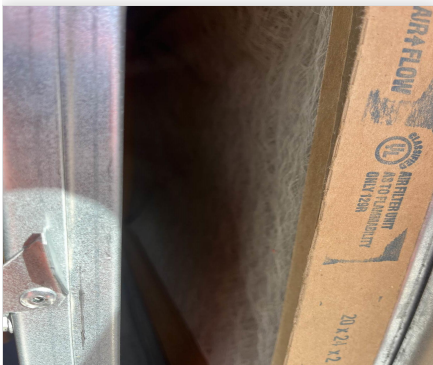
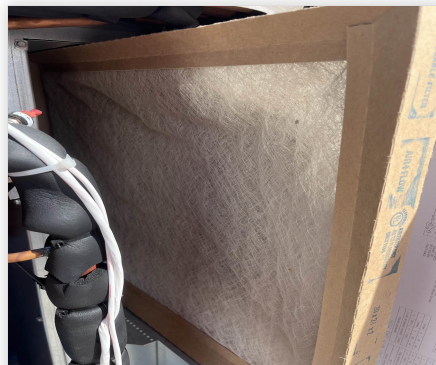
Issue Name : RTU-1 Filters
Description : RTU-1 has Construction filters installed at time of TAB. Recommend replacing with MERV type filters prior to store turnover. Filter quantity: 4-20X24X2
Created By : National TAB **Assigned To :** National TAB - Tyler Youells
Status : Open
Priority : Low **Asset Tag :**
Originated Date : 10/08/2024 - Tyler Youells - National TAB

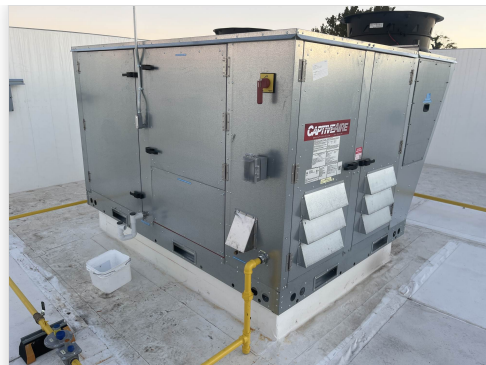
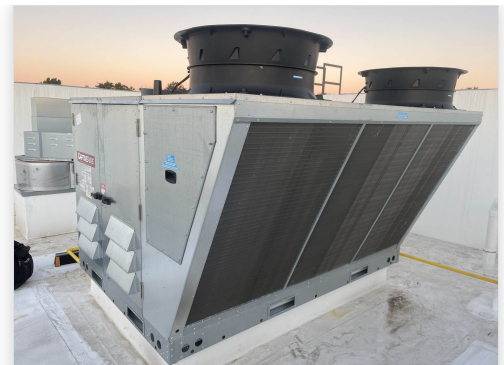
Unit Data - PHOTO LOG

Unit Data		
	Design	Actual
MFG	YORK	CAPTIVEAIRE
Serial Num	-	6079969
Model Num	ZJ150	CAS-HVAC3-1.250-15-15T
Type	DOAS	DOAS
Configuration	VERTICAL	VERTICAL
Num OA Filters 1	-	4
OA Filter Size 1	-	16X25X2
Num Final Filter 1	-	8
Final Filter Size 1	-	20X25X2

Test Data		
	Design	Actual
SF CFM	2375	2387
SF RPM	-	1537
RA CFM	0	0
OA CFM	2375	2387
RL Voltage	-	159V
RL Amperage	-	4.4 VFD
SF Rotation	-	CW
SF System SetPt	-	53HZ
RA Damper Position	-	CLOSED
Min OA Damper Position	-	FULL OPEN
Min OA Damper Type	-	DOAS
OA Enthalpy Setpt	-	DEFAULT

[1] UNIT SCHEDULED AT 2375CFM. DIFFUSER ADD TO 2790. NTI LOWERED DIFFUSER DESIGN VALUES PROPORTIONALLY APART FROM THE OFFICE FLOW.

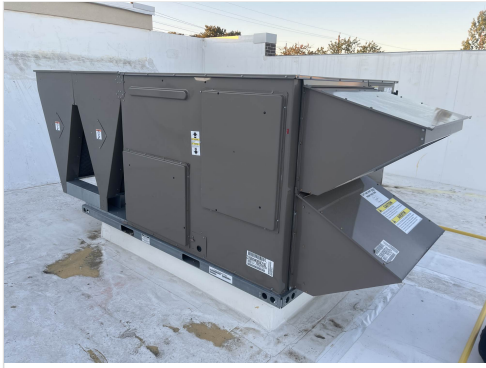
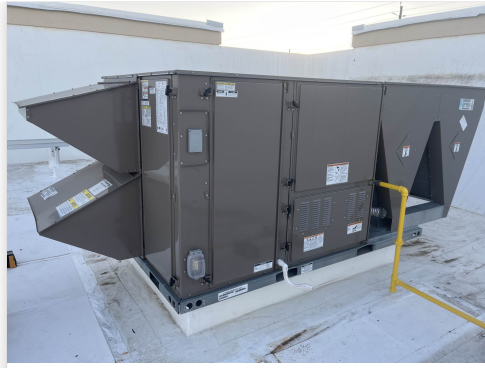
Unit Data - PHOTO LOG

Unit Data		
	Design	Actual
MFG	YORK	YORK
Serial Num	-	N2C4182732
Model Num	ZJ150	ZJ150N24R2B5DCE1A2
Type	RTU	RTU
Configuration	VERTICAL	VERTICAL
Num OA Filters 1	-	1
OA Filter Size 1	-	30X22
Num Final Filter 1	-	4
Final Filter Size 1	-	20X24X2

Test Data		
	Design	Actual
SF CFM	5000	5111
SF RPM	-	1188
RA CFM	4019	4147
OA CFM	981	964
RL Voltage	-	212/211.1/211.3
RL Amperage	-	11.4 VFD
SF Rotation	-	CW
SF System SetPt	-	60HZ
RA Damper Position	-	MECHANICAL LINKAGE
Min OA Damper Position	-	23%/33%
Min OA Damper Type	-	ECONOMIZER
OA Enthalpy Setpt	-	27BTU/# DEFAULT

General	
	Actual
Fan Rotation Correct	YES
Unit Filters Clean	YES/CONSTRUCTION
Condensate Drain Installed	YES

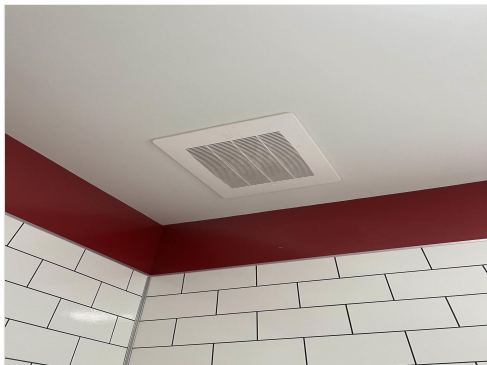
Unit Data - PHOTO LOG

Unit Data		
	Design	Actual
MFG	GREENHECK	LOREN COOK
Model Num	SP-A200-390	GEMINI 160
Serial Num	-	NL
Type	CEILING	CEILING

Test Data		
	Design	Actual
CFM	150	163
Fan RPM	-	1100
Fan Rotation	-	CW
Motor RPM	-	1100
System SetPt	-	WIRED FOR HIGH
RL Voltage	-	120.4
RL Amperage	-	0.47

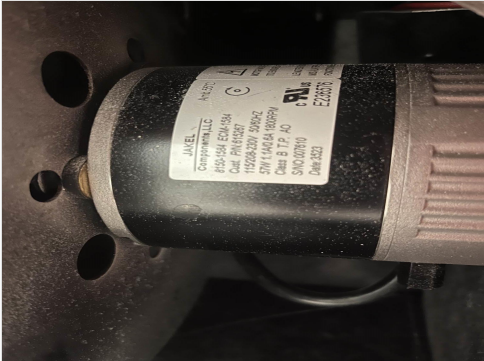
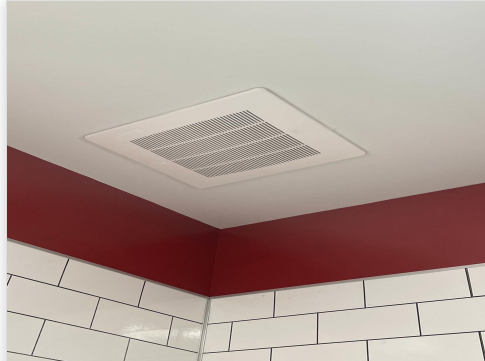
Unit Data - PHOTO LOG

Unit Data		
	Design	Actual
MFG	GREENHECK	LOREN COOK
Model Num	SP-A200-390	NOT ACCESSIBLE
Serial Num	-	NOT ACCESSIBLE
Type	CEILING	CEILING

Test Data		
	Design	Actual
CFM	75	69
Fan RPM	-	1800
Fan Rotation	-	CW
Motor RPM	-	1800
System SetPt	-	FULL SPEED
RL Voltage	-	120.6
RL Amperage	-	0.9

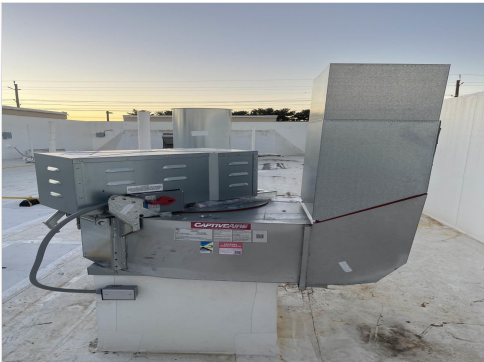
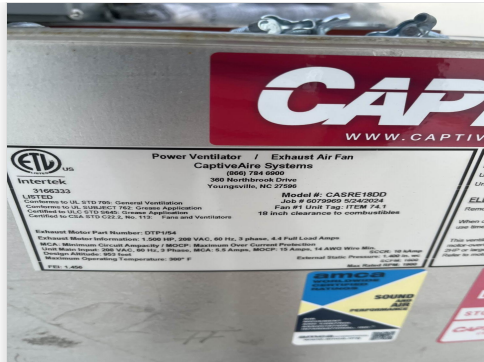
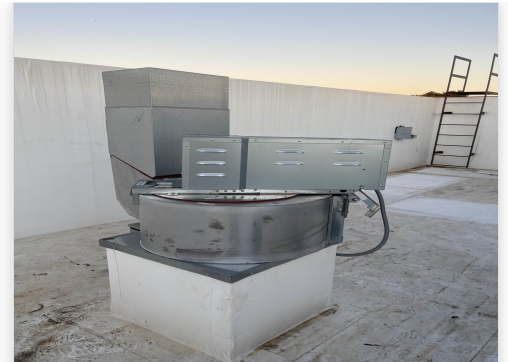
Unit Data - PHOTO LOG

Unit Data		
	Design	Actual
MFG	GREENHECK	CAPTIVEAIRE
Model Num	SP-A200-390	CASRE18DD
Serial Num	-	6079969
Type	UTILITY	UTILITY
Configuration	VERTICAL	VERTICAL

Test Data		
	Design	Actual
CFM	1600	1765
Fan RPM	-	1302
Fan Rotation	-	CCW
Motor RPM	-	1302
System SetPt	-	44.9HZ
RL Voltage	-	169 VFD
RL Amperage	-	4.4 VFD
Total ESP	1.500"	NA
Fan Inlet SP	-	NA
Fan Discharge SP	-	ATM

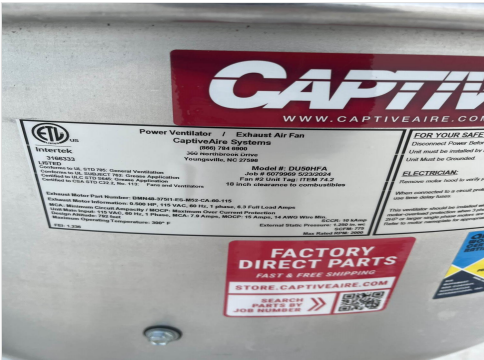
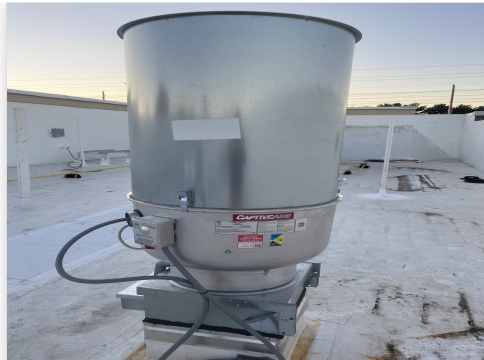
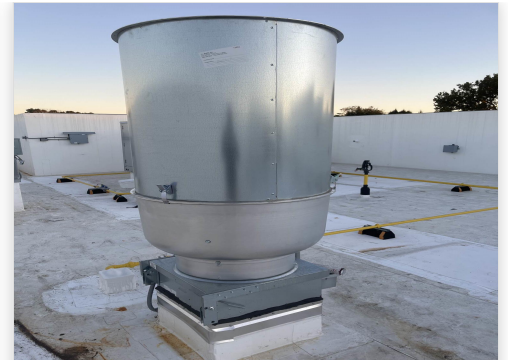
Unit Data - PHOTO LOG

Unit Data		
	Design	Actual
MFG	GREENHECK	CAPTIVEAIRE
Model Num	SP-A200-390	DU50HFA
Serial Num	-	6079969
Type	CRE	CRE
Configuration	UPBLAST	UPBLAST

Test Data		
	Design	Actual
CFM	775	846
Fan RPM	-	1260
Fan Rotation	-	CCW
Motor RPM	-	1260
System SetPt	-	70%
RL Voltage	-	120.9
RL Amperage	-	5.16
Total ESP	-	1.37"
Fan Inlet SP	-	-1.37"
Fan Discharge SP	-	ATM

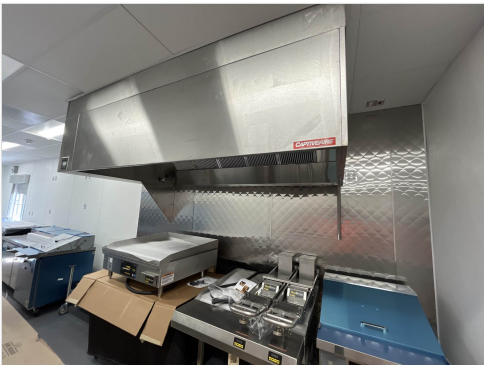
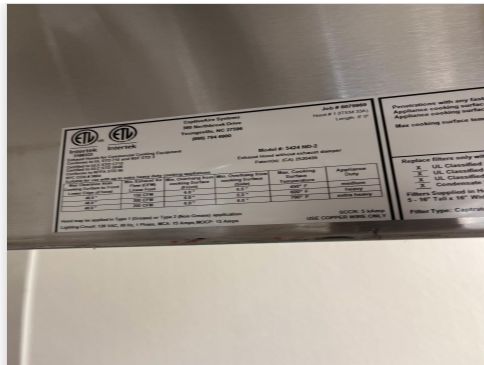
Unit Data - PHOTO LOG

Unit Data		
	Design	Actual
MFG	CAPTIVEAIRE	CAPTIVEAIRE
Model Num	5424 ND-2	5424 ND-2
Job / Serial Num	-	6079969
Type	TYPE I CANOPY	TYPE I CANOPY
Hood length	96"	96"
Hood Width	54"	54"

Test Data Exhaust		
	Design	Actual
Filter Type	CAPTRATE SOLO FILTER	CAPTRATE SOLO
Filter Size 1	16X16	16X16
Filter Qty 1	5	5
Filter AK factor size 1	1.62	1.62
Filter Total AK Area	8.1	8.1
Filter1 FPM	-	210
Filter2 FPM	-	218
Filter3 FPM	-	229
Filter4 FPM	-	215
Filter5 FPM	-	218
Filter Ave FPM(corr)	-	218
CFM	1600	1765

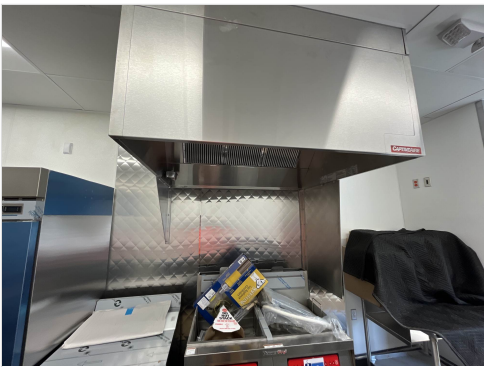
Unit Data - PHOTO LOG

Unit Data		
	Design	Actual
MFG	CAPTIVEAIRE	CAPTIVEAIRE
Model Num	5424 ND-2	5424 ND-2
Job / Serial Num	-	6079969
Type	TYPE I CANOPY	TYPE I CANOPY
Hood length	60"	60"
Hood Width	54"	54'

Test Data Exhaust		
	Design	Actual
Filter Type	CAPTRATE SOLO FILTER	CAPTRATE SOLO
Filter Size 1	16X16	16X16
Filter Qty 1	3	3
Filter AK factor size 1	1.62	1.62
Filter Total AK Area	4.86	4.86
Filter1 FPM	-	173
Filter2 FPM	-	187
Filter3 FPM	-	162
Filter Ave FPM(corr)	-	174
CFM	775	846
