Report: TAB Report
Function: Test, Adjust, & Balance
Date: 10/08/2024
Completed By: National TAB

PROJECT
10-14-24 FREDDYS - CINNAMINSON, NJ

Project: 10-14-24 FREDDYS - CINNAMINSON, NJ

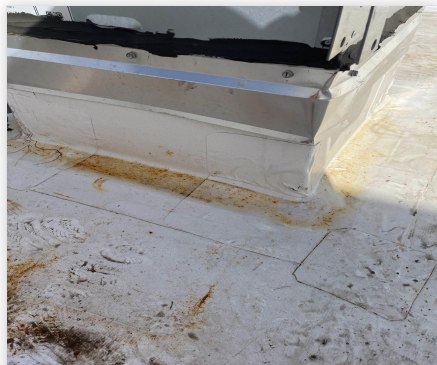
Issue Name : KEF-2 Shaking
Description : KEF-1 shakes when running. Shaking seems to be coming from the curb connection at the roof and is exacerbated by the heavy grease flue on the fan. Talking with Tom, GC will add more securement screws to the curb and reseal the roof membrane.
Created By : National TAB **Assigned To :** National TAB - Tyler Youells
Status : Open
Priority : Medium **Asset Tag :**
Originated Date : 10/08/2024 - Tyler Youells - National TAB

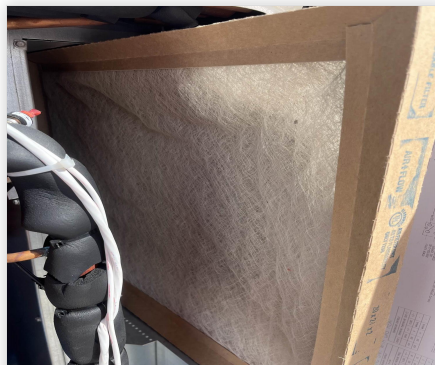
Issue Name : RTU-1 Filters
Description : RTU-1 has Construction filters installed at time of TAB. Recommend replacing with MERV type filters prior to store turnover. Filter quantity: 4-20X24X2
Created By : National TAB **Assigned To :** National TAB - Tyler Youells
Status : Open
Priority : Low **Asset Tag :**
Originated Date : 10/08/2024 - Tyler Youells - National TAB

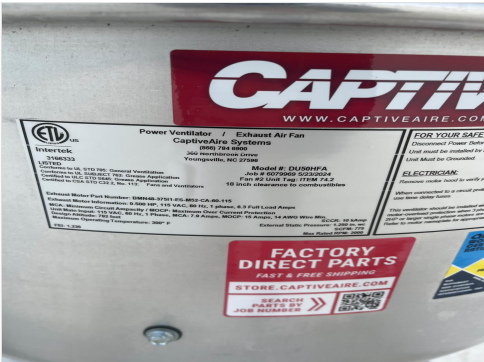
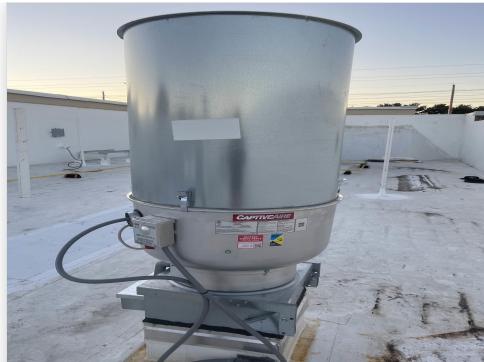
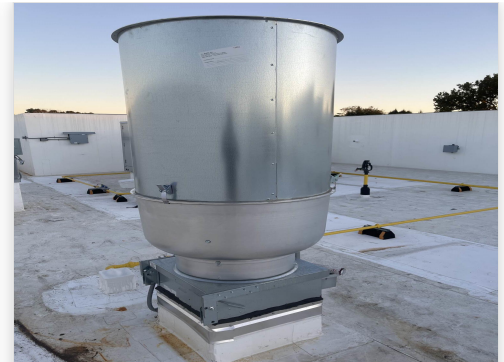
Unit Data - PHOTO LOG

Unit Data		
	Design	Actual
MFG	GREENHECK	CAPTIVEAIRE
Model Num	SP-A200-390	DU50HFA
Serial Num	-	6079969
Type	CRE	CRE
Configuration	UPBLAST	UPBLAST

Motor Data		
	Design	Actual
Motor MFG	-	TELCO GREEN
Frame	-	NL
Horsepower	-	0.50
Motor Rpm	-	1800
Phase	-	1
Voltage (rated)	-	115
Amperage (rated)	-	6.3
Service Factor	-	1

Test Data		
	Design	Actual
CFM	775	846
Fan RPM	-	1260
Fan Rotation	-	CCW
Motor RPM	-	1260
System SetPt	-	70%
RL Voltage	-	120.9
RL Amperage	-	5.16
Total ESP	-	1.37"
Fan Inlet SP	-	-1.37"
Fan Discharge SP	-	ATM
