**Report: Test and Balance
Date: 7/31/2020**

**PROJECT
CHIPOTLE - LINDENHURST #31-3325 (LINDENHURST,
NY)**

96 E SUNRISE HWY
LINDENHURST, NY 11757

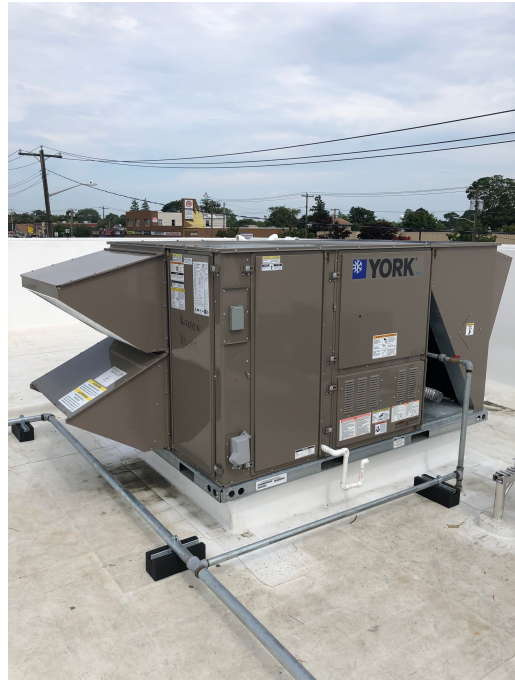
RTU1

Unit Data		
	Design	Actual
MFG	YORK	YORK
Model Num	ZJ078	ZJ078N12P2B5E AB2A2
Serial Num	-	N2D0696919
Type	RTU	RTU
Configuration	VERTICAL DISCHARGE	VERTICAL
Num OA Filters 1	-	1
OA Filter Size 1	-	29X20.75
Num Final Filter 1	-	4
Final Filter Size 1	-	20X24X2
Num Final Filter 2	-	-
Final Filter Size 2	-	-

Test Data		
	Design	Actual
SF CFM	2400	2330
SF RPM	-	869
RA CFM	1900	1789
OA CFM	500	541
RL Voltage	-	203/207/205
RL Amperage	-	2.8/3.3/2.5
SF Rotation	-	CW
RA Damper Position	-	84%
Min OA Damper Position	-	16%
Min OA Damper Type	-	ECONOMIZER

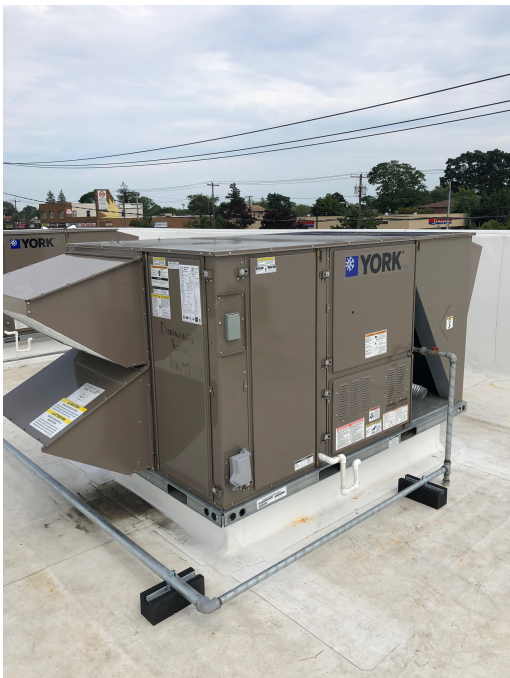
RTU2

Unit Data		
	Design	Actual
MFG	YORK	YORK
Model Num	ZJ090	ZJ090N18R2B5 EAB2A2
Serial Num	-	N2D0696921
Type	RTU	RTU
Configuration	VERTICAL DISCHARGE	VERTICAL
Num OA Filters 1	-	1
OA Filter Size 1	-	29X20.75
Num Final Filter 1	-	4
Final Filter Size 1	-	20X24X2
Num Final Filter 2	-	-
Final Filter Size 2	-	-

Test Data		
	Design	Actual
SF CFM	3200	3276
SF RPM	-	988
RA CFM	2200	2187
OA CFM	1000	1089
RL Voltage	-	203/204/206
RL Amperage	-	3.8/4.2/5.2
SF Rotation	-	CW
RA Damper Position	-	84%
Min OA Damper Position	-	16%
Min OA Damper Type	-	ECONOMIZER

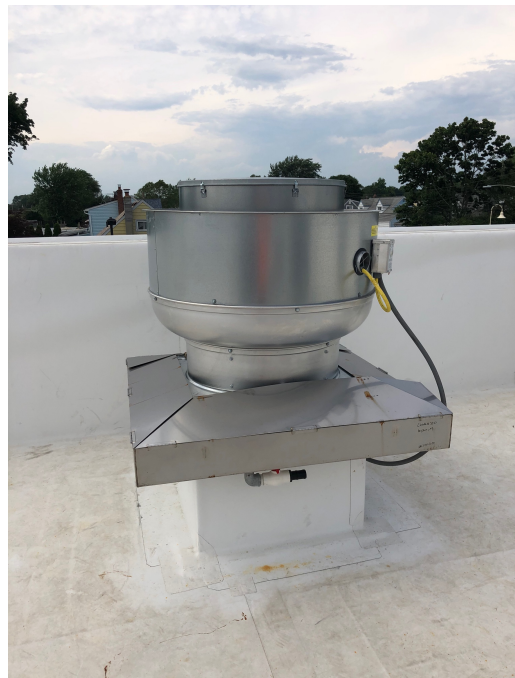
EF1

Unit Data		
	Design	Actual
MFG	CAPTIVE-AIRE	CAPTIVE-AIRE
Model Num	NCA24HPFA	NCA24HPFA
Serial Num	-	4027098
Type	CENTRIFUGAL	CENTRIFUGAL
Configuration	UPBLAST	UPBLAST

Test Data		
	Design	Actual
CFM	2925	3106
Fan RPM	-	918
Fan Rotation	-	CCW
Motor RPM	-	1752
RL Voltage	-	205/205/205
RL Amperage	-	3.6/3.8/3.6
Suction ESP	-	-1.12"
Discharge ESP	-	ATM
Total ESP	1.20"	1.12"

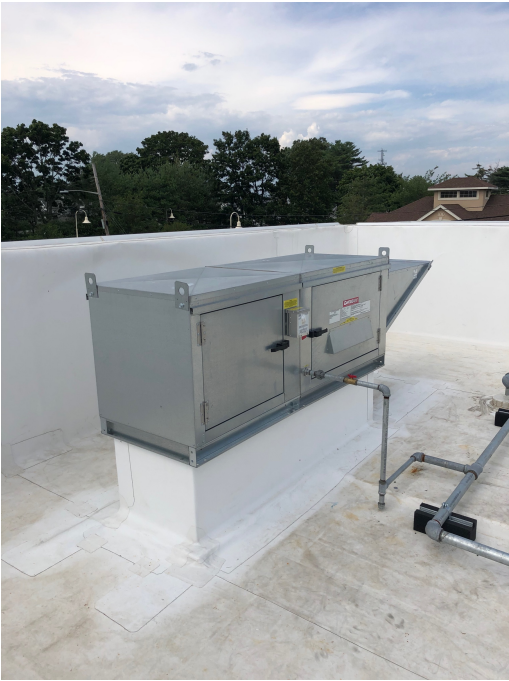
MAU

Unit Data		
	Design	Actual
MFG	CAPTIVE-AIRE	CAPTIVE-AIRE
Model Num	A1-D.250-G10	A1-D.250-G10
Serial Num	-	4027098
Type	MUA	MUA
Configuration	VERTICAL DISCHARGE	VERTICAL

Test Data		
	Design	Actual
CFM	1775	1638
SF RPM	-	1120
Motor RPM	-	1766
RL Voltage	-	205/205/205
RL Amperage	-	3.3/3.4/3.4
Total ESP	0.80"	NA
Fan Discharge SP	-	NA

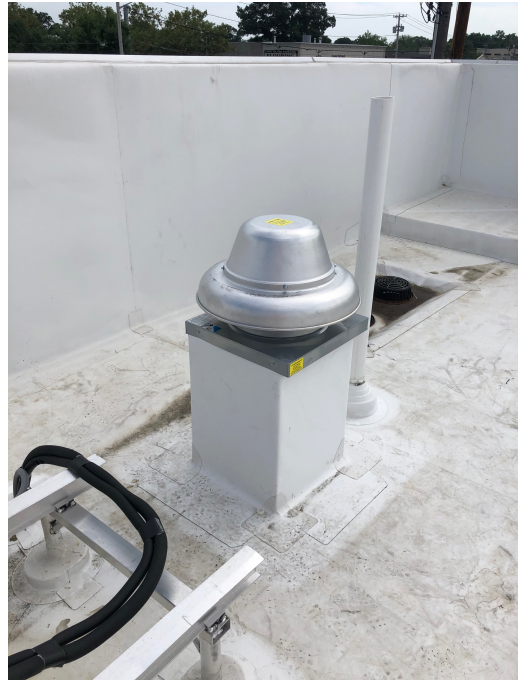
EF2

Unit Data		
	Design	Actual
MFG	CAPTIVE-AIRE	CAPTIVE-AIRE
Model Num	DR12HFA	DR12HFA
Serial Num	-	4027098
Type	CENTRIFUGAL	CENTRIFUGAL
Configuration	DOWNBLAST	DOWNBLAST

Test Data		
	Design	Actual
CFM	150	155
Fan RPM	-	860
Fan Rotation	-	CCW
Motor RPM	-	860
System SetPt	-	48%
RL Voltage	-	125
RL Amperage	-	0.23
Total ESP	0.60"	0.41"
Fan Inlet SP	-	-0.41"
Fan Discharge SP	-	ATM

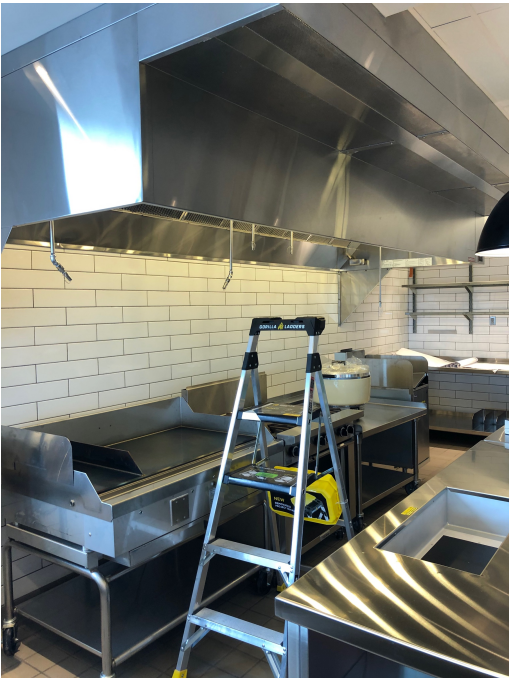
HOOD

Unit Data		
	Design	Actual
MFG	CAPTIVE-AIRE	CAPTIVE-AIRE
Model Num	5424 ND-2-ACPSP-F	5424 ND-2-ACPSP-F
Job / Serial Num	-	4027098
Type	TYPE I CANOPY	TYPE I
Hood length	156	156
Hood Width	54	54
Supply Plenum Type	ACPSP	ACPSP
Supply Plenum Width	12	12
Supply Plenum Length	168	168

Performance Data		
	Design	Actual
Exh-Supply Net CFM	1150	1468
Smoke Generation Type	-	90 SECOND EMITTER
Cooking Equip Heat On	-	YES
Hood Capture %	-	100%
End Panels Installed (Y/N)	-	YES
Space Offset Temp Riser 1	-	15
Space Offset Temp Riser 2	-	15
Riser Temp F (idle) Riser 1	-	72.8
Riser Temp F (idle) Riser 2	-	73.3
Ambient Room Temp	-	72.0
100% override functional	-	YES
