Report: TAB Report
Function: Test, Adjust, & Balance
Date: 03/12/2026
Completed By: National TAB

03-09-26 Culvers - Brooklyn, OH

5080 Tiedeman Rd

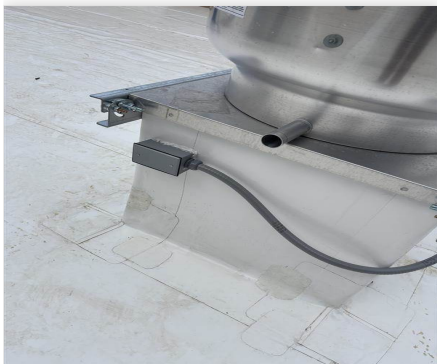
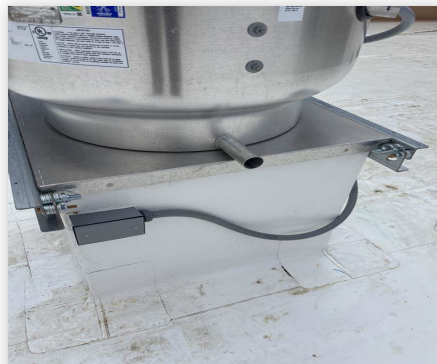
Issue Name : PRV-2 & PRV-3 missing grease cups
Description : Grease cups were not shipped with the units. Recommend requesting them from Accurex to prevent grease buildup on roof
Created By : National TAB **Assigned To :** National TAB - Brianna Biggs
Status : Open
Priority : Low **Asset Tag :**
Originated Date : 03/11/2026 - Aaron Cosby - National TAB

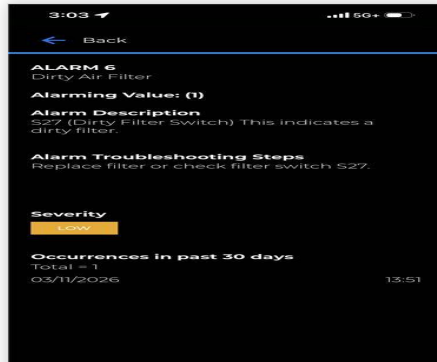
Issue Name : RTU-1 & RTU-2 dirty filters
Description : Filters were not changed after construction. Recommend replacing (12x 24"X24"X2")
Created By : National TAB **Assigned To :** National TAB - Brianna Biggs
Status : Open
Priority : Medium **Asset Tag :**
Originated Date : 03/11/2026 - Aaron Cosby - National TAB

- **03/12/2026 National TAB - Aaron Cosby**
 - Filters will be replaced 3/16/26 or 3/17/26

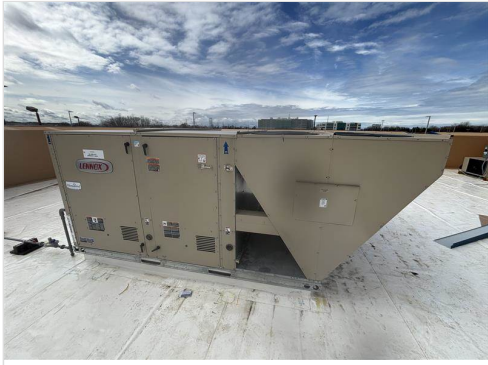
Asset: RTU1

Unit Data		
	Design	Actual
MFG	ACCUREX	LENNOX
Serial Num	-	5625L03497
Model Num	XRT-70-15L-G-G0	LGT240H5MS1Y
Type	RTU	RTU
Configuration	VERTICAL	VERTICAL
Num OA Filters 1	-	3
OA Filter Size 1	-	25"X13"
Num Final Filter 1	-	6
Final Filter Size 1	-	24"X24"X2"

Test Data		
	Design	Actual
SF CFM	6150	5990
SF RPM	2503	979
RA CFM	4400	4158
OA CFM	1750	1832
RL Voltage	-	214/215/216
RL Amperage	-	12.18 VFD
SF Rotation	-	CCW
SF System SetPt	-	74 HZ
Min OA Damper Position	-	42%
Min OA Damper Type	-	ECONOMIZER
OA Enthalpy Setpt	-	10 mA

General	
	Actual
Fan Rotation Correct	PASS
Unit Filters Clean	FAIL
Condensate Drain Installed	PASS

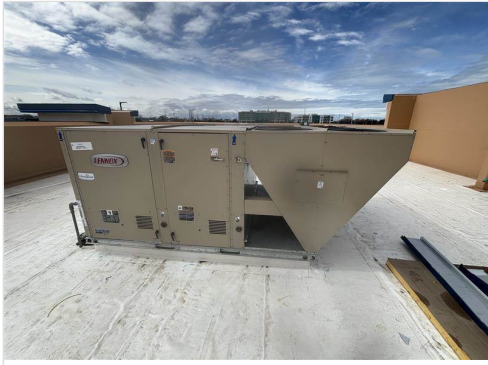
Asset: RTU2

Unit Data		
	Design	Actual
MFG	ACCUREX	LENNOX
Serial Num	-	5625L03496
Model Num	XRT-70-15L-G-G0	LGT240H5MS1Y
Type	RTU	RTU
Configuration	VERTICAL	VERTICAL
Num OA Filters 1	-	3
OA Filter Size 1	-	25"X13"
Num Final Filter 1	-	6
Final Filter Size 1	-	24"X24"X2"

Test Data		
	Design	Actual
SF CFM	6150	6610
SF RPM	2503	846
RA CFM	4450	4829
OA CFM	1700	1781
RL Voltage	-	215/213/214
RL Amperage	-	10.59 VFD
SF Rotation	-	CCW
SF System SetPt	-	64 HZ
Min OA Damper Position	-	38%
Min OA Damper Type	-	ECONOMIZER
OA Enthalpy Setpt	-	10 mA

General	
	Actual
Fan Rotation Correct	GOOD
Unit Filters Clean	FAIL
Condensate Drain Installed	GOOD

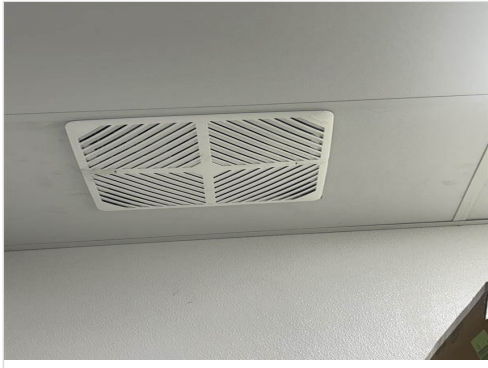
Asset: EF1

Unit Data		
	Design	Actual
MFG	ACCUREX	GREENHECK
Model Num	XCR-B80	SP-B80
Serial Num	-	28149193
Type	CEILING	CEILING

Test Data		
	Design	Actual
CFM	75	68
Fan RPM	881	900
System SetPt	-	MAX
RL Voltage	-	115
RL Amperage	-	0.1
Fan Inlet SP	-	NA
Fan Discharge SP	-	ATM

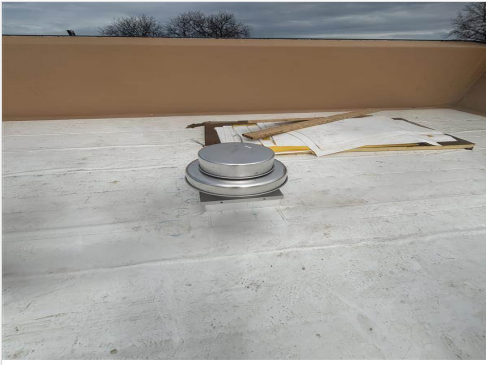
Asset: PRV1

Unit Data		
	Design	Actual
MFG	ACCUREX	ACCUREX
Model Num	XRED-090-VG	XRED-090-VG
Serial Num	-	28153660
Type	DOWNBLAST	DOWNBLAST
Configuration	VERTICAL	VERTICAL

Test Data		
	Design	Actual
CFM	375	352
Fan Rotation	-	CW
Motor RPM	-	1312
System SetPt	-	75%
RL Voltage	-	115
RL Amperage	-	1.2
Total ESP	0.50"	0.44"
Fan Inlet SP	-	-0.44"
Fan Discharge SP	-	ATM

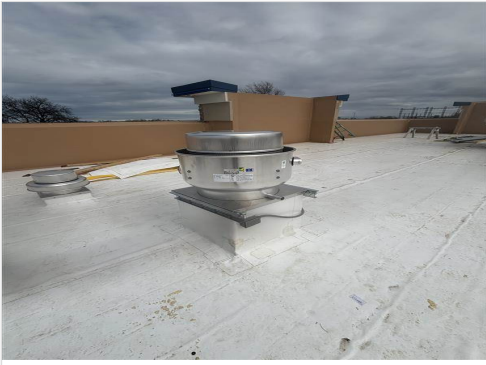
Asset: PRV2

Unit Data		
	Design	Actual
MFG	ACCUREX	ACCUREX
Model Num	XCUE-140-VG	XCUE-140-VG
Serial Num	-	281660118
Type	UPBLAST	UPBLAST
Configuration	VERTICAL	VERTICAL

Test Data		
	Design	Actual
CFM	1500	1542
Fan Rotation	-	CW
Motor RPM	-	1138
System SetPt	-	6.6 VDC
RL Voltage	-	115
RL Amperage	-	3.8
Total ESP	1.80"	0.41"
Fan Inlet SP	-	-0.41"
Fan Discharge SP	-	ATM

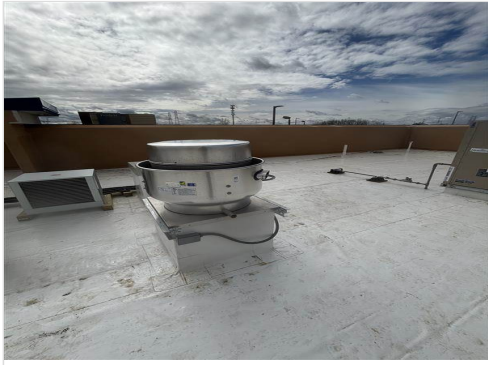
Asset: PRV3

Unit Data		
	Design	Actual
MFG	ACCUREX	ACCUREX
Model Num	XCUE-140-VG	XCUE-140-VG
Serial Num	-	281660119
Type	UPBLAST	UPBLAST
Configuration	VERTICAL	VERTICAL

Test Data		
	Design	Actual
CFM	1500	1637
Fan Rotation	-	CW
Motor RPM	-	1121
System SetPt	-	6.5 VDC
RL Voltage	-	115
RL Amperage	-	3.7
Total ESP	1.0"	0.45"
Fan Inlet SP	-	-0.45"
Fan Discharge SP	-	ATM

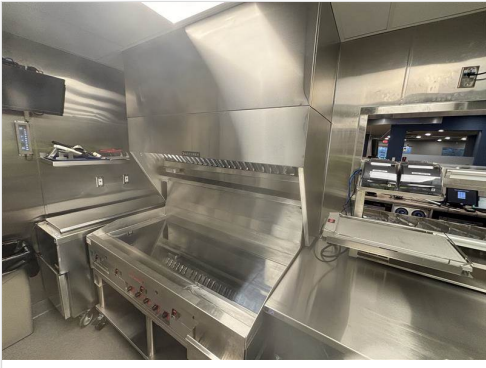
Asset: HD1

Unit Data		
	Design	Actual
MFG	ACCUREX	ACCUREX
Model Num	XSEC-64-S	XSEC-64-S
Job / Serial Num	-	28157423
Type	TYPE 1 CANOPY	TYPE I LOW PROXIMITY
Hood length	64"	64"
Hood Width	30"	26"

Test Data Exhaust		
	Design	Actual
Filter Type	X-TRACTOR	X-TRACTOR
Filter Size 1	16X16	16"X16"
Filter Qty 1	4	4
Filter AK factor size 1	1.53	1.53
Filter Total AK Area	6.12	6.12
Filter1 FPM	-	278
Filter2 FPM	-	228
Filter3 FPM	-	239
Filter4 FPM	-	265
Filter Ave FPM(corr)	-	252
CFM	1500	1542

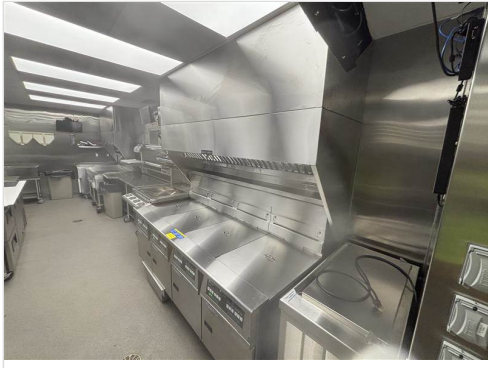
Asset: HD2

Unit Data		
	Design	Actual
MFG	ACCUREX	ACCUREX
Model Num	XSEC-83-S	XSEC-83-S
Job / Serial Num	-	28157422
Type	TYPE 1 CANOPY	TYPE I LOW PROXIMITY
Hood length	83"	83"
Hood Width	30"	26"

Test Data Exhaust		
	Design	Actual
Filter Type	X-TRACTOR	X-TRACTOR
Filter Size 1	16X16	16"X16"
Filter Qty 1	5	5
Filter AK factor size 1	1.53	1.53
Filter Total AK Area	7.65	7.65
Filter1 FPM	-	233
Filter2 FPM	-	214
Filter3 FPM	-	211
Filter4 FPM	-	180
Filter5 FPM	-	232
Filter Ave FPM(corr)	-	214
CFM	1500	1637
