Report: TAB Report
Function: Test, Adjust, & Balance
Date: 03/12/2026
Completed By: National TAB

03-09-26 Culvers - Brooklyn, OH

Project: 03-09-26 Culvers - Brooklyn, OH
Function: Test, Adjust, & Balance

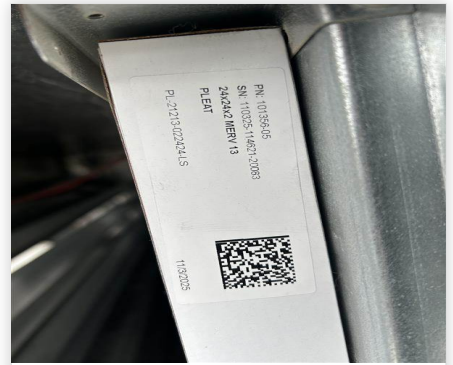
Issue Name : RTU-1 & RTU-2 dirty filters
Description : Filters were not changed after construction. Recommend replacing (12x 24"X24"X2")
Created By : National TAB **Assigned To :** National TAB - Brianna Biggs
Status : Open
Priority : Medium **Asset Tag :**
Originated Date : 03/11/2026 - Aaron Cosby - National TAB
