Report: TAB Report
Function: Test, Adjust, & Balance
Date: 03/12/2026
Completed By: National TAB

03-09-26 Culvers - Brooklyn, OH

5080 Tiedeman Rd

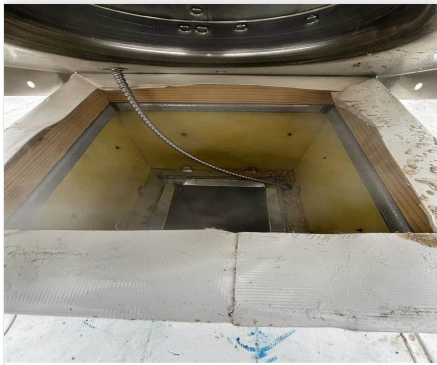
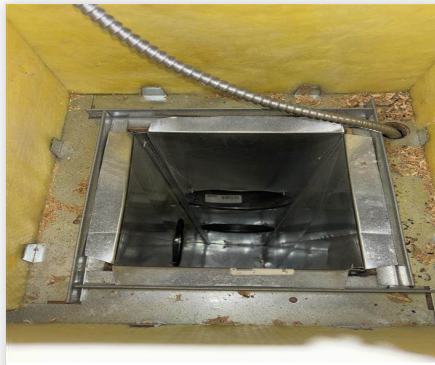
Issue Name : PRV-1 missing a backdraft damper
Description : The backdraft damper was not found at the store. Recommend installing one and ensuring it fully opens to not impact airflow.
Created By : National TAB **Assigned To :** National TAB - Will Turnbough
Status : Open
Priority : Low **Asset Tag :**
Originated Date : 03/11/2026 - Aaron Cosby - National TAB

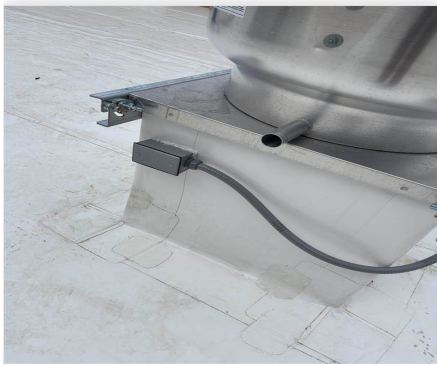
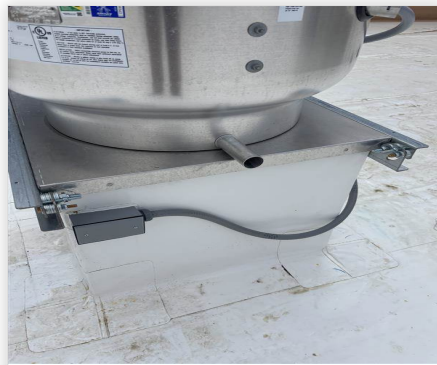
Issue Name : PRV-2 & PRV-3 missing grease cups
Description : Grease cups were not shipped with the units. Recommend requesting them from Accurex to prevent grease buildup on roof
Created By : National TAB **Assigned To :** National TAB - Will Turnbough
Status : Open
Priority : Low **Asset Tag :**
Originated Date : 03/11/2026 - Aaron Cosby - National TAB

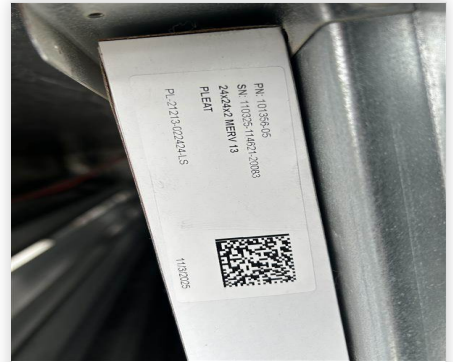
Issue Name : RTU-1 & RTU-2 dirty filters
Description : Filters were not changed after construction. Recommend replacing (12x 24"X24"X2")
Created By : National TAB **Assigned To :** National TAB - Will Turnbough
Status : Open
Priority : Medium **Asset Tag :**
Originated Date : 03/11/2026 - Aaron Cosby - National TAB

- **03/12/2026 National TAB - Aaron Cosby**
 - Filters will be replaced 3/16/26 or 3/17/26
