**Report: TAB**

**Function: Test, Adjust, & Balance**

**Date: 11/13/2025**

## 11-10-25 REI #021 REI - SACRAMENTO, CA

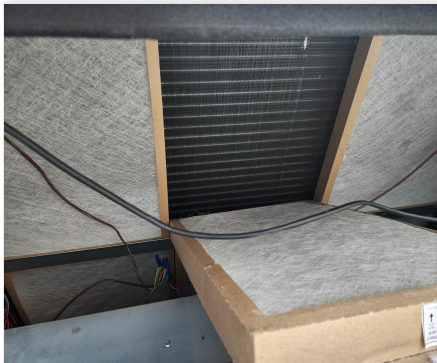
Project Issue File Details

**Issue Name :** ALL RTU'S HAVE CONSTRUCTION FILTERS INSTALLED  
**Description :** Construction filters are installed on all RTU's. Recommend to have filters replaced with standard pleated filters  
**Created By :** National TAB                      **Assigned To :** National TAB - Dan Hertenstein  
**Status :** Open  
**Priority :** Low                                      **Asset Tag :**  
**Originated Date :** 11/12/2025 - Zack Eismin - National TAB

CHANGE CONSTRUCTION FILTERS

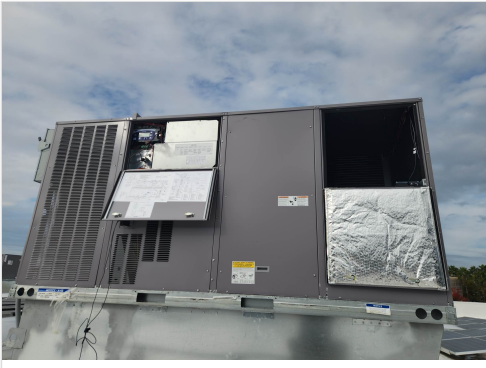
## Unit Data - PHOTO LOG

Asset: RTU1

Unit Data		
	Design	Actual
MFG	CARRIER	CARRIER
Serial Num	-	2025P04602
Model Num	50FE-M16D3M5-3U5D0	50FE-M16D3M5A3U5D0
Type	RTU	RTU
Configuration	VERTICAL	VERTICAL
Num OA Filters 1	-	2
OA Filter Size 1	-	22.5X25.5
Num Final Filter 1	-	6
Final Filter Size 1	-	18X24X2
Num Final Filter 2	-	
Final Filter Size 2	-

Test Data		
	Design	Actual
SF CFM	6000	6047
SF RPM	1747	1900
RA CFM	5100	5136
OA CFM	900	911
RL Voltage	-	9.36/9.36/9.36
RL Amperage	-	213/213/213
SF Rotation	-	CCW
SF System SetPt	-	84%
RA Damper Position	-	83%
Min OA Damper Position	-	17%
Min OA Damper Type	-	MOTORIZED
OA Enthalpy Setpt	-	N/A

Performance Data		
	Design	Actual
MA Plenum SP	-	-0.71"
Fan Suction SP	-	-1.1"
Fan Discharge SP	-	0.89"
Total ESP	1.00"	1.60"
Fan Total SP	-	1.99"

General	
	Actual
Fan Rotation Correct	YES
Unit Filters Clean	YES, CONSTRUCTION FILTERS
Condensate Drain Installed	YES

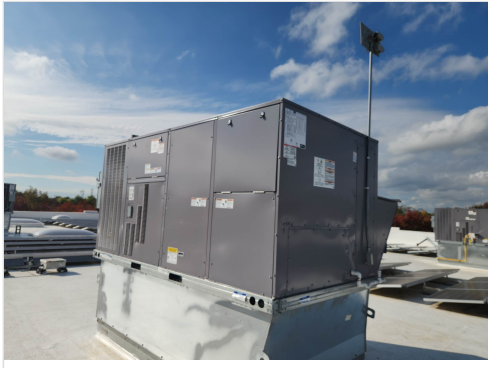
## Unit Data - PHOTO LOG

Asset: RTU2

Unit Data		
	Design	Actual
MFG	CARRIER	CARRIER
Serial Num	-	2025P04603
Model Num	50FE-M16D3M5-3U5D0	50FE-M16D3M5A3U5D0
Type	RTU	RTU
Configuration	VERTICAL	VERTICAL
Num OA Filters 1	-	2
OA Filter Size 1	-	22.5X25.5
Num Final Filter 1	-	6
Final Filter Size 1	-	18X24X2
Num Final Filter 2	-	
Final Filter Size 2	-

Test Data		
	Design	Actual
SF CFM	6000	6011
SF RPM	1747	1900
RA CFM	-	5114
OA CFM	900	897
RL Voltage	-	213/213/213
RL Amperage	-	9.31/9.31/9.31
SF Rotation	-	CCW
SF System SetPt	-	84%
RA Damper Position	-	81%
Min OA Damper Position	-	19%
Min OA Damper Type	-	MOTORIZED
OA Enthalpy Setpt	-	N/A

Performance Data		
	Design	Actual
MA Plenum SP	-	-0.72"
Fan Suction SP	-	-1.12"
Fan Discharge SP	-	0.86"
Total ESP	1.00"	1.58"
Fan Total SP	-	1.98"

General	
	Actual
Fan Rotation Correct	YES
Unit Filters Clean	YES, CONSTRUCTION FILTERS
Condensate Drain Installed	YES

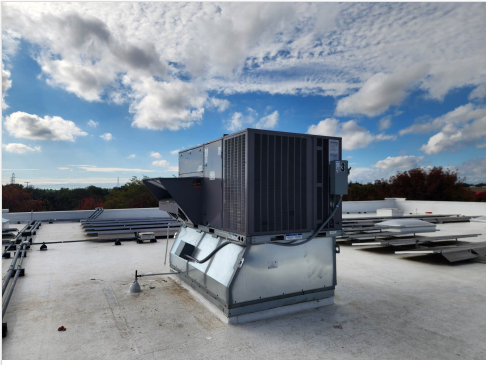
## Unit Data - PHOTO LOG

Asset: RTU3

Unit Data		
	Design	Actual
MFG	CARRIER	CARRIER
Serial Num	-	2025P04601
Model Num	50FE-M16D3M5-3U5D0	50FE-M16D3M5A3U5D0
Type	RTU	RTU
Configuration	VERTICAL	VERTICAL
Num OA Filters 1	-	2
OA Filter Size 1	-	22.5X25.5
Num Final Filter 1	-	6
Final Filter Size 1	-	18X24X2
Num Final Filter 2	-	
Final Filter Size 2	-

Test Data		
	Design	Actual
SF CFM	6000	6058
SF RPM	1747	1900
RA CFM	5100	5037
OA CFM	900	921
RL Voltage	-	213/213/213
RL Amperage	-	9.31/9.32/9.31
SF Rotation	-	CCW
SF System SetPt	-	84%
RA Damper Position	-	82%
Min OA Damper Position	-	18%
Min OA Damper Type	-	MOTORIZED
OA Enthalpy Setpt	-	N/A

Performance Data		
	Design	Actual
MA Plenum SP	-	-0.71"
Fan Suction SP	-	-1.13"
Fan Discharge SP	-	0.87"
Total ESP	1.00"	1.58"
Fan Total SP	-	2.00"

General	
	Actual
Fan Rotation Correct	YES
Unit Filters Clean	YES, CONSTRUCTION FILTERS
Condensate Drain Installed	YES

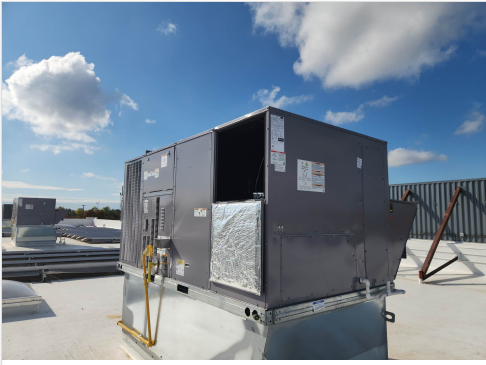
## Unit Data - PHOTO LOG

Asset: RTU4

Unit Data		
	Design	Actual
MFG	CARRIER	CARRIER
Serial Num	-	2025P004551
Model Num	48FEEM16D3M5-3U5D0	48FEEM16D3M5A3U5D0
Type	RTU	RTU
Configuration	VERTICAL	VERTICAL
Num OA Filters 1	-	2
OA Filter Size 1	-	22.5C25.5
Num Final Filter 1	-	6
Final Filter Size 1	-	18X24X2
Num Final Filter 2	-	
Final Filter Size 2	-

Test Data		
	Design	Actual
SF CFM	6000	5988
SF RPM	1823	1900
RA CFM	5100	571
OA CFM	900	917
RL Voltage	-	213/213/213
RL Amperage	-	9.4/9.4/9.4
SF Rotation	-	CCW
SF System SetPt	-	84%
RA Damper Position	-	81%
Min OA Damper Position	-	19%
Min OA Damper Type	-	MOTORIZED
OA Enthalpy Setpt	-	N/A

Performance Data		
	Design	Actual
MA Plenum SP	-	-0.73"
Fan Suction SP	-	-1.15"
Fan Discharge SP	-	0.81"
Total ESP	1"	1.54"
Fan Total SP	-	1.96"

General	
	Actual
Fan Rotation Correct	YES
Unit Filters Clean	YES, CONSTRUCTION FILTER
Condensate Drain Installed	YES

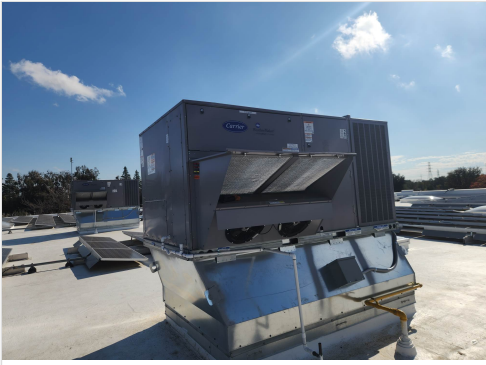
## Unit Data - PHOTO LOG

Asset: RTU5

Unit Data		
	Design	Actual
MFG	CARRIER	CARRIER
Serial Num	-	2025P04553
Model Num	48FEEM16D3M5-3U5D0	48FEEM16D3M5A3U5D0
Type	RTU	RTU
Configuration	VERTICAL	VERTICAL
Num OA Filters 1	-	2
OA Filter Size 1	-	22.5X25.5
Num Final Filter 1	-	6
Final Filter Size 1	-	18X24X2
Num Final Filter 2	-	
Final Filter Size 2	-

Test Data		
	Design	Actual
SF CFM	6000	6103
SF RPM	1823	1900
RA CFM	5100	5156
OA CFM	900	957
RL Voltage	-	213/213/213
RL Amperage	-	9.31/9.31/9.31
SF Rotation	-	CCW
SF System SetPt	-	84%
RA Damper Position	-	82%
Min OA Damper Position	-	18%
Min OA Damper Type	-	MOTORIZED
OA Enthalpy Setpt	-	N/A

Performance Data		
	Design	Actual
MA Plenum SP	-	-0.69"
Fan Suction SP	-	-1.05"
Fan Discharge SP	-	0.76"
Total ESP	1"	1.45"
Fan Total SP	-	1.81"

General	
	Actual
Fan Rotation Correct	YES
Unit Filters Clean	YES, CONSTRUCTION FILTERS
Condensate Drain Installed	YES

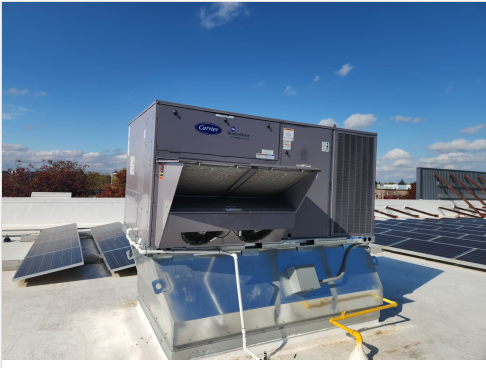
## Unit Data - PHOTO LOG

Asset: RTU6

Unit Data		
	Design	Actual
MFG	CARRIER	CARRIER
Serial Num	-	2025P04554
Model Num	48FEEM16D3M5-3U5D0	48FEEM16D3M5A3U5D0
Type	RTU	RTU
Configuration	VERTICAL	
Num OA Filters 1	-	2
OA Filter Size 1	-	22.5X25.5
Num Final Filter 1	-	6
Final Filter Size 1	-	18X24X2
Num Final Filter 2	-	
Final Filter Size 2	-

Test Data		
	Design	Actual
SF CFM	6000	6033
SF RPM	1823	1900
RA CFM	5100	5021
OA CFM	900	912
RL Voltage	-	213/213/213
RL Amperage	-	9.27/9.27/9.27
SF Rotation	-	CCW
SF System SetPt	-	84%
RA Damper Position	-	83%
Min OA Damper Position	-	17%
Min OA Damper Type	-	MOTORIZED
OA Enthalpy Setpt	-	N/A

Performance Data		
	Design	Actual
MA Plenum SP	-	-0.75"
Fan Suction SP	-	-1.17"
Fan Discharge SP	-	0.88"
Total ESP	1"	1.63"
Fan Total SP	-	1.80"

General	
	Actual
Fan Rotation Correct	YES
Unit Filters Clean	YES, CONSTRUCTION FILTERS
Condensate Drain Installed	YES

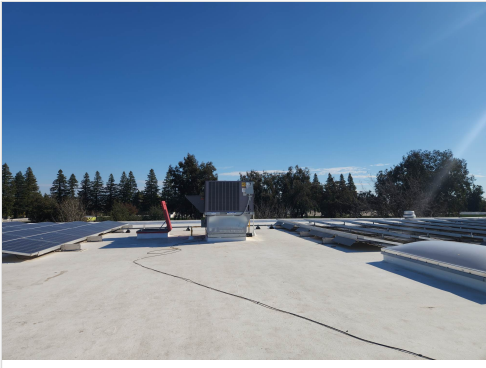
## Unit Data - PHOTO LOG

Asset: RTU7

Unit Data		
	Design	Actual
MFG	CARRIER	CARRIER
Serial Num	-	2325P77749
Model Num	48FEEM08D3M5-3U5D0	48FEEM08D3M5A3U5D0
Type	RTU	RTU
Configuration	VERTICAL	VERTICAL
Num OA Filters 1	-	1
OA Filter Size 1	-	35X19.5
Num Final Filter 1	-	4
Final Filter Size 1	-	20X16X2
Num Final Filter 2	-	
Final Filter Size 2	-

Test Data		
	Design	Actual
SF CFM	3000	3019
SF RPM	-	1639
RA CFM	2550	2560
OA CFM	450	459
RL Voltage	-	213/213/213
RL Amperage	-	5.7/5.7/5.7
SF Rotation	-	CCW
SF System SetPt	-	72%
RA Damper Position	-	82%
Min OA Damper Position	-	18%
Min OA Damper Type	-	MOTORIZED
OA Enthalpy Setpt	-	N/A

Performance Data		
	Design	Actual
MA Plenum SP	-	-0.59"
Fan Suction SP	-	-0.97"
Fan Discharge SP	-	0.67"
Total ESP	-	1.26"
Fan Total SP	-	1.64"

General	
	Actual
Fan Rotation Correct	YES
Unit Filters Clean	YES, CONSTRUCTION FILTERS
Condensate Drain Installed	YES

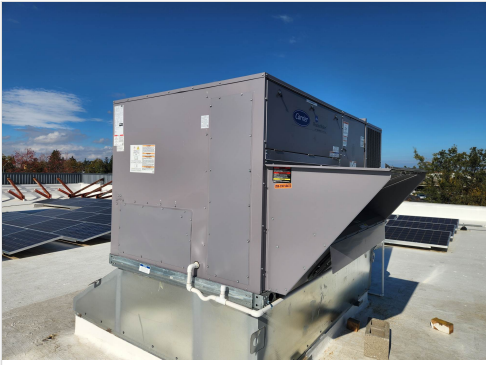
## Unit Data - PHOTO LOG

Asset: RTU8

Unit Data		
	Design	Actual
MFG	CARRIER	CARRIER
Serial Num	-	2025P04552
Model Num	48FEEM16D3M5-3U5D0	48FEEM16D3M5A3U5D0
Type	RTU	RTU
Configuration	VERTICAL	VERTICAL
Num OA Filters 1	-	2
OA Filter Size 1	-	22.5X25.5
Num Final Filter 1	-	6
Final Filter Size 1	-	18X24X2
Num Final Filter 2	-	
Final Filter Size 2	-

Test Data		
	Design	Actual
SF CFM	6000	6019
SF RPM	1823	1900
RA CFM	5100	5103
OA CFM	900	916
RL Voltage	-	213/213/213
RL Amperage	-	9.35/9.35/9.35
SF Rotation	-	CCW
SF System SetPt	-	84%
RA Damper Position	-	83%
Min OA Damper Position	-	17%
Min OA Damper Type	-	MOTORIZED
OA Enthalpy Setpt	-	N/A

Performance Data		
	Design	Actual
MA Plenum SP	-	-0.71"
Fan Suction SP	-	-1.17"
Fan Discharge SP	-	0.83"
Total ESP	1"	1.54"
Fan Total SP	-	2.0"

General	
	Actual
Fan Rotation Correct	YES
Unit Filters Clean	YES, CONSTRUCTION FILTERS
Condensate Drain Installed	YES

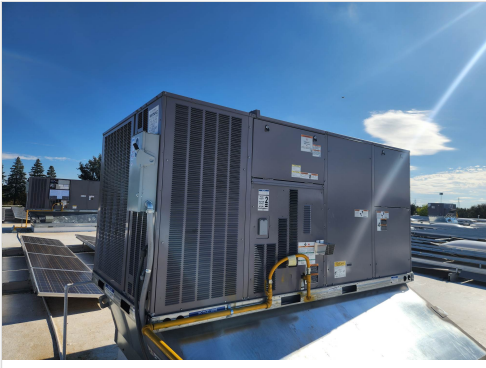
## Unit Data - PHOTO LOG

Asset: RTU9

Unit Data		
	Design	Actual
MFG	CARRIER	CARRIER
Serial Num	-	2025P04550
Model Num	48FEEM16D3M5-3U5D0	48FEEM16D3M5A3U5D0
Type	RTU	RTU
Configuration	VERTICAL	VERTICAL
Num OA Filters 1	-	2
OA Filter Size 1	-	22.5X25.5
Num Final Filter 1	-	6
Final Filter Size 1	-	18X24X2
Num Final Filter 2	-	
Final Filter Size 2	-

Test Data		
	Design	Actual
SF CFM	6000	6077
SF RPM	1823	1900
RA CFM	5100	5136
OA CFM	900	941
RL Voltage	-	213/213/213
RL Amperage	-	9.38/9.938/9.38
SF Rotation	-	CCW
SF System SetPt	-	82%
RA Damper Position	-	83%
Min OA Damper Position	-	17%
Min OA Damper Type	-	MOTORIZED
OA Enthalpy Setpt	-	N/A

Performance Data		
	Design	Actual
MA Plenum SP	-	-0.71"
Fan Suction SP	-	-1.17"
Fan Discharge SP	-	0.88"
Total ESP	1"	1.59"
Fan Total SP	-	2.05"

General	
	Actual
Fan Rotation Correct	YES
Unit Filters Clean	YES, CONSTRUCTION FILTERS
Condensate Drain Installed	YES
