Report: TAB Remarks
Function: Test, Adjust, & Balance
Date: 03/31/2026
Completed By: National TAB

Moxies Restaurant (Fort Lauderdale, FL)

Project: Moxies Restaurant (Fort Lauderdale, FL)

Issue List

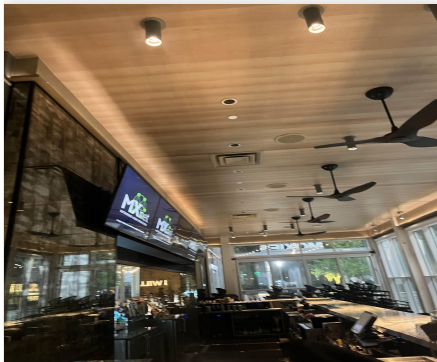
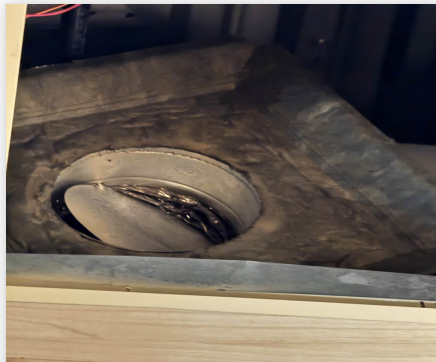
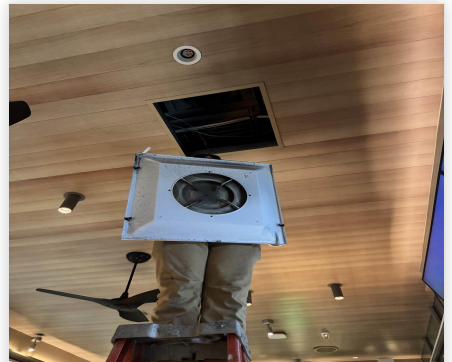
Issue Name : Additional AHU 1-6 Diffusers install
Description : Diffusers in the lower level exterior facing bar area are not fully connected to the ductwork and is causing drafting above the ceiling. Air is not properly being distributed into the space. Recommend MC properly connect collar to diffuser face for both diffusers in this area
Created By : National TAB **Assigned To :** National TAB - Joe Hertenstein
Status : Open
Priority : Urgent **Asset Tag :**
Originated Date : 03/31/2026 - Tyler Youells - National TAB

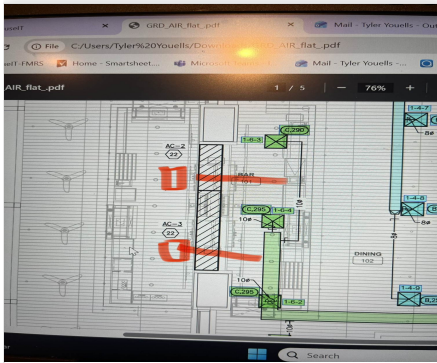
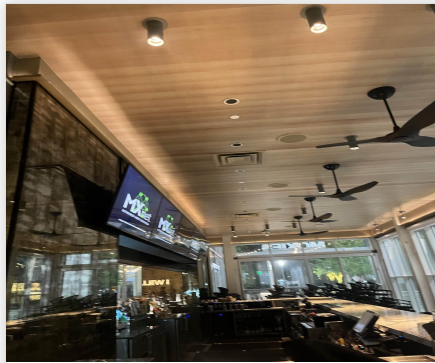
Issue Name : AHU 1-6 Ducting
Description : Two diffusers installed in the lower level exterior facing bar not shown on drawings, they appear to be connected to AHU 1-6 but need a taller ladder to confirm.
Created By : National TAB **Assigned To :** National TAB - Joe Hertenstein
Status : Open
Priority : InfoOnly **Asset Tag :**
Originated Date : 03/31/2026 - Tyler Youells - National TAB

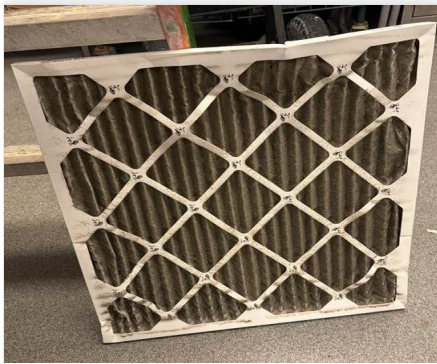
Issue Name : Air filters need to be changed
Description : air filters are well pass the change date.
Created By : National TAB **Assigned To :** National TAB - Joe Hertenstein
Status : Open
Priority : Medium **Asset Tag :**
Originated Date : 03/31/2026 - LAURA CUESTA - National TAB

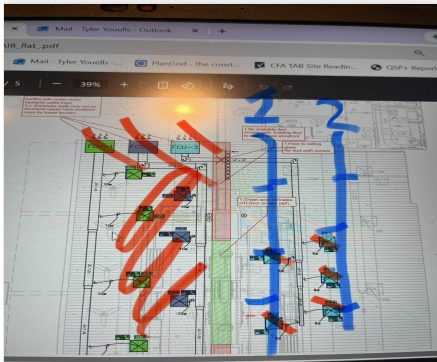
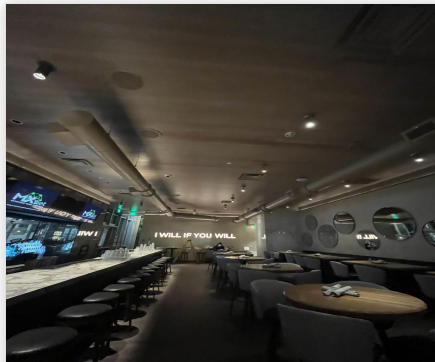
Issue Name : FCUs Note
Description : FCUs 1/2 are located, FCUs 3/4 are not found. Ducting does not match the prints and duct is exposed spiral and not connected to 4 way diffusers. Need to figure out if FCUs 3/4 exist.
Created By : National TAB **Assigned To :** National TAB - Tyler Youells
Status : Open
Priority : InfoOnly **Asset Tag :**
Originated Date : 03/31/2026 - Tyler Youells - National TAB

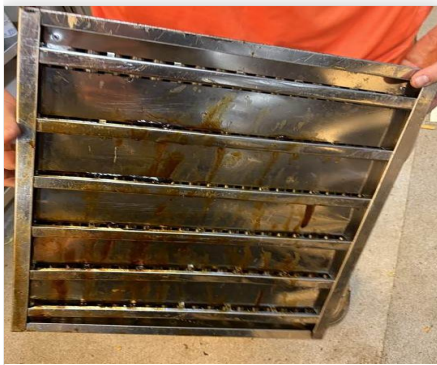
Issue Name : Hood grease filters need to be cleaned
Description : For all of the hoods the filters have not been cleaned in a while, a lot of grease build up, would recommend a cleaning baffle filters
Created By : National TAB **Assigned To :** National TAB - Joe Hertenstein
Status : Open
Priority : Medium **Asset Tag :**
Originated Date : 03/31/2026 - LAURA CUESTA - National TAB

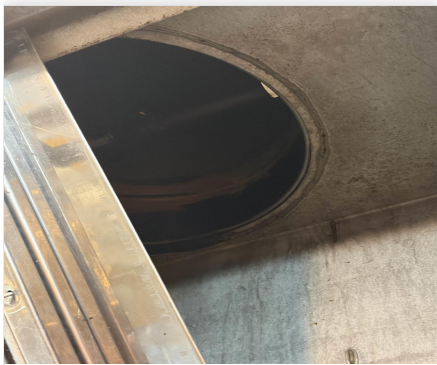
Issue Name : Hood out of design
Description : Hoods have no way of restricting air flow, preventing from increasing speed setpoints, as it will have a knock on affect for all since they share the same fan
Created By : National TAB **Assigned To :** National TAB - Joe Hertenstein
Status : Open
Priority : Medium **Asset Tag :**
Originated Date : 03/31/2026 - LAURA CUESTA - National TAB

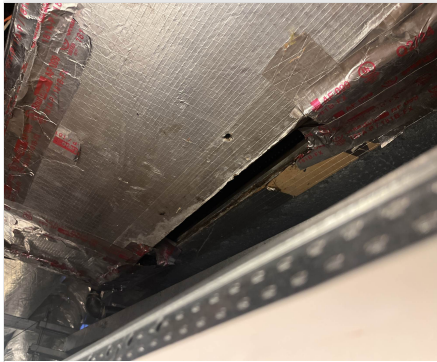
Issue Name : Seal AHU1-3 MA plenum
Description : Seal the 2" gap between the mixed air plenum and unit. Air is being sucked up through the gap from above ceiling for AHU1.3
Created By : National TAB **Assigned To :** National TAB - Joe Hertenstein
Status : Open
Priority : Medium **Asset Tag :**
Originated Date : 03/31/2026 - Tyler Youells - National TAB
