Report: PRELIMINARY TAB REPORT

Function: Test, Adjust, & Balance

04-07-25 FIVE GUYS TOLEDO, OH

6920 CENTRAL AVE

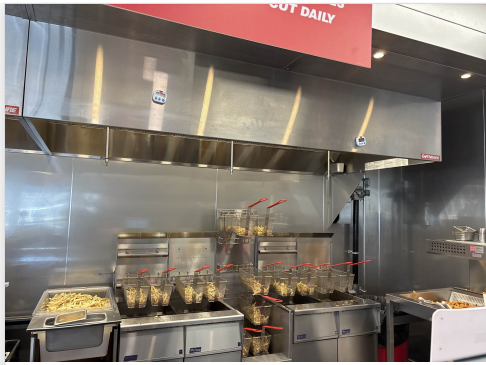
Unit Data - PHOTO LOG

Asset: HD1

AREA:FRYER HOOD

Unit Data		
	Design	Actual
MFG	CAPTIVEAIRE	CAPTIVEAIRE
Model Num	5424 ND-2-ACPSP-F	5424 ND-2
Job / Serial Num	-	6879563
Type	TYPE I - CANOPY	TYPE 1 CANOPY
Hood length	108"	105"
Hood Width	54"	54"
Supply Plenum Type	-	ACPSP
Supply Plenum Width	14"	14"
Supply Plenum Length	129"	105"

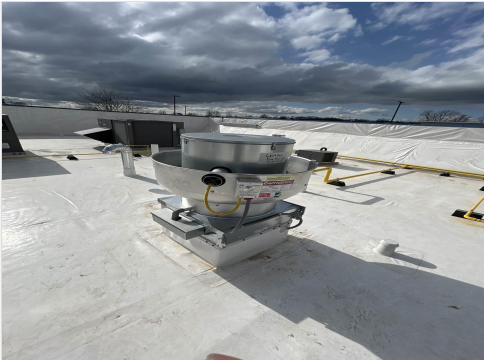
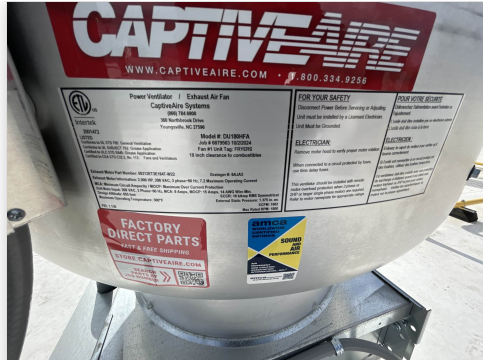
Unit Data - PHOTO LOG

Asset: EF1

AREA:FRYER HOOD

Unit Data		
	Design	Actual
MFG	CAPTIVEAIRE	CAPTIVEAIRE
Model Num	DU180HFA	DU180HFA
Serial Num	-	6879563
Type	UPBLAST	UPBLAST
Configuration	CEILING	VERTICAL
