Report: TAB

Function: Test, Adjust, & Balance

04-07-25 FIVE GUYS TOLEDO, OH

Project: 04-07-25 FIVE GUYS TOLEDO, OH

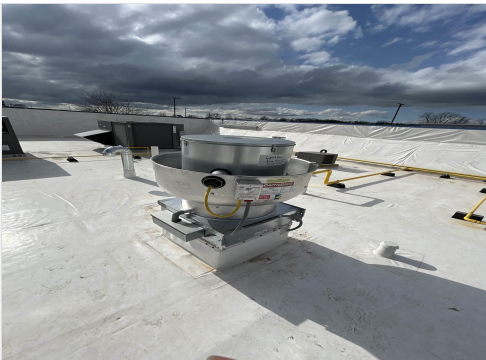
Unit Data - PHOTO LOG

Asset: EF1

AREA:FRYER HOOD

Test Data		
	Design	Actual
CFM	1662	1581
Fan RPM	-	700
Fan Rotation	-	CCW
Motor RPM	-	700
System SetPt	-	35.9Hz
RL Voltage	-	117 VFD
RL Amperage	-	3.0VFD
Total ESP	1.375"	0.54"
Fan Inlet SP	-	-0.54"
Fan Discharge SP	-	ATM

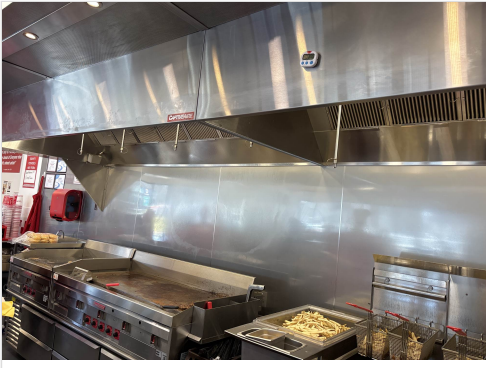
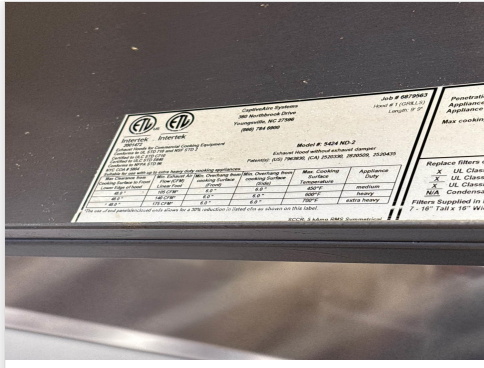
Unit Data - PHOTO LOG

Asset: HD2

AREA:GRILL HOOD

Test Data Exhaust		
	Design	Actual
Filter Type	CAPTRATE SOLO FILTER	CAPTRATE SOLO
Filter Size 1	16X16	16"X16"
Filter Qty 1	6	7
Filter AK factor size 1	1.62	1.62
Filter Total AK Area	9.72	11.34
Filter1 FPM	-	148
Filter2 FPM	-	159
Filter3 FPM	-	180
Filter4 FPM	-	185
Filter5 FPM	-	161
Filter6 FPM	-	156
Filter7 FPM	-	173
Filter Ave FPM(corr)	-	269
CFM	1852	1882
