**Report: PRELIMINARY TAB**  
**Function: Test, Adjust, & Balance**  
**Date: 04/08/2025**  
**Completed By: National TAB**

**PROJECT**  
**04-07-25 FIVE GUYS TOLEDO, OH**

Sunforest Building Company

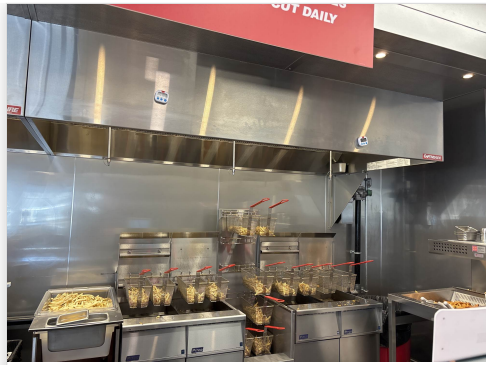
# Unit Data - PHOTO LOG

Asset: HD1

AREA:FRYER HOOD

Unit Data		
	Design	Actual
MFG	CAPTIVEAIRE	CAPTIVEAIRE
Model Num	5424 ND-2-ACPSP-F	5424 ND-2
Job / Serial Num	-	6879563
Type	TYPE I - CANOPY	TYPE 1 CANOPY
Hood length	108"	105"
Hood Width	54"	54"
Supply Plenum Type	-	ACPSP
Supply Plenum Width	14"	14"
Supply Plenum Length	129"	105"

Test Data Exhaust		
	Design	Actual
Filter Type	CAPTRATE SOLO FILTER	CAPTRATE SOLO
Filter Size 1	16X16	16"X16"
Filter Qty 1	6	6
Filter AK factor size 1	1.62	1.62
Filter Total AK Area	11.34	9.72
Filter1 FPM	-	149
Filter2 FPM	-	154
Filter3 FPM	-	182
Filter4 FPM	-	186
Filter5 FPM	-	157
Filter6 FPM	-	154
Filter Ave FPM(corr)	-	264
CFM	1662	1584

Test Data Supply		
	Design	Actual
Total Area	12.54	10.2
Kv factor (Vel)	0.89	0.89
Num of Readings	-	12
Reading1 FPM	-	92
Reading2 FPM	-	99
Reading3 FPM	-	114
Reading4 FPM	-	104
Reading5 FPM	-	132
Reading6 FPM	-	129
Reading7 FPM	-	105
Reading8 FPM	-	103
Reading9 FPM	-	79
Reading10 FPM	-	107
Reading11 FPM	-	129
Reading12 FPM	-	131
Ave FPM(corr)	-	98
CFM	1247	1125

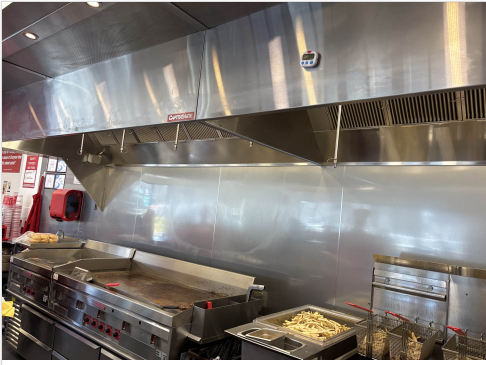
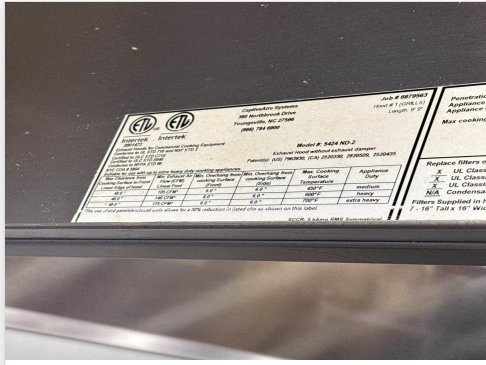
# Unit Data - PHOTO LOG

Asset: HD2

AREA:GRILL HOOD

Unit Data		
	Design	Actual
MFG	CAPTIVEAIRE	CAPTIVEAIRE
Model Num	5424 ND2-ACPSP-F	5424 ND-2
Job / Serial Num	-	6879563
Type	TYPE I - CANOPY	TYPE 1 CANOPY
Hood length	108"	117"
Hood Width	54"	54"
Supply Plenum Type	-	ACPSP
Supply Plenum Width	14"	14"
Supply Plenum Length	105"	129"

Test Data Exhaust		
	Design	Actual
Filter Type	CAPTRATE SOLO FILTER	CAPTRATE SOLO
Filter Size 1	16X16	16"X16"
Filter Qty 1	6	7
Filter AK factor size 1	1.62	1.62
Filter Total AK Area	9.72	11.34
Filter1 FPM	-	148
Filter2 FPM	-	159
Filter3 FPM	-	180
Filter4 FPM	-	185
Filter5 FPM	-	161
Filter6 FPM	-	156
Filter7 FPM	-	173
Filter Ave FPM(corr)	-	269
CFM	1852	1882

Test Data Supply		
	Design	Actual
Total Area	10.20	12.54
Kv factor (Vel)	0.89	0.89
Num of Readings	-	12
Reading1 FPM	-	135
Reading2 FPM	-	116
Reading3 FPM	-	99
Reading4 FPM	-	120
Reading5 FPM	-	102
Reading6 FPM	-	107
Reading7 FPM	-	147
Reading8 FPM	-	113
Reading9 FPM	-	144
Reading10 FPM	-	107
Reading11 FPM	-	121
Reading12 FPM	-	105
Ave FPM(corr)	-	105
CFM	1574	1480

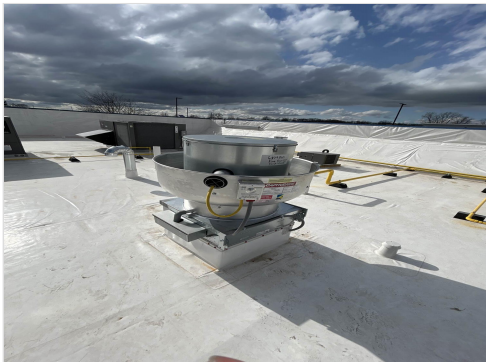
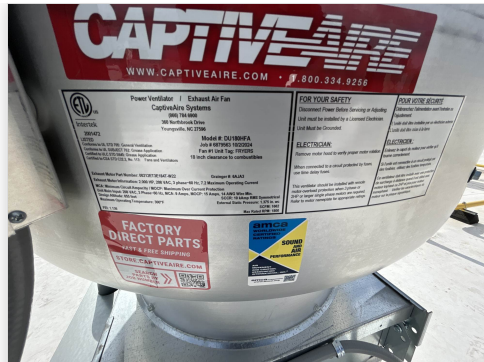
## Unit Data - PHOTO LOG

Asset: EF1

AREA:FRYER HOOD

Unit Data		
	Design	Actual
MFG	CAPTIVEAIRE	CAPTIVEAIRE
Model Num	DU180HFA	DU180HFA
Serial Num	-	6879563
Type	UPBLAST	UPBLAST
Configuration	CEILING	VERTICAL

Test Data		
	Design	Actual
CFM	1662	1581
Fan RPM	-	700
Fan Rotation	-	CCW
Motor RPM	-	700
System SetPt	-	35.9Hz
RL Voltage	-	117 VFD
RL Amperage	-	3.0VFD
Total ESP	1.375"	0.54"
Fan Inlet SP	-	-0.54"
Fan Discharge SP	-	ATM

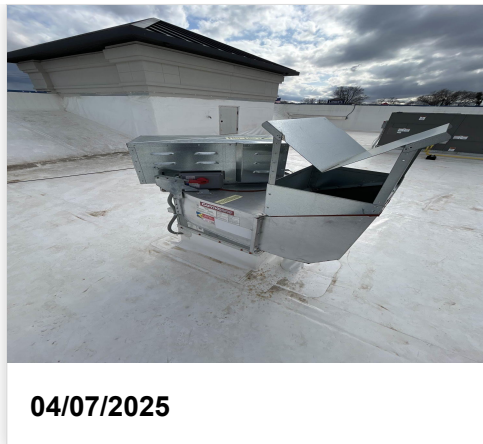
### Unit Data - PHOTO LOG

Asset: EF2

AREA:GRILL

Unit Data		
	Design	Actual
MFG	CAPTIVEAIRE	CAPTIVEAIRE
Model Num	CASRE15DD	CASRE15DD
Serial Num	-	6879563
Type	UTILITY	UTILITY SET
Configuration	VERTICAL	VERTICAL

Test Data		
	Design	Actual
CFM	1852	1882
Fan RPM	-	1468
Fan Rotation	-	CCW
Motor RPM	-	1468
System SetPt	-	50.5Hz
RL Voltage	-	112 VFD
RL Amperage	-	3.3 VFD
Total ESP	0.5"	INACCESSIBLE
Fan Inlet SP	-	INACCESSIBLE
Fan Discharge SP	-	ATM

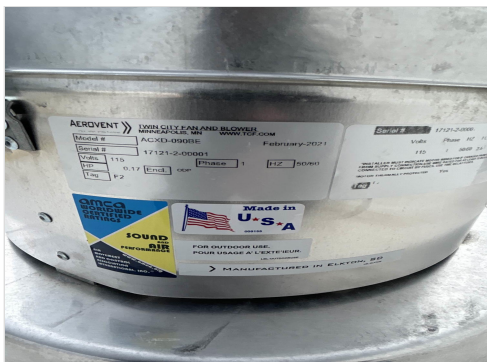
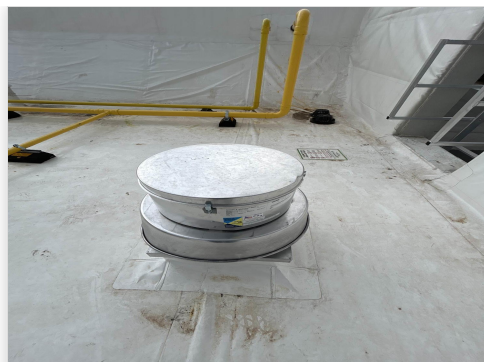
### Unit Data - PHOTO LOG

Asset: EF3

AREA:TOILET

Unit Data		
	Design	Actual
MFG	GREENHECK	TWIN CITY
Model Num	G-095-E	ACXD-090BE
Serial Num	-	17121-2-00001
Type	DOWNBLAST	DOWNBLAST
Configuration	VERTICAL	VERTICAL

Test Data		
	Design	Actual
CFM	225	222
Fan RPM	-	INACCESSIBLE
Fan Rotation	-	CCW
Motor RPM	-	INACCESSIBLE
System SetPt	-	VIA DIAL
RL Voltage	-	123
RL Amperage	-	0.4
Total ESP	0.50"	0.19"
Fan Inlet SP	-	-0.19"
Fan Discharge SP	-	ATM

Notes:  
EF3 DESIGNED AT 375 CFM. AIR DEFICE TOTALS= 225 CFM. ADJUSTED UNITS DESIGN TO REFLECT AIR DEVICE TOTALS.

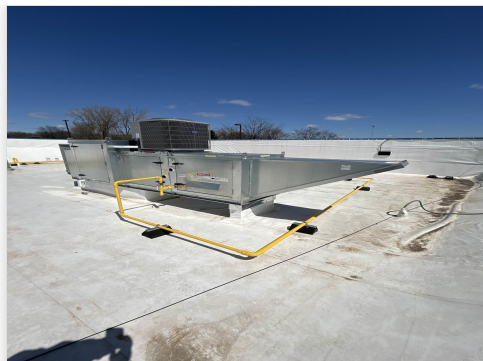
### Unit Data - PHOTO LOG

Asset: MUA1

AREA:MUA

Unit Data		
	Design	Actual
MFG	CAPTIVEAIRE	CAPTIVEAIRE
Model Num	A2-D.500-20D-MPU	A2-D.500-20D-MPU
Serial Num	-	6879563
Type	MUA	MUA
Configuration	VERTICAL	VERTICAL

Test Data		
	Design	Actual
CFM	2821	2838
SF RPM	-	1245
Motor RPM	-	1245
SF System SetPt	-	42.7Hz
RL Voltage	-	107 VFD
RL Amperage	-	5.4VFD
Total ESP	-	0.37"
Fan Discharge SP	-	0.37"

Gas Heat		
	Design	Actual
Heater Operates (y/n)	-	YES
Flame Status (pass/fail)	-	PASS
Inlet Air Temp SetPt	55	55
Discharge Air Temp SetPt	60	60
Air Flow Switch SP Actual	-	0.32"
