**Report: TAB**

**Function: Test, Adjust, & Balance**

## **04-07-25 FIVE GUYS TOLEDO, OH**

Sunforest Building Company

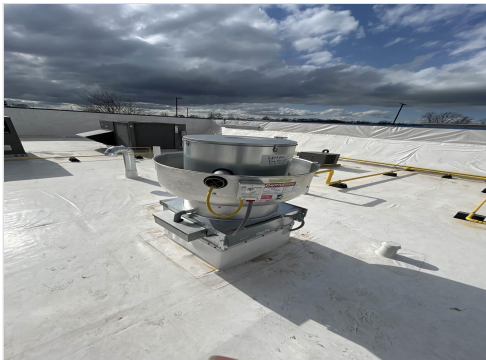
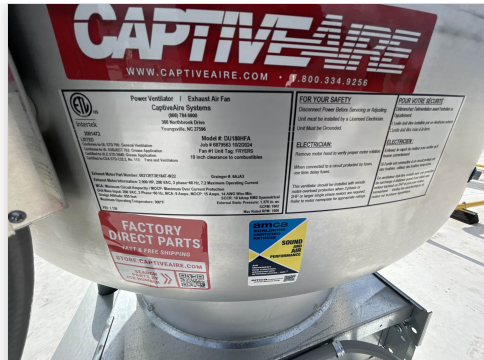
### Unit Data - PHOTO LOG

Asset: EF1

AREA:FRYER HOOD

Test Data		
	Design	Actual
CFM	1662	1581
Fan RPM	-	700
Fan Rotation	-	CCW
Motor RPM	-	700
System SetPt	-	35.9Hz
RL Voltage	-	117 VFD
RL Amperage	-	3.0VFD
Total ESP	1.375"	0.54"
Fan Inlet SP	-	-0.54"
Fan Discharge SP	-	ATM

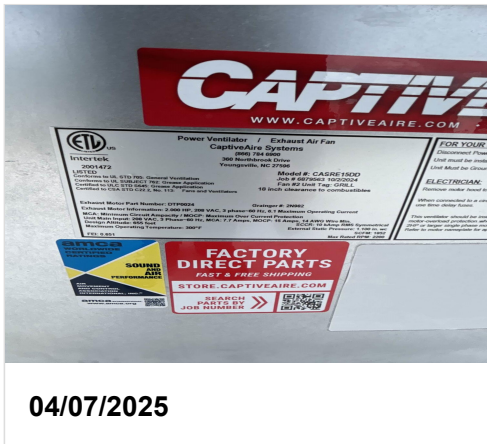
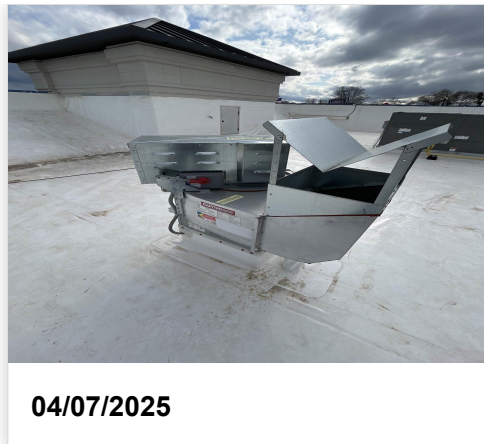
## Unit Data - PHOTO LOG

Asset: EF2

AREA:GRILL

Test Data		
	Design	Actual
CFM	1852	1882
Fan RPM	-	1468
Fan Rotation	-	CCW
Motor RPM	-	1468
System SetPt	-	50.5Hz
RL Voltage	-	112 VFD
RL Amperage	-	3.3 VFD
Total ESP	0.5"	INACCESSIBLE
Fan Inlet SP	-	INACCESSIBLE
Fan Discharge SP	-	ATM

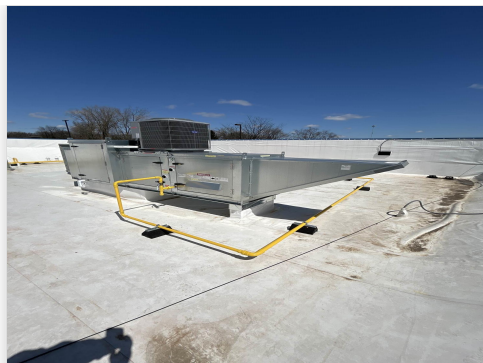
### Unit Data - PHOTO LOG

Asset: MUA1

AREA:MUA

Test Data		
	Design	Actual
CFM	2821	2838
SF RPM	-	1245
Motor RPM	-	1245
SF System SetPt	-	42.7Hz
RL Voltage	-	107 VFD
RL Amperage	-	5.4VFD
Total ESP	-	0.37"
Fan Discharge SP	-	0.37"

Gas Heat		
	Design	Actual
Heater Operates (y/n)	-	YES
Flame Status (pass/fail)	-	PASS
Inlet Air Temp SetPt	55	55
Discharge Air Temp SetPt	60	60
Air Flow Switch SP Actual	-	0.32"

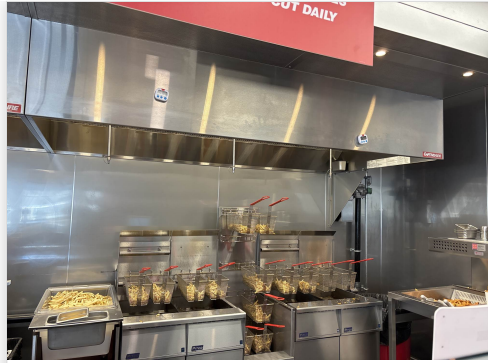
# Unit Data - PHOTO LOG

Asset: HD1

AREA:FRYER HOOD

Unit Data		
	Design	Actual
MFG	CAPTIVEAIRE	CAPTIVEAIRE
Model Num	5424 ND-2-ACPSP-F	5424 ND-2
Job / Serial Num	-	6879563
Type	TYPE I - CANOPY	TYPE 1 CANOPY
Hood length	108"	105"
Hood Width	54"	54"
Supply Plenum Type	-	ACPSP
Supply Plenum Width	14"	14"
Supply Plenum Length	129"	105"

Test Data Exhaust		
	Design	Actual
Filter Type	CAPTRATE SOLO FILTER	CAPTRATE SOLO
Filter Size 1	16X16	16"X16"
Filter Qty 1	6	6
Filter AK factor size 1	1.62	1.62
Filter Total AK Area	11.34	9.72
Filter1 FPM	-	149
Filter2 FPM	-	154
Filter3 FPM	-	182
Filter4 FPM	-	186
Filter5 FPM	-	157
Filter6 FPM	-	154
Filter Ave FPM(corr)	-	264
CFM	1662	1584
