Report: TAB

Function: Test, Adjust, & Balance

04-07-25 FIVE GUYS TOLEDO, OH

Sunforest Building Company

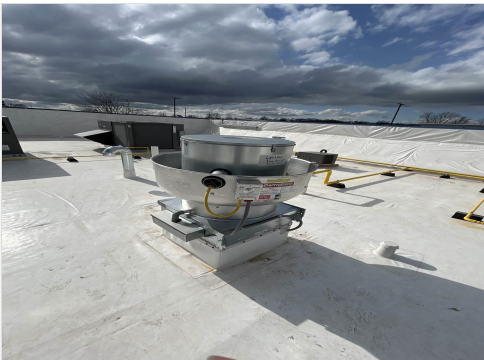
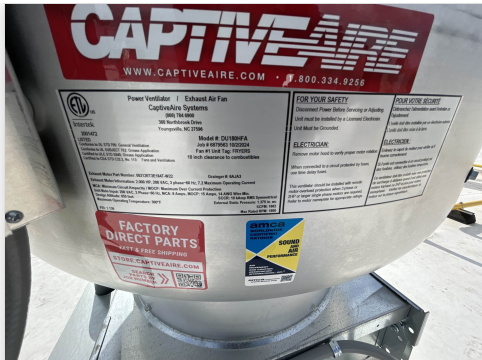
Asset: EF1

AREA:FRYER HOOD

Unit Data		
	Design	Actual
MFG	CAPTIVEAIRE	CAPTIVEAIRE
Model Num	DU180HFA	DU180HFA
Serial Num	-	6879563
Type	UPBLAST	UPBLAST
Configuration	CEILING	VERTICAL

Test Data		
	Design	Actual
CFM	1662	1581
Fan RPM	-	700
Fan Rotation	-	CCW
Motor RPM	-	700
System SetPt	-	35.9Hz
RL Voltage	-	117 VFD
RL Amperage	-	3.0VFD
Total ESP	1.375"	0.54"
Fan Inlet SP	-	-0.54"
Fan Discharge SP	-	ATM
