Report: PRELIMINARY TAB REPORT

Function: Test, Adjust, & Balance

04-07-25 FIVE GUYS TOLEDO, OH

Sunforest Building Company

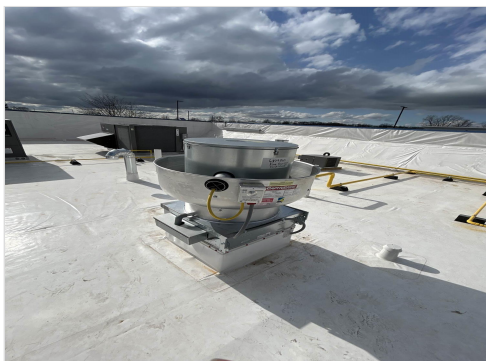
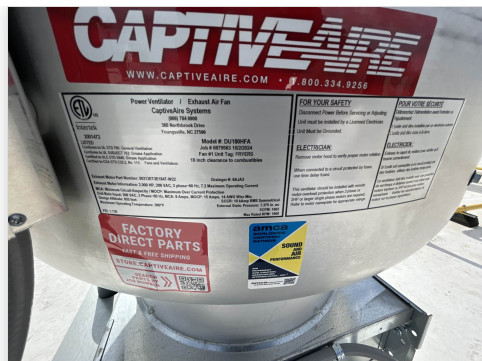
Unit Data - PHOTO LOG

Asset: EF1

AREA:FRYER HOOD

Unit Data		
	Design	Actual
MFG	CAPTIVEAIRE	CAPTIVEAIRE
Model Num	DU180HFA	DU180HFA
Serial Num	-	6879563
Type	UPBLAST	UPBLAST
Configuration	CEILING	VERTICAL

Test Data		
	Design	Actual
CFM	1662	1581
Fan RPM	-	700
Fan Rotation	-	CCW
Motor RPM	-	700
System SetPt	-	35.9Hz
RL Voltage	-	117 VFD
RL Amperage	-	3.0VFD
Total ESP	1.375"	0.54"
Fan Inlet SP	-	-0.54"
Fan Discharge SP	-	ATM

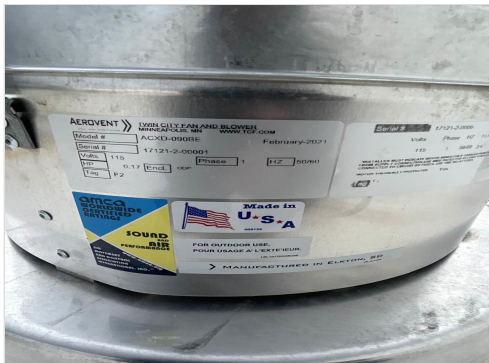
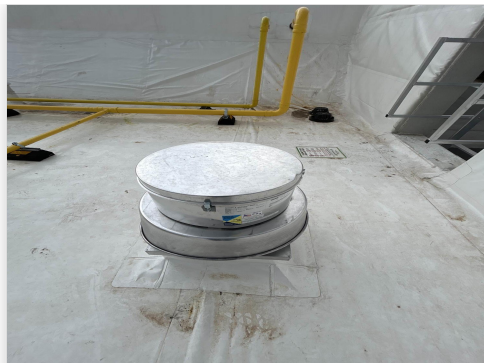
Unit Data - PHOTO LOG

Asset: EF3

AREA:TOILET

Unit Data		
	Design	Actual
MFG	GREENHECK	TWIN CITY
Model Num	G-095-E	ACXD-090BE
Serial Num	-	17121-2-00001
Type	DOWNBLAST	DOWNBLAST
Configuration	VERTICAL	VERTICAL

Test Data		
	Design	Actual
CFM	225	222
Fan RPM	-	INACCESSIBLE
Fan Rotation	-	CCW
Motor RPM	-	INACCESSIBLE
System SetPt	-	VIA DIAL
RL Voltage	-	123
RL Amperage	-	0.4
Total ESP	0.50"	0.19"
Fan Inlet SP	-	-0.19"
Fan Discharge SP	-	ATM

EF3 DESIGNED AT 375 CFM. AIR DEFICE TOTALS= 225 CFM. ADJUSTED UNITS DESIGN TO REFLECT AIR DEVICE TOTALS.
