Report: TAB REPORT
Function: Test, Adjust, & Balance
Date: 08/06/2024

PROJECT
07-29-24 CAVA CHESTERFIELD, VA
(IRONWILL CENTRE)

Project: 07-29-24 CAVA CHESTERFIELD, VA (IRONWILL CENTRE)

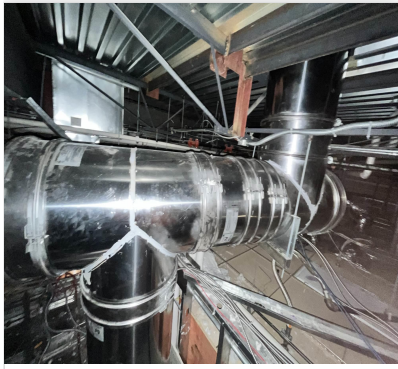
Grease duct is the Captiveaire round duct
