**Report: TAB Report**  
**Function: Test, Adjust, & Balance**  
**Date: 07/08/2025**  
**Completed By: National TAB**

**07-07-25 WAWA #0888 NEWARK, DE**

2645 CAPITOL TRAIL

WAWA ENGINEERS

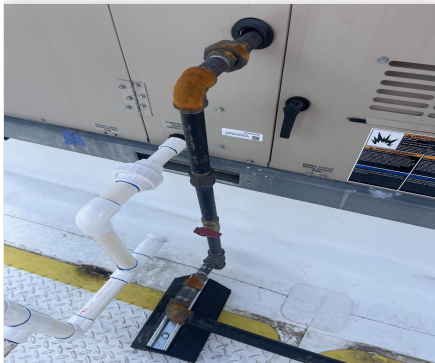
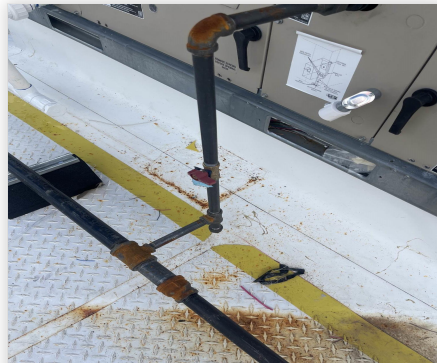
Project Issue File Details

**Issue Name :** RTU-1/3 Gas valves off  
**Description :** RTU-1/3 has valves are off at time of TAB. MC to complete proper startup of heater when gas is on to the building.  
**Created By :** National TAB                      **Assigned To :** National TAB - Dan Hertenstein  
**Status :** Open  
**Priority :** Low                                      **Asset Tag :**  
**Originated Date :** 07/07/2025 - Tyler Youells - National TAB

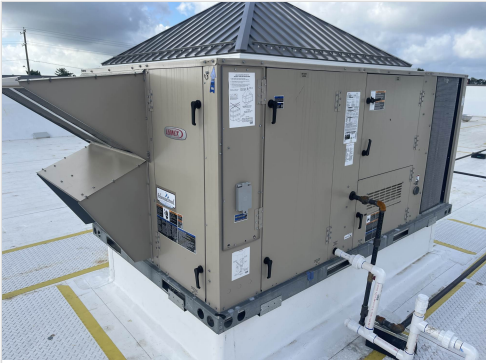
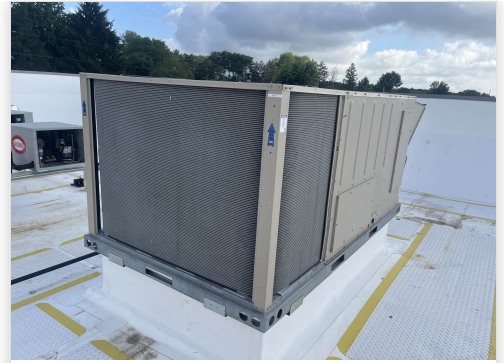
Asset: RTU1

Unit Data		
	Design	Actual
MFG	LENNOX ENLIGHT	LENNOX ENLIGHT
Serial Num	-	5623L01660
Model Num	LGT092H4E	LGT092H4ES1Y
Type	RTU	RTU
Configuration	VERTICAL	VERTICAL
Num OA Filters 1	-	2
OA Filter Size 1	-	25X16
Num Final Filter 1	-	4
Final Filter Size 1	-	20X25X2

Test Data		
	Design	Actual
SF CFM	3000	2970
SF RPM	-	1298
MOTOR RPM	-	1298
RA CFM	2450	2427
OA CFM	550	543
RL Voltage	-	207.1/207.5/206.5
RL Amperage	-	2.5/2.5/2.5
SF System SetPt	-	59%
RA Damper Position	-	MECHANICAL LINKAGE
OA Damper Position	-	28%
OA Damper Type	-	ECONOMIZER

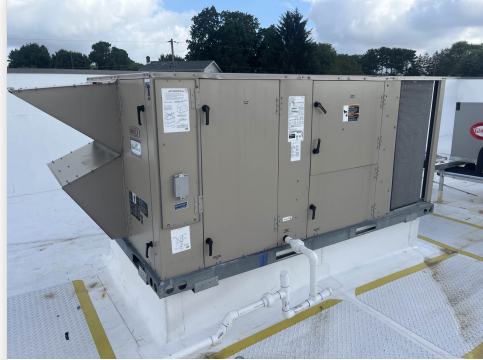
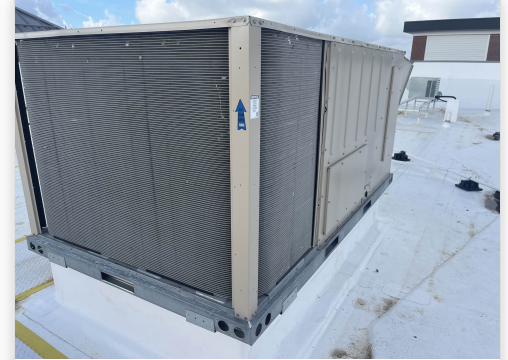
Asset: RTU2

Unit Data		
	Design	Actual
MFG	LENNOX ENLIGHT	LENNOX ENLIGHT
Serial Num	-	5624A03656
Model Num	LCT150H4E	LCT150H4EN1Y
Type	RTU	RTU
Configuration	VERTICAL	VERTICAL
Num OA Filters 1	-	2
OA Filter Size 1	-	25X16
Num Final Filter 1	-	4
Final Filter Size 1	-	20X25X2

Test Data		
	Design	Actual
SF CFM	5000	5032
SF RPM	-	2024
MOTOR RPM	-	2024
RA CFM	4050	4069
OA CFM	950	963
RL Voltage	-	206.4/206.1/206.1
RL Amperage	-	7.5/7.5/7.4
SF System SetPt	-	92%
RA Damper Position	-	MECHANICAL LINKAGE
OA Damper Position	-	28%
OA Damper Type	-	ECONOMIZER

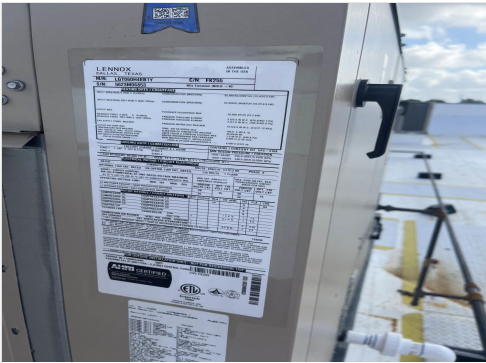
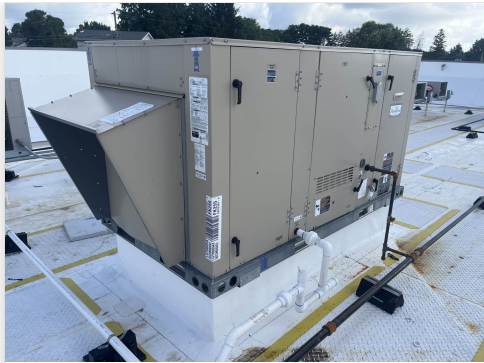
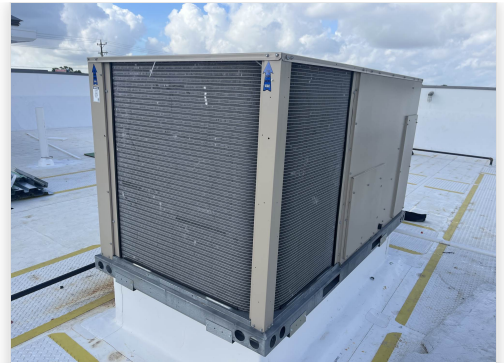
Asset: RTU3

Unit Data		
	Design	Actual
MFG	LENNOX ENLIGHT	LENNOX ENLIGHT
Serial Num	-	5623M06853
Model Num	LGT060H4E	LGT060H4EB1Y
Type	RTU	RTU
Configuration	VERTICAL	VERTICAL
Num OA Filters 1	-	1
OA Filter Size 1	-	30X16
Num Final Filter 1	-	4
Final Filter Size 1	-	20X20X2

Test Data		
	Design	Actual
SF CFM	2000	2008
SF RPM	-	756
MOTOR RPM	-	756
RA CFM	1600	1616
OA CFM	400	392
RL Voltage	-	206.5
RL Amperage	-	5.7
SF System SetPt	-	72%
RA Damper Position	-	MECHANICAL LINKAGE
OA Damper Position	-	10%
OA Damper Type	-	ECONOMIZER

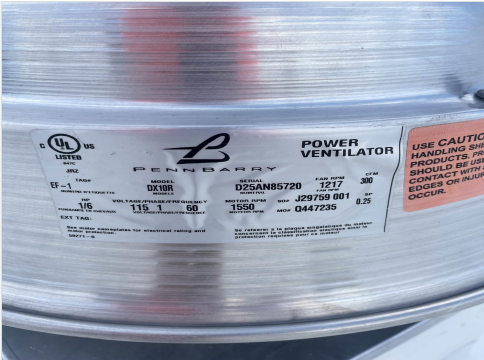
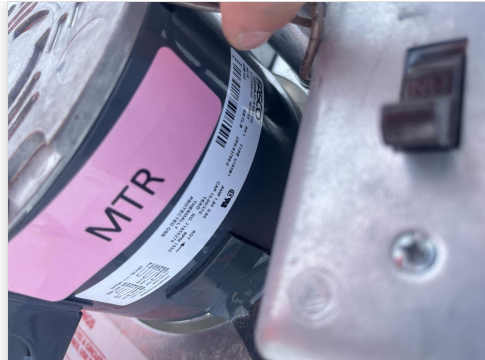
Asset: EF1

Unit Data		
	Design	Actual
MFG	PENNBARRY	PENNBARRY
Model Num	DX10R	DX10R
Serial Num	-	D25AN85720
Type	DOWNBLAST	DOWNBLAST
Configuration	VERTICAL	VERTICAL

Test Data		
	Design	Actual
CFM	300	306
Fan RPM	1550	NA
Fan Rotation	-	CCW
System SetPt	-	MARKED ON DIAL
RL Voltage	-	113.8
RL Amperage	-	1.5
Total ESP	.250"	0.48"
Fan Inlet SP	-	-0.48"
Fan Discharge SP	-	ATM
