Report: TAB Report

Function: Test, Adjust, & Balance

07-07-25 WAWA #0888 NEWARK, DE

WAWA ENGINEERS

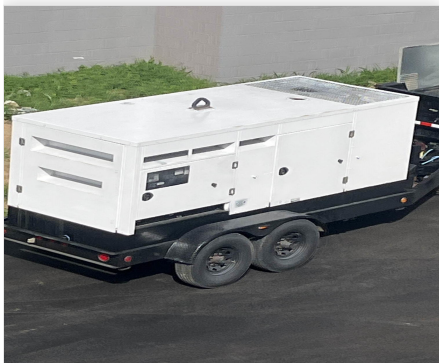
Issue Name : INFO: Generator power
Description : Building is not on permanent power at time of TAB. Building is currently on generator. All phasing was correct at time of TAB. MC/EC to verify correct phasing once building is connected to permanent power
Created By : National TAB **Assigned To :** National TAB - Dan Hertenstein
Status : Open
Priority : InfoOnly **Asset Tag :**
Originated Date : 07/07/2025 - Tyler Youells - National TAB

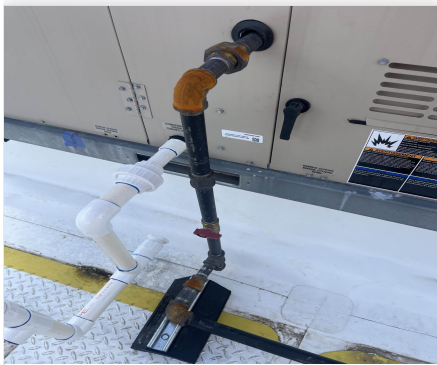
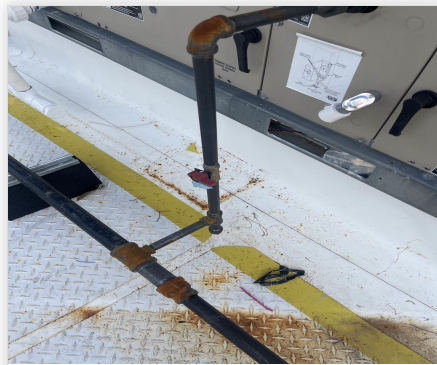
Issue Name : RTU-1/3 Gas valves off
Description : RTU-1/3 has valves are off at time of TAB. MC to complete proper startup of heater when gas is on to the building.
Created By : National TAB **Assigned To :** National TAB - Dan Hertenstein
Status : Open
Priority : Low **Asset Tag :**
Originated Date : 07/07/2025 - Tyler Youells - National TAB

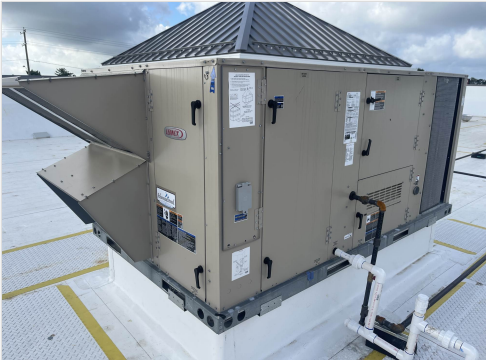
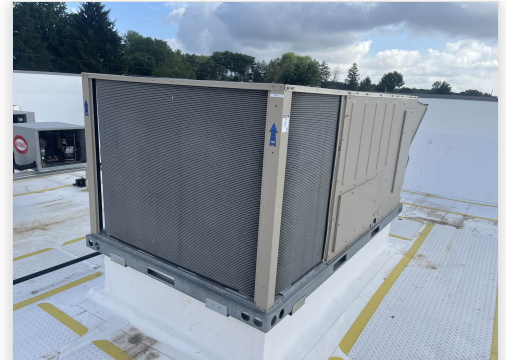
Unit Data - PHOTO LOG

Asset: RTU1

Unit Data		
	Design	Actual
MFG	LENNOX ENLIGHT	LENNOX ENLIGHT
Serial Num	-	5623L01660
Model Num	LGT092H4E	LGT092H4ES1Y
Type	RTU	RTU
Configuration	VERTICAL	VERTICAL
Num OA Filters 1	-	2
OA Filter Size 1	-	25X16
Num Final Filter 1	-	4
Final Filter Size 1	-	20X25X2

Test Data		
	Design	Actual
SF CFM	3000	2970
SF RPM	-	1298
MOTOR RPM	-	1298
RA CFM	2450	2427
OA CFM	550	543
RL Voltage	-	207.1/207.5/206.5
RL Amperage	-	2.5/2.5/2.5
SF System SetPt	-	59%
RA Damper Position	-	MECHANICAL LINKAGE
OA Damper Position	-	28%
OA Damper Type	-	ECONOMIZER

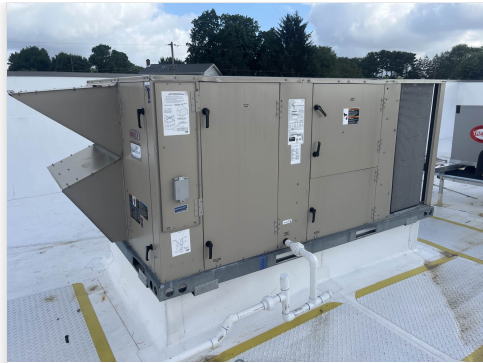
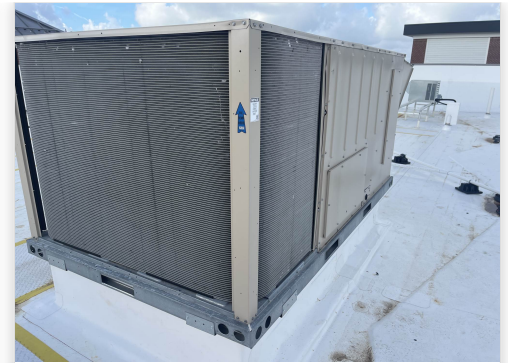
Unit Data - PHOTO LOG

Asset: RTU2

Unit Data		
	Design	Actual
MFG	LENNOX ENLIGHT	LENNOX ENLIGHT
Serial Num	-	5624A03656
Model Num	LCT150H4E	LCT150H4EN1Y
Type	RTU	RTU
Configuration	VERTICAL	VERTICAL
Num OA Filters 1	-	2
OA Filter Size 1	-	25X16
Num Final Filter 1	-	4
Final Filter Size 1	-	20X25X2

Test Data		
	Design	Actual
SF CFM	5000	5032
SF RPM	-	2024
MOTOR RPM	-	2024
RA CFM	4050	4069
OA CFM	950	963
RL Voltage	-	206.4/206.1/206.1
RL Amperage	-	7.5/7.5/7.4
SF System SetPt	-	92%
RA Damper Position	-	MECHANICAL LINKAGE
OA Damper Position	-	28%
OA Damper Type	-	ECONOMIZER

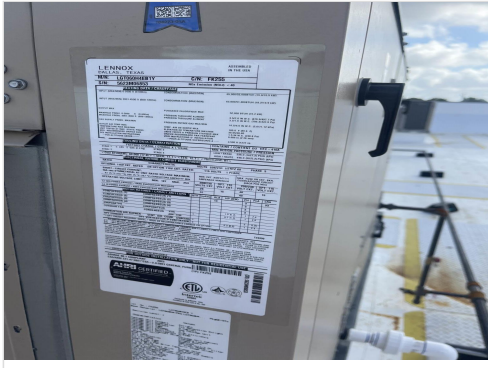
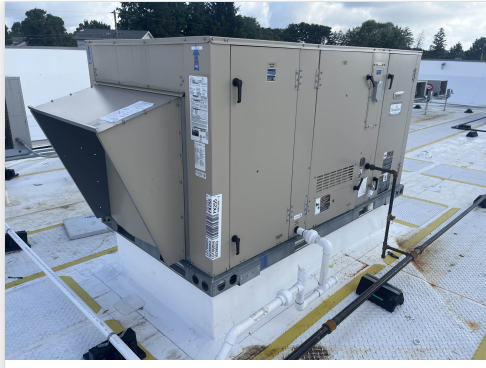
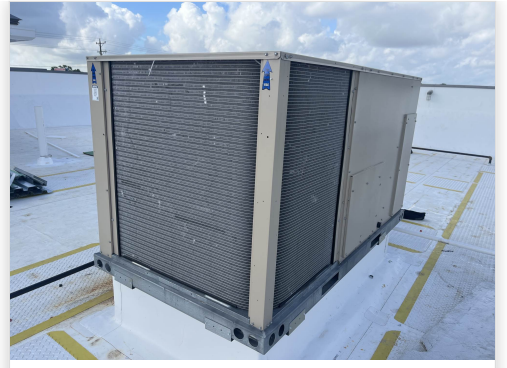
Unit Data - PHOTO LOG

Asset: RTU3

Unit Data		
	Design	Actual
MFG	LENNOX ENLIGHT	LENNOX ENLIGHT
Serial Num	-	5623M06853
Model Num	LGT060H4E	LGT060H4EB1Y
Type	RTU	RTU
Configuration	VERTICAL	VERTICAL
Num OA Filters 1	-	1
OA Filter Size 1	-	30X16
Num OA Filters 2	-	
OA Filter Size 2	-	
Num Final Filter 1	-	4
Final Filter Size 1	-	20X20X2
Num Final Filter 2	-	
Final Filter Size 2	-

Test Data		
	Design	Actual
SF CFM	2000	2008
SF RPM	-	756
MOTOR RPM	-	756
RA CFM	1600	1616
OA CFM	400	392
RL Voltage	-	206.5
RL Amperage	-	5.7
SF System SetPt	-	72%
RA Damper Position	-	MECHANICAL LINKAGE
OA Damper Position	-	10%
OA Damper Type	-	ECONOMIZER

RTU-3 was missing power exhaust relief dampers but MC installed

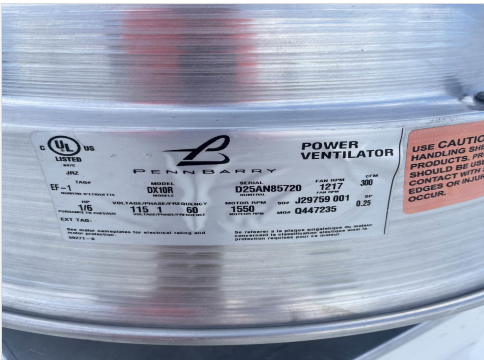
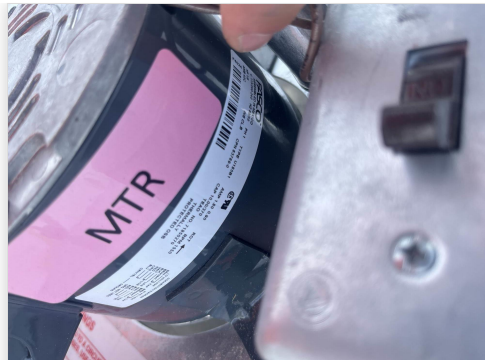
Unit Data - PHOTO LOG

Asset: EF1

Unit Data		
	Design	Actual
MFG	PENNBARRY	PENNBARRY
Model Num	DX10R	DX10R
Serial Num	-	D25AN85720
Type	DOWNBLAST	DOWNBLAST
Configuration	VERTICAL	VERTICAL

Test Data		
	Design	Actual
CFM	300	306
Fan RPM	1550	NA
Fan Rotation	-	CCW
System SetPt	-	MARKED ON DIAL
RL Voltage	-	113.8
RL Amperage	-	1.5
Total ESP	.250"	0.48"
Fan Inlet SP	-	-0.48"
Fan Discharge SP	-	ATM

EC wired in the speed controller for EF-1

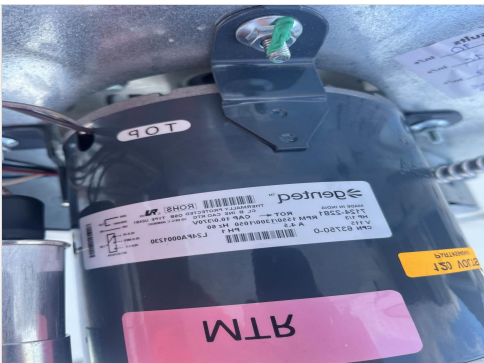
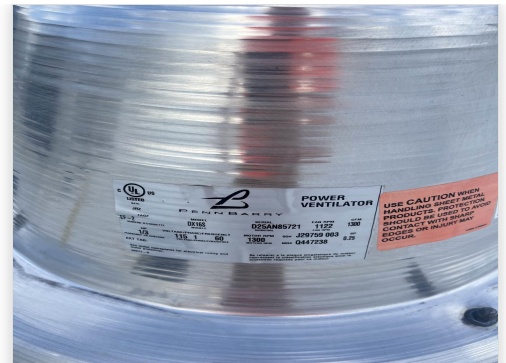
Unit Data - PHOTO LOG

Asset: EF2

Test Data		
	Design	Actual
CFM	1300	969
Fan Rotation	-	CCW
System SetPt	-	FULL SPEED
RL Voltage	-	116.1
RL Amperage	-	4.7
Total ESP	.250"	0.87"
Fan Inlet SP	-	-0.87"
Fan Discharge SP	-	ATM

[1] BACKDRAFT DAMPER INSTALLED IS TOO SMALL AND IS NOW RESTRICTING FLOW. UNABLE TO BALANCE UNIT TO DESIGN

EF-2 cannot achieve +/-5%, the backdraft damper installed is too small and is restricting flow. suction pressure was -0.89"

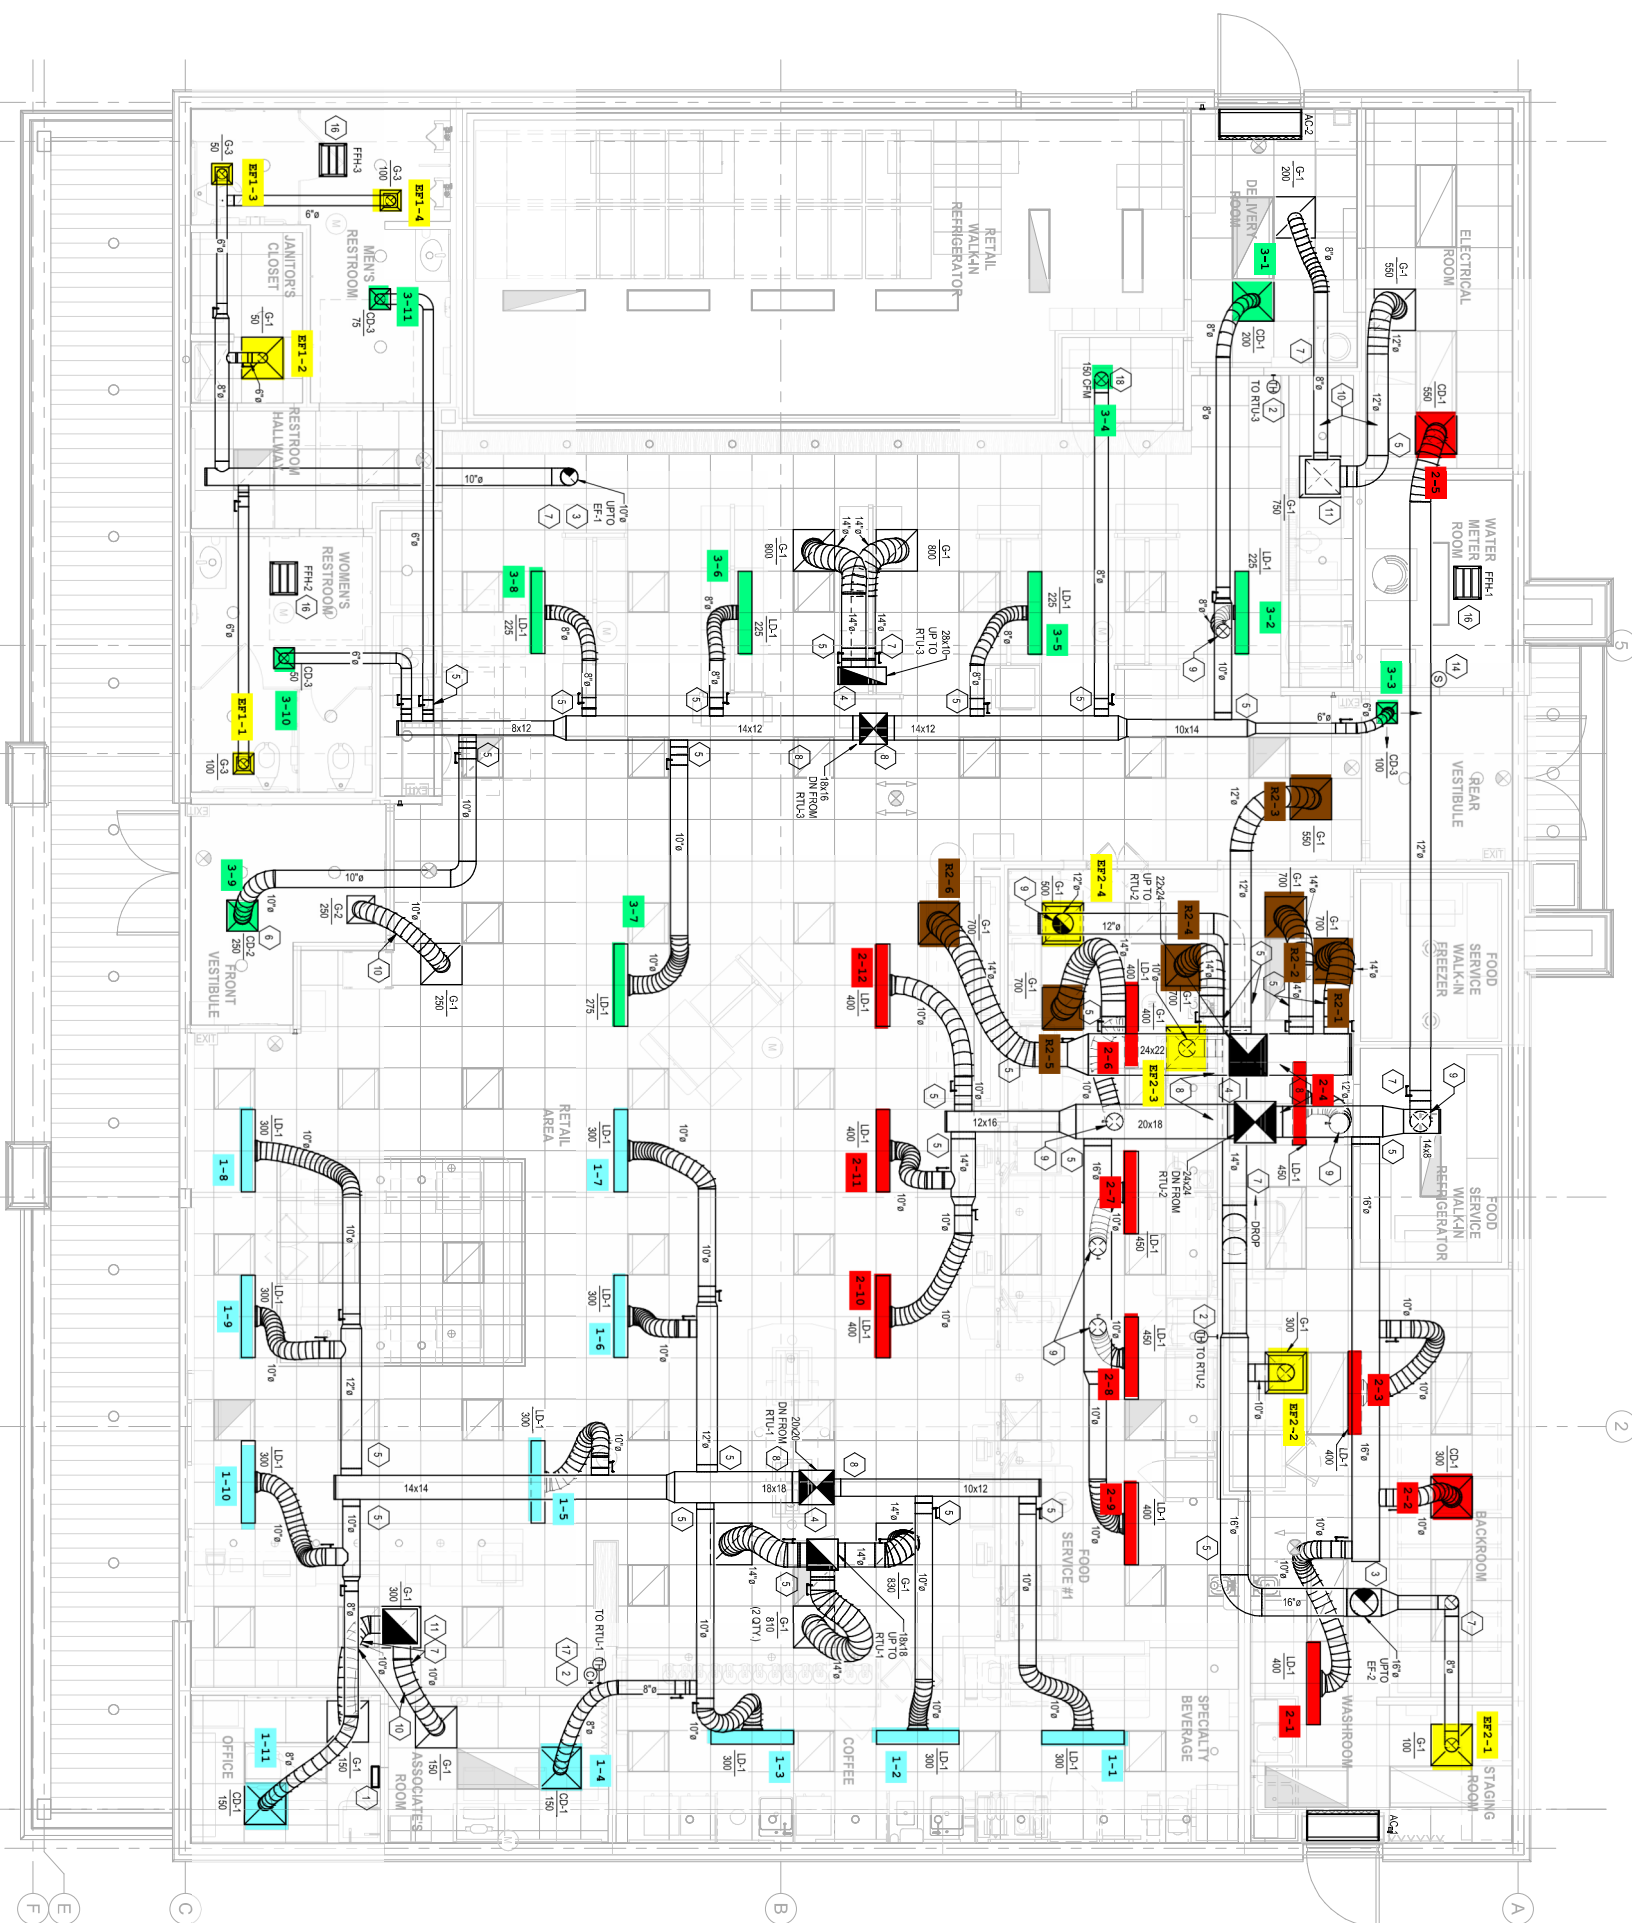
EF2/BOH

Asset									
Asset Name	Location	Type	Size	DESIGN CFM	AK	CFM(1)	CFM(2)	FINAL CFM	% to design
EGRD1	BOH	G1	8"	100	1	168	215	92	92.0
EGRD2	BOH	G1	10"	300	1	206	308	254	84.7
EGRD3	BOH	G1	10"	400	1	150	209	200	50.0
EGRD4	BOH	G1	12"	500	1	346	526	423	84.6
Total				1300		870	1258	969	74.54%
