Report: TAB Report
Function: Test, Adjust, & Balance
Date: 07/24/2025
Completed By: National TAB

07-21-25 ALBERTSONS #1948 MESA, AZ

Project: 07-21-25 ALBERTSONS #1948 MESA, AZ

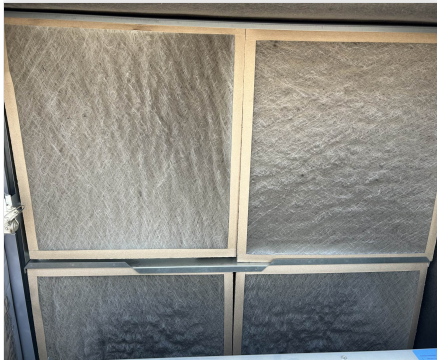
Issue Name : RTU-1 FILTER CHANGE REQUIRED
Description : Filter replacement required for RTU-1. Construction filter currently installed inside unit. Recommend replacing with MERV8 filters.
Created By : National TAB **Assigned To :** National TAB - Dan Hertenstein
Status : Open
Priority : Low **Asset Tag :**
Originated Date : 07/22/2025 - David Nicolas Sanchez - National TAB

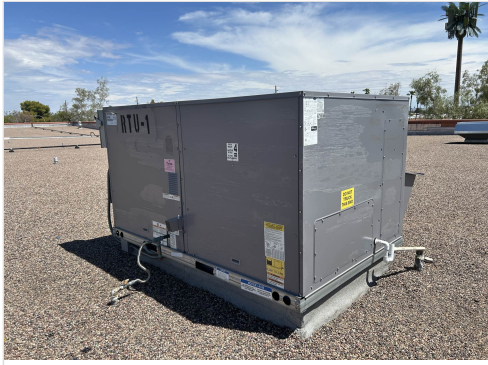
Unit Data - PHOTO LOG

| General | |
|---|---|
| Unit Filters Clean | NO |

Supply airflow calculated based on 10 ton unit. Design CFM: 4,000

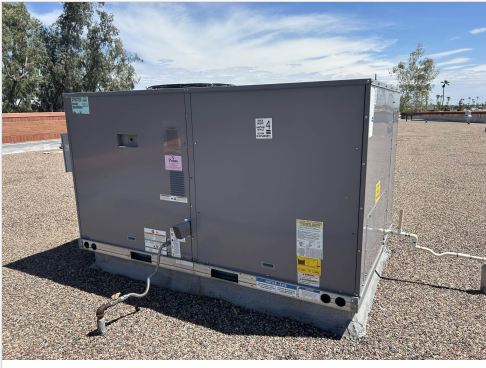
Unit Data - PHOTO LOG

Notes:
No outside air vent installed. Unable to set outside air.

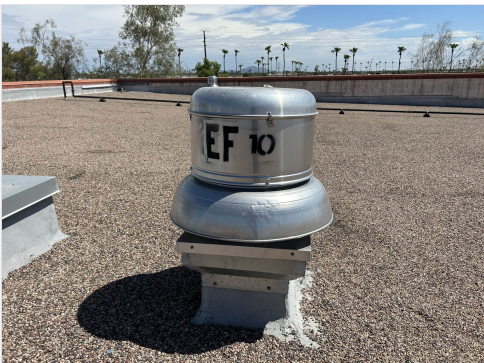
Unit Data - PHOTO LOG

Low airflow. Unable to speed up unit. No restrictions observed.

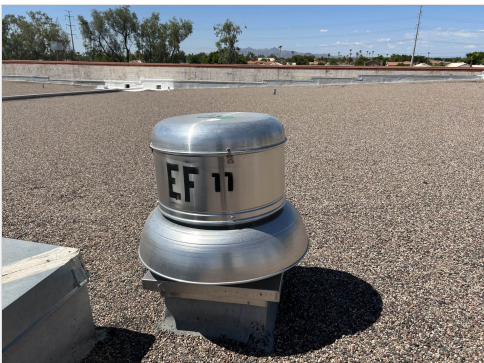
Unit Data - PHOTO LOG

Low airflow. Unable to speed up unit. No restrictions observed.
