**Report: TAB Report**

**Function: Test, Adjust, & Balance**

**07-21-25 ALBERTSONS #1948 MESA, AZ**

Project: 07-21-25 ALBERTSONS #1948 MESA, AZ

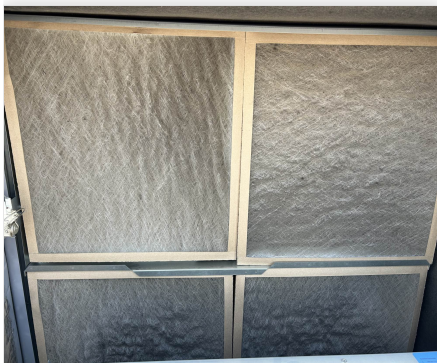
**Issue Name :** RTU-1 FILTER CHANGE REQUIRED  
**Description :** Filter replacement required for RTU-1. Construction filter currently installed inside unit. Recommend replacing with MERV8 filters.  
**Created By :** National TAB                      **Assigned To :** National TAB - Dan Hertenstein  
**Status :** Open  
**Priority :** Low    **Asset Tag :**  
**Originated Date :** 07/22/2025 - David Nicolas Sanchez - National TAB

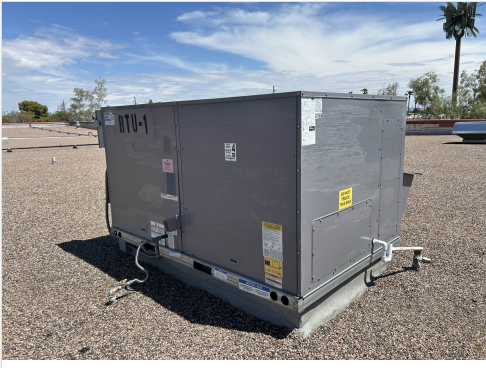
Asset: AC1

General	
	Actual
Fan Rotation Correct	YES
Unit Filters Clean	NO
Condensate Drain Installed	YES

Supply airflow calculated based on 10 ton unit. Design CFM: 4,000

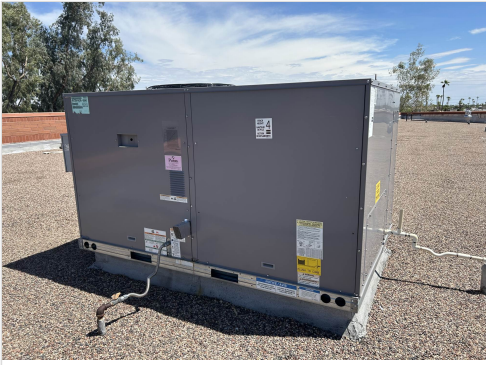
Asset: AC2

Notes:  
No outside air vent installed. Unable to set outside air.

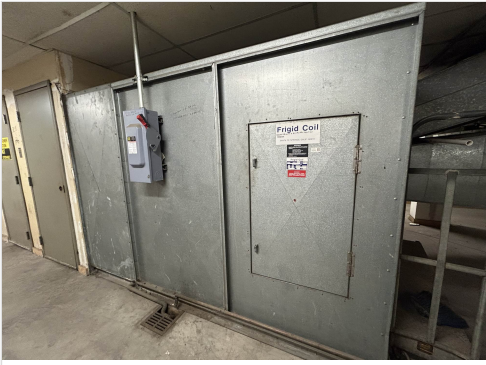
Asset: AHU1

Notes:  
Unable to located VFD. Speed adjustment not possible.

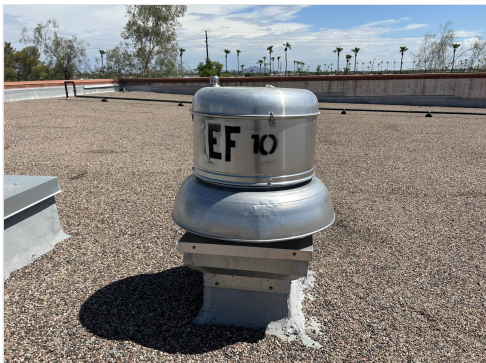
Low airflow. Unable to speed up unit. No restrictions observed.
