Report: TAB Report
Function: Test, Adjust, & Balance
Date: 07/24/2025
Completed By: National TAB

PROJECT
07-21-25 ALBERTSONS #1948 MESA, AZ

Project: 07-21-25 ALBERTSONS #1948 MESA, AZ

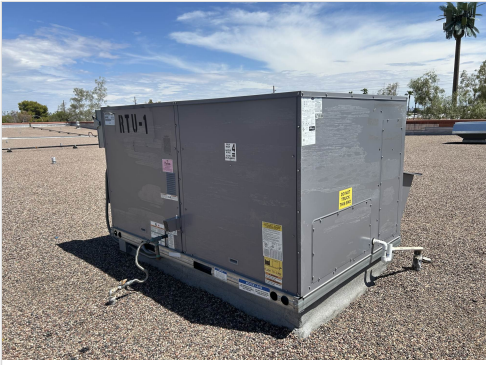
Asset: AC1

Test Data		
	Design	Actual
SF CFM	4000	4284
SF RPM	-	1985
RA CFM	3600	3887
OA CFM	400	397
RL Voltage	-	199/198/198
RL Amperage	-	7.35/7.43/7.31
SF Rotation	-	CCW
SF System SetPt	-	C
RA Damper Position	-	7.05V
Min OA Damper Position	-	2.95V
Min OA Damper Type	-	ECONOMIZER
OA Enthalpy Setpt	-	ES5

General	
	Actual
Fan Rotation Correct	YES
Unit Filters Clean	NO
Condensate Drain Installed	YES

Supply airflow calculated based on 10 ton unit. Design CFM: 4,000

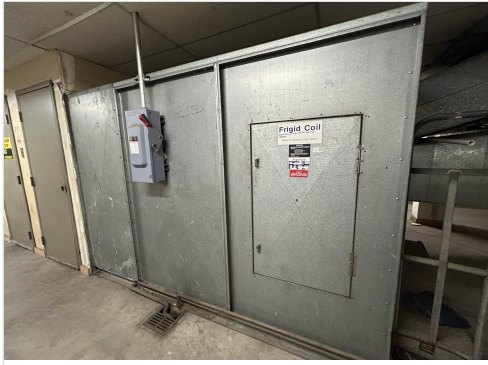
Asset: AHU1

Test Data		
	Design	Actual
SF CFM	35000	32308
SF RPM	-	NA
RA CFM	35000	32308
OA CFM	0	0
RL Voltage	-	NA
RL Amperage	-	NA
SF Rotation	-	CW
SF System SetPt	-	N/A
RA Damper Position	-	N/A
Min OA Damper Position	-	N/A
Min OA Damper Type	-	N/A
OA Enthalpy Setpt	-	N/A

Notes:
Unable to located VFD. Speed adjustment not possible.
