Report: TAB Report
Function: Test, Adjust, & Balance
Date: 07/24/2025
Completed By: National TAB

PROJECT
07-21-25 ALBERTSONS #1948 MESA, AZ

441 N VAL VISTA DRIVE

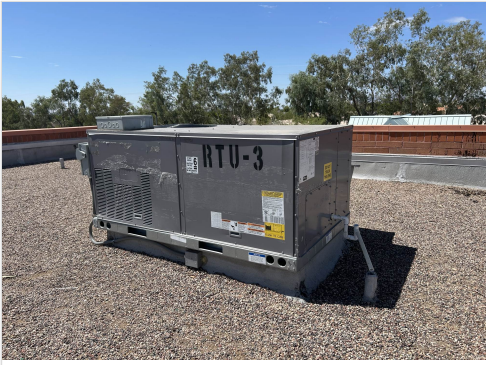
Unit Data - PHOTO LOG

Asset: AC3

AREA:PHARMACY

Test Data		
	Design	Actual
SF CFM	1000	1070
SF RPM	-	1675
RA CFM	900	965
OA CFM	100	105
RL Voltage	-	203
RL Amperage	-	3.13
SF Rotation	-	CCW
SF System SetPt	-	C
RA Damper Position	-	7.25V
Min OA Damper Position	-	2.75V
Min OA Damper Type	-	ECONOMIZER
OA Enthalpy Setpt	-	ES5
