**Report: TAB Report**  
**Function: Test, Adjust, & Balance**  
**Date: 07/31/2025**  
**Completed By: National TAB**

**07-28-25 WAWA #7606 NICHOLASVILLE, KY**

3000 LEXINGTON RD

Project: 07-28-25 WAWA #7606 NICHOLASVILLE, KY

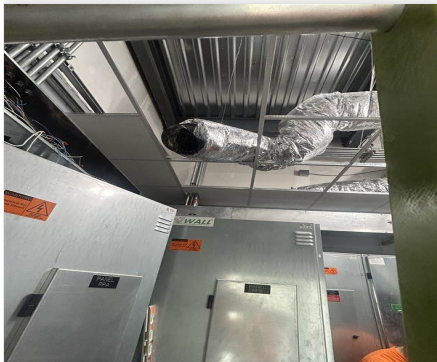
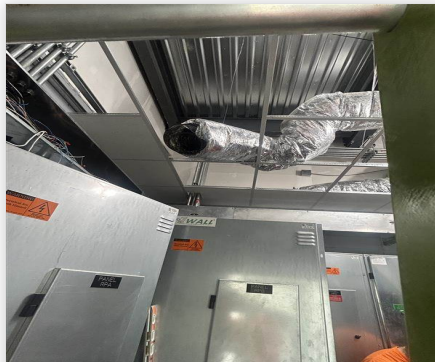
**Issue Name :** RTU-1-11 Diffuser not installed  
**Description :** Ductwork is run but diffuser not installed. Expected to be finished by EOD 7/30  
**Created By :** National TAB                      **Assigned To :** National TAB - Brianna Biggs  
**Status :** Closed  
**Priority :** **Urgent**                                      **Asset Tag :**  
**Originated Date :** 07/30/2025 - Aaron Cosby - National TAB

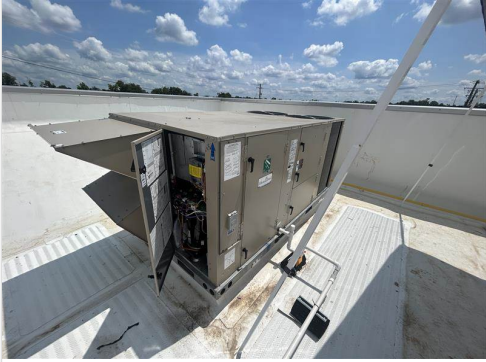
Asset: RTU1

Unit Data		
	Design	Actual
MFG	LENNOX	LENNOX
Serial Num	-	5624L04596
Model Num	LCT150H4E	LCT150H4E
Type	RTU	RTU
Configuration	VERTICAL	VERTICAL
Num OA Filters 1	-	2
OA Filter Size 1	-	23X14"
Num Final Filter 1	-	4
Final Filter Size 1	-	20X25X2"

Test Data		
	Design	Actual
SF CFM	4500	4512
SF RPM	-	1370
MOTOR RPM	-	NA
RA CFM	3800	3813
OA CFM	700	699
RL Voltage	-	208/208/210
RL Amperage	-	3.9/3.8/3.8
SF System SetPt	-	77%
OA Damper Position	-	40%
OA Damper Type	-	DEMAND CTRL

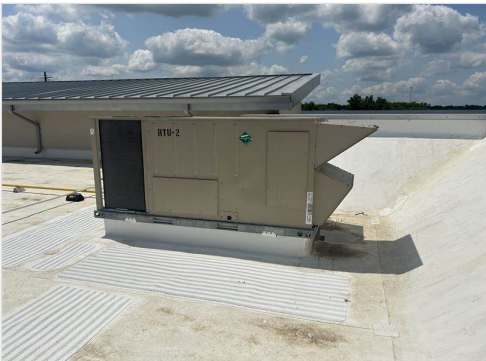
Asset: RTU2

Unit Data		
	Design	Actual
MFG	LENNOX	LENNOX
Serial Num	-	5624L02337
Model Num	LGT102H4E	LGT102H4E
Type	RTU	RTU
Configuration	VERTICAL	VERTICAL
Num OA Filters 1	-	2
OA Filter Size 1	-	23X14"
Num Final Filter 1	-	4
Final Filter Size 1	-	20X25X2"

Test Data		
	Design	Actual
SF CFM	3400	3408
SF RPM	-	1495
RA CFM	3020	3012
OA CFM	380	396
RL Voltage	-	210/207/211
RL Amperage	-	5.0/5.2/5.0
SF System SetPt	-	84%
OA Damper Position	-	28%
OA Damper Type	-	DEMAND CTRL

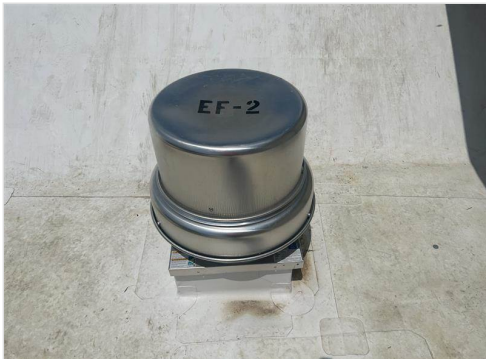
Asset: EF2

Unit Data		
	Design	Actual
MFG	GREENHECK	GREENHECK
Model Num	GB-098-6	GB-098-6
Serial Num	-	26530529
Type	DOWNBLAST	DOWNBLAST
Configuration	VERTICAL	VERTICAL

Test Data		
	Design	Actual
CFM	400	385
Fan RPM	-	1197
Fan Rotation	-	CW
Motor RPM	-	1760
System SetPt	-	3 TURNS OUT
RL Voltage	-	115
RL Amperage	-	3.5
Fan Inlet SP	-	-0.23"
Fan Discharge SP	-	ATM
