Report: TAB Report
Function: Test, Adjust, & Balance
Date: 07/31/2025
Completed By: National TAB

07-28-25 WAWA #7606 NICHOLASVILLE, KY

Project: 07-28-25 WAWA #7606 NICHOLASVILLE, KY

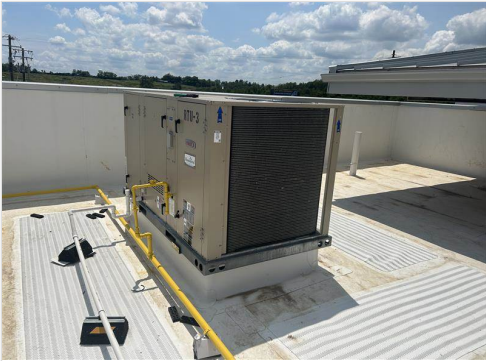
Unit Data - PHOTO LOG

Asset: RTU3

Unit Data		
	Design	Actual
MFG	LENNOX	LENNOX
Serial Num	-	5624M01116
Model Num	LGT072H4E	LGT072H4E
Type	RTU	RTU
Configuration	VERTICAL	VERTICAL
Num OA Filters 1	-	2
OA Filter Size 1	-	23X14"
Num Final Filter 1	-	4
Final Filter Size 1	-	20X25X2"

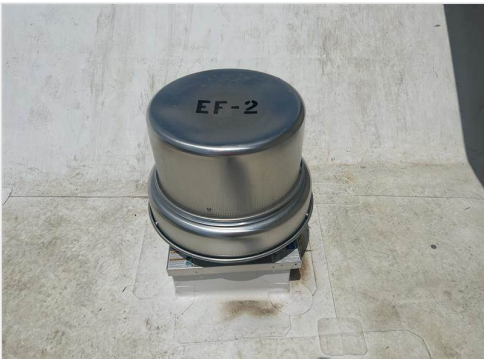
Unit Data - PHOTO LOG

Asset: EF2

Unit Data		
	Design	Actual
MFG	GREENHECK	GREENHECK
Model Num	GB-098-6	GB-098-6
Serial Num	-	26530529
Type	DOWNBLAST	DOWNBLAST
Configuration	VERTICAL	VERTICAL
