**Report: TAB REPORT**  
**Function: Test, Adjust, & Balance**  
**Date: 04/22/2024**

**04-01-24 CHIPOTLE #27-4685 ELKO, NV**  
**(ELKO)**

2405 Mountain City Highway

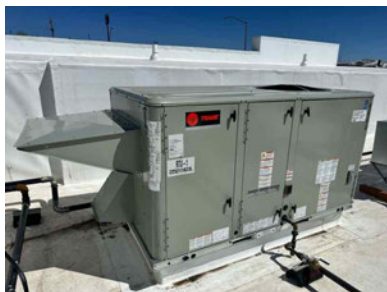
**SYSTEM/UNIT: RTU-01**  
**AREA: Dining**

Filter Data	
Condition	Partially Loaded
Filter Type	Pleated
MERV Rating	-
Filter Size Set 1 (in)	20x25x2
# Filters Set 1	4
Filter Size Set 2 (in)	-
# Filters Set 2	-

Final Airflow (CFM)	
Actual Total CFM	3565
Actual Grille Total CFM	3565
Actual Return Air CFM	2487
Actual Min O/A CFM	1078
Fan CFM Test Method	Supply Outlet Total
OA Method/Instrument	Face Velocity/RVA
OA Ak (sq ft)	5.023
OA Damper % (High Spd)	30% Open
OA Damper % (Low Spd)	50% Open
RA Damper % (High Spd)	70% Open

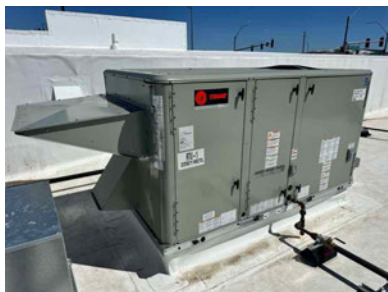
**SYSTEM/UNIT: RTU-02**  
**AREA: Kitchen**

Filter Data	
Condition	Partially Loaded
Filter Type	Pleated
MERV Rating	-
Filter Size Set 1 (in)	20x25x2
# Filters Set 1	4
Filter Size Set 2 (in)	-
# Filters Set 2	-

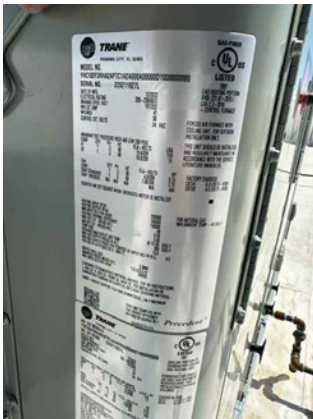
Submittal Make Photo:

Name: Submittal Make.jpg  
 Captured: 4/3/2024 9:10 AM  
 Caption:

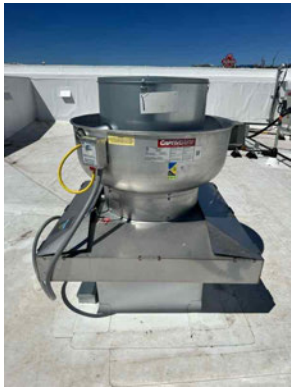
SYSTEM/UNIT: EF-01

Unit Data	
Make (tag)	Captive Aire
Model # (tag)	DU180HFA
Serial # (tag)	5952631
Unit Location	Roof
Unit Discharge	Upblast
Fan Service	Exhaust
Fan Type	Centrifugal (AF)
Fan Discharge	Upblast
Fan Arrangement	SWSI

Verification	Response	Notes	By	Date/Time
1	Fan Rotation is Correct?	Yes	OC	4/2/24 16:38
2	Belts are Tight?	NA	OC	4/2/24 16:38
3	Internal motorized damper is fully opening?	Yes	OC	4/2/24 16:38
4	Motor is operating below the FLA rating?	Yes	OC	4/2/24 16:38
5	Unit free of noticeable noise and vibration?	Yes	OC	4/2/24 16:38
6	There is no major leakage around base of fan?	Yes	OC	4/2/24 16:38
7	Is the motor operating below the motor FLA rating?	Yes	OC	4/2/24 16:38

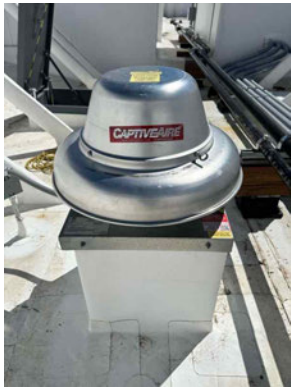
SYSTEM/UNIT: EF-02

Unit Data	
Make (tag)	Captive Aire
Model # (tag)	DR12HFA
Serial # (tag)	5952631
Unit Location	Roof
Unit Discharge	Upblast
Fan Service	Exhaust
Fan Type	Centrifugal (AF)
Fan Discharge	Upblast
Fan Arrangement	SWSI

Verification	Response	Notes	By	Date/Time
1 Fan Rotation is Correct?	Yes		OC	4/2/24 16:43
2 Belts are Tight?	NA		OC	4/2/24 16:43
3 Internal motorized damper is fully opening?	Yes		OC	4/2/24 16:43
4 Motor is operating below the FLA rating?	Yes		OC	4/2/24 16:43
5 Unit free of noticeable noise and vibration?	Yes		OC	4/2/24 16:43
6 There is no major leakage around base of fan?	Yes		OC	4/2/24 16:43
7 Is the motor operating below the motor FLA rating?	Yes		OC	4/2/24 16:43
8 Back draft damper installed and can it fully open?	Yes		OC	4/2/24 16:43

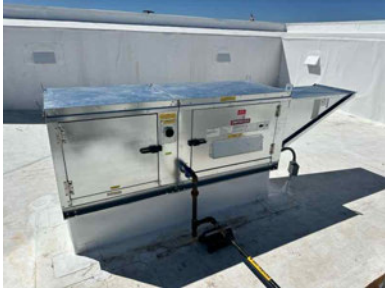
**SYSTEM/UNIT: MAU-01**

Design Airflow (CFM)		Final Airflow (CFM)	
Design Airflow	1300	Actual Airflow	1324
Design Grille Airflow	Not Provided	Actual Grille Airflow	Not Applicable
		Fan CFM Test Method	See Kitchen Hood Sheet
		Test Method Ak (sq ft)	-
Unit Design Data		Unit Data	
Submittal Make	Captiveaire	Make (tag)	Captive Aire
Submittal Model #	A1-D.250-15D	Model # (tag)	A1-D.250-15D
Submittal Airflow	1300	Serial # (tag)	5952631
Sched./Sub. Volts	208	Unit Location	Roof
Sched./Sub. Phase	3	Unit Discharge	Upblast
Sched./Sub. HP	1	Fan Service	Exhaust
Submittal BHP	Not Provided	Fan Type	Centrifugal (AF)
		Fan Discharge	Upblast
		Fan Arrangement	SWSI
Design Static Pressures (in wg)		Fan Design Data	
Design External SP	0.50	Submittal Motor RPM	Not Provided
Submittal Total SP	Not Provided	Submittal Fan RPM	-
Motor Nameplate Data		Fan Data	
Motor Make (tag)	TECO	Actual Fan RPM/Speed	51.9 HZ
Motor Frame (tag)	143T	Actual Motor RPM	Not Accessible

Verification	Response	Notes	By	Date/Time
1	Fan Rotation is Correct?	Yes	OC	4/2/24 17:07
2	Belts are Tight?	NA	OC	4/2/24 17:07
3	Internal motorized damper is fully opening?	Yes	OC	4/2/24 17:07
4	Motor is operating below the FLA rating?	Yes	OC	4/2/24 17:07
5	Unit free of noticeable noise and vibration?	Yes	OC	4/2/24 17:07
6	There is no major leakage around base of fan?	Yes	OC	4/2/24 17:07
