Report: TAB Report
Function: Test, Adjust, & Balance
Date: 11/11/2025
Completed By: National TAB

PROJECT
11-03-25 CULVERS QUEEN CREEK, AZ

Project: 11-03-25 CULVERS QUEEN CREEK, AZ

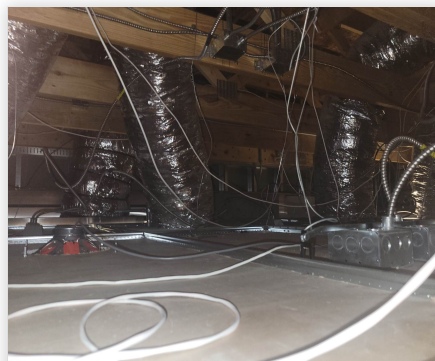
Project Issue File Details

Issue Name : RTU-2: KITCHEN DUCTWORK DEVIATES FROM DESIGN
Description : All diffusers are to have rigid 90 and rigid vertical duct at the connection to each diffuser. None of the diffusers are installed in this manner; flex is used instead. This can impact hood capture on cookline diffusers and may also contribute to airflow distribution. 3 supply diffusers on the RTU-2 are below design airflow with unit near FLA
Created By : National TAB **Assigned To :** National TAB - Dan Hertenstein
Status : Open
Priority : Medium **Asset Tag :** RTU1
Originated Date : 11/05/2025 - Christine Weale - National TAB

[1] DUCTWORK DEVIATES FROM DESIGN. SOME LOW DIFFUSERS, UNABLE TO PUSH MORE AIR TO THOSE DIFFUSERS WITHOUT SACRFICING TOTAL SYSTEM PERFORMANCE. NOT ANTICIPATED TO CAUSE ANY ISSUE.

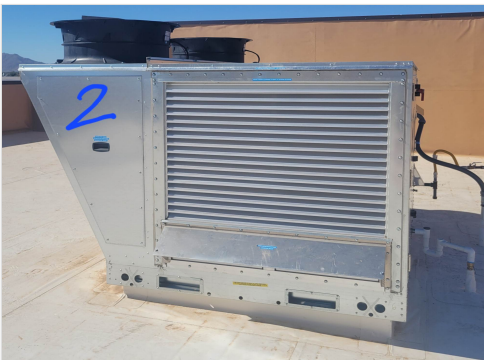
Unit Data - PHOTO LOG

Asset: RTU2

AREA:DINING

Unit Data		
	Design	Actual
MFG	LENNOX	CAPTIVEAIRE
Serial Num	-	7486191
Model Num	ENLIGHT LGT	CAS-HVAC3-1.250-24-15T
Type	RTU	RTU
Configuration	VERTICAL	VERTICAL
Num OA Filters 1	-	4
OA Filter Size 1	-	24X14
Num Final Filter 1	-	8
Final Filter Size 1	-	20X25X2

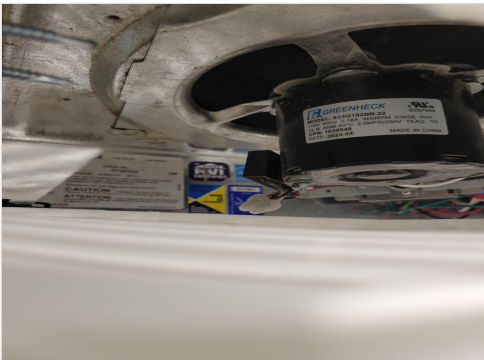
Unit Data - PHOTO LOG

Asset: EF1

AREA:MOP ROOM

Unit Data		
	Design	Actual
MFG	ACCUREX	GREENHECK
Model Num	SP-B80	S33G182BB-22
Serial Num	-	27167232
Type	CEILING	CEILING
Configuration	VERTICAL	VERTICAL

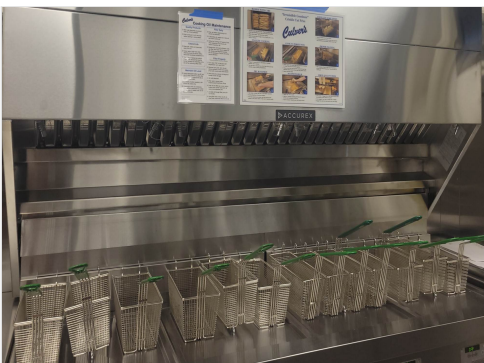
Unit Data - PHOTO LOG

Asset: HD2

AREA:FRYER HOOD

Unit Data		
	Design	Actual
MFG	ACCUREX	ACCUREX
Model Num	XXEP-83-S	XXEP-83-S
Job / Serial Num	-	27133770
Type	TYPE I LOW PROXIMILTY	TYPE I LOW PROXIMITY
Hood length	83"	83"
Hood Width	23"	17"
