Report: TAB Report
Function: Test, Adjust, & Balance
Date: 11/11/2025
Completed By: National TAB

PROJECT
11-03-25 CULVERS QUEEN CREEK, AZ

Project: 11-03-25 CULVERS QUEEN CREEK, AZ

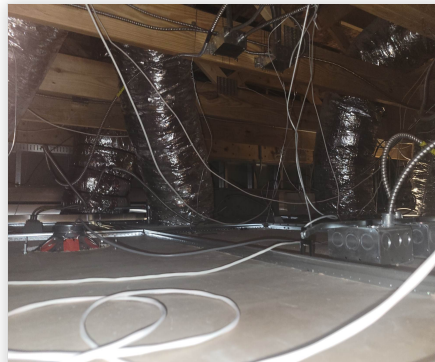
Issue Name : IMPROPER DUCT IN KITCHEN
Description : Diffusers in front of kitchen exhaust hoods are fed by flex only instead of hard elbows and straight duct. Possibly this and/or design, are why SGRD2, 15, & 16 are consistently below design. Recommend ensuring hard duct is installed per MSET so air flow is better directed and efficient.

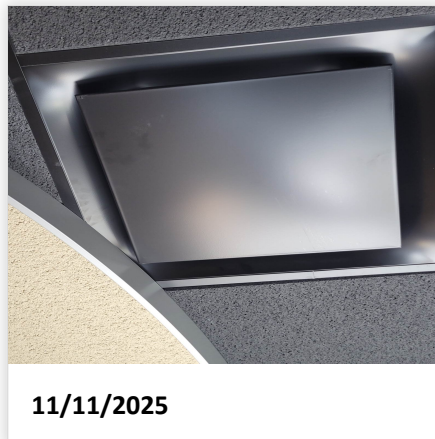
Issue Name : INACCURATE MEASUREMENT DUE TO INCORRECT PLACEMENT
Description : Multiple registers in DR are placed incorrectly along scalloped edge of ceiling. A sealed measurement is impossible, thus readings are inaccurate. Ensured as close as possible to design, so not expected to be more than +/-10%. Recommend ensuring these are placed correctly as per GRD. Below is just an example of 1, there were at least 3.
Created By : National TAB **Assigned To :** National TAB - Dan Hertenstein
Status : Open
Priority : Low **Asset Tag :** RTU2
Originated Date : 11/11/2025 - Christine Weale - National TAB

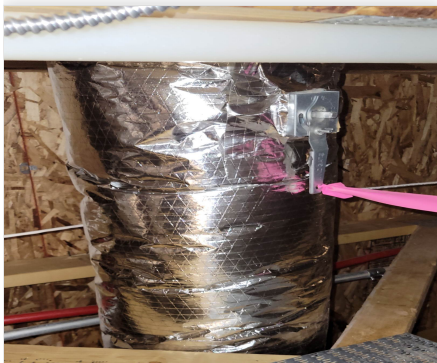
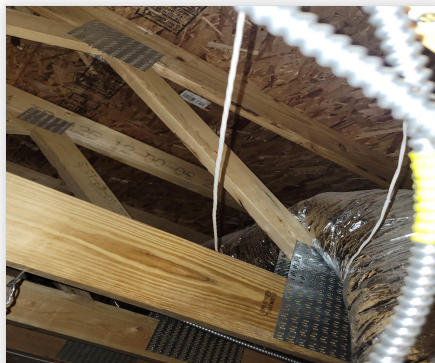
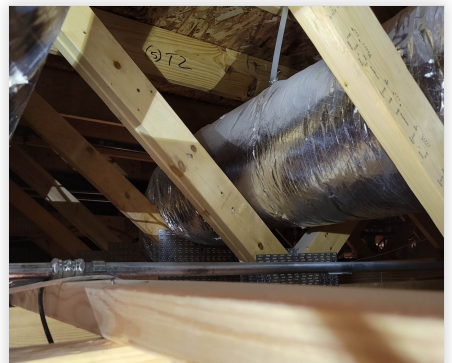
Issue Name : KINKED DUCT - LOW FLOW
Description : Super low flow ~45cfm/400cfm due to kinked duct. Actually creating backflow and reading as a negative sometimes. Damper is fully open.
UPDATE: FIXED BY MECH.
Created By : National TAB **Assigned To :** National TAB - Dan Hertenstein
Status : Closed
Priority : Urgent **Asset Tag :** SGRD5
Originated Date : 11/04/2025 - Christine Weale - National TAB

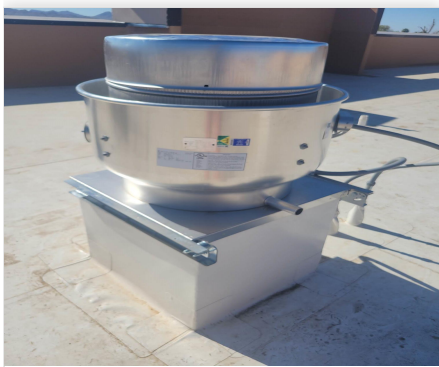
Issue Name : NO GREASE CUPS ON HOOD EXHAUSTS
Description : Grease traps not installed under grease conduits for both Kitchen Hood exhausts, PRV-2 and PRV-3. UPDATE: INSTALLED.
Created By : National TAB **Assigned To :** National TAB - Dan Hertenstein
Status : Closed
Priority : Low **Asset Tag :**
Originated Date : 11/05/2025 - Christine Weale - National TAB

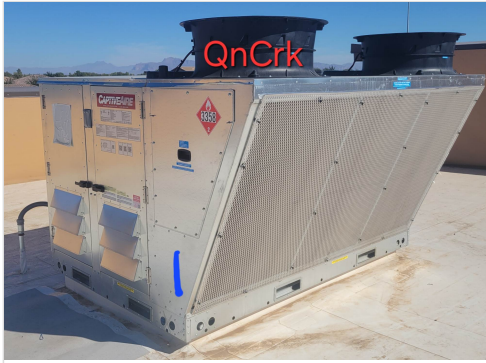
Unit Data - PHOTO LOG

Notes:
ONLY LAST 2 PASSES WERE RECORDED.

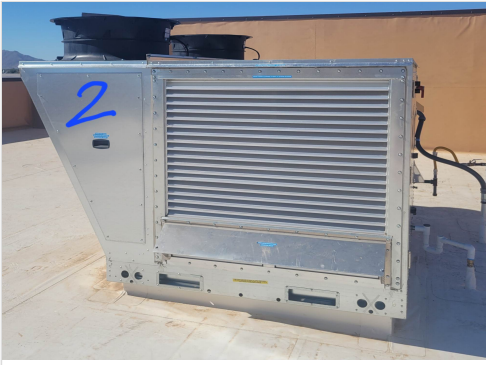
Unit Data - PHOTO LOG

Notes:
RTU1 ACTUALLY FEEDS KITCHEN, RTU2 SUPPLIES DINING. DID NOT CHANGE ASSEST INFO.

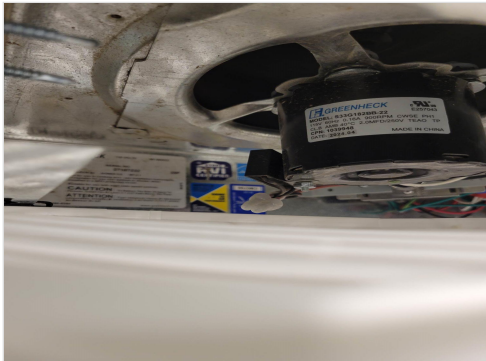
Unit Data - PHOTO LOG

Notes:
HIGHER THAN DESIGN DUE TO LACK OF ACCESS, SHOULD NOT BE AN ISSUE.

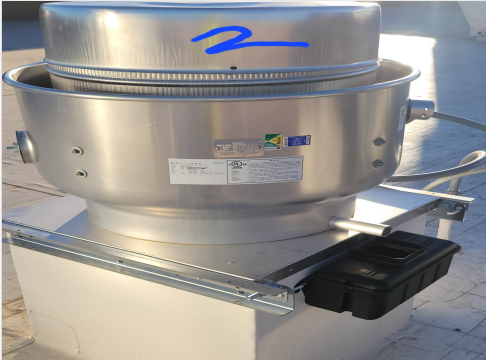
Unit Data - PHOTO LOG

Notes:
PRV-2 AND PRV-3 ARE BACKWARDS ON THE ROOF.
