Report: TAB Report
Function: Test, Adjust, & Balance
Date: 06/23/2025
Completed By: National TAB

PROJECT
06-16-25 FREDDY'S GLENDORA, CA

Project: 06-16-25 FREDDY'S GLENDORA, CA

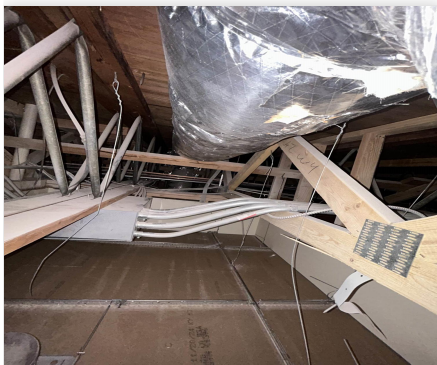
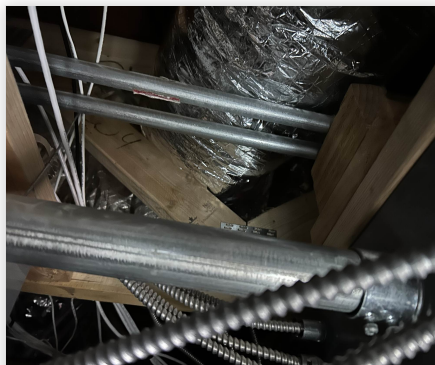
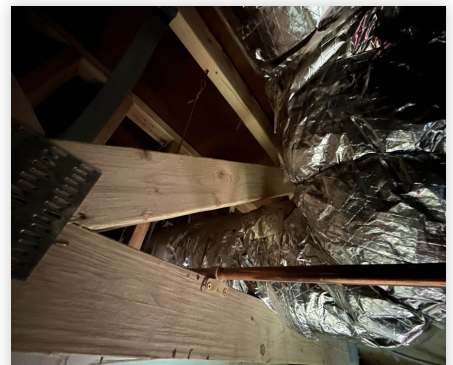
Issue Name : DOAS-1 NO DAMPERS INSTALLED
Description : Damper not installed/not found for all branches. Unable to adjust diffusers to design airflow. Recommend installing dampers to ensure proper airflow distribution in kitchen area.
Created By : National TAB **Assigned To :** National TAB - Will Turnbough
Status : Open
Priority : Low **Asset Tag :**
Originated Date : 06/16/2025 - David Nicolas Sanchez - National TAB

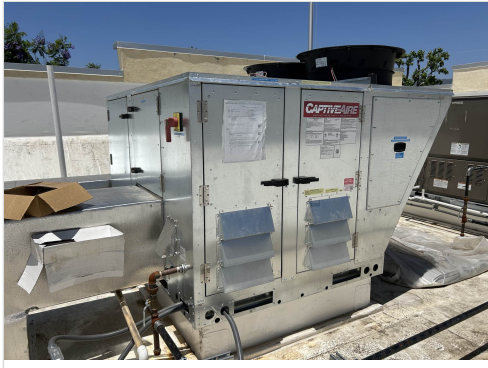
Unit Data - PHOTO LOG

Asset: DOAS1

Test Data		
	Design	Actual
SF CFM	2300	2514
SF RPM	-	1500
RA CFM	0	0
OA CFM	2300	2514
RL Voltage	-	151@VFD
RL Amperage	-	4.4@VFD
SF Rotation	-	CCW
SF System SetPt	-	51.6HZ
RA Damper Position	-	0%
Min OA Damper Position	-	100%
Min OA Damper Type	-	ECONOMIZER
OA Enthalpy Setpt	-	N/A

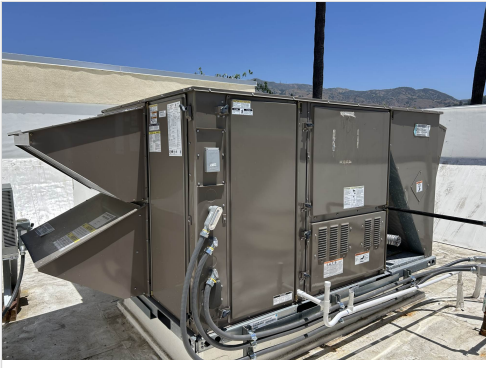
Unit Data - PHOTO LOG

Asset: RTU1

Test Data		
	Design	Actual
SF CFM	3000	3042
SF RPM	-	645
RA CFM	2367	2392
OA CFM	633	650
RL Voltage	-	201/201/201
RL Amperage	-	3.55/3.95/4.10
SF Rotation	-	CW
SF System SetPt	-	60%
RA Damper Position	-	70%
Min OA Damper Position	-	30%
Min OA Damper Type	-	ECONOMIZER
OA Enthalpy Setpt	-	28BTU

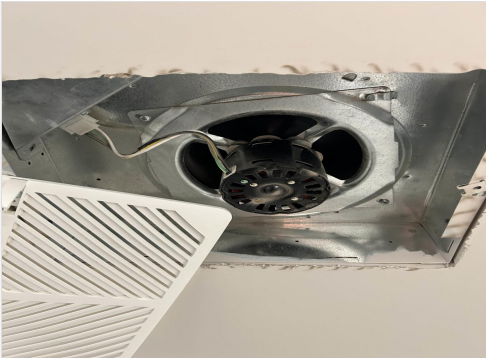
Unit Data - PHOTO LOG

Asset: EF1

Test Data		
	Design	Actual
CFM	150	184
Fan RPM	-	DD
Fan Rotation	-	CW
Motor RPM	-	DD
System SetPt	-	SINGLE SPEED

Issue Name : RESTROOM EXHAUST FANS HIGH AIRFLOW
Description : Restroom exhaust fans above design airflow. Speed controller not installed unable to lower fan speed. Fans has been wired for single speed.
Created By : National TAB **Assigned To :** National TAB - Will Turnbough
Status : Open
Priority : Low **Asset Tag :**
Originated Date : 06/23/2025 - David Nicolas Sanchez - National TAB

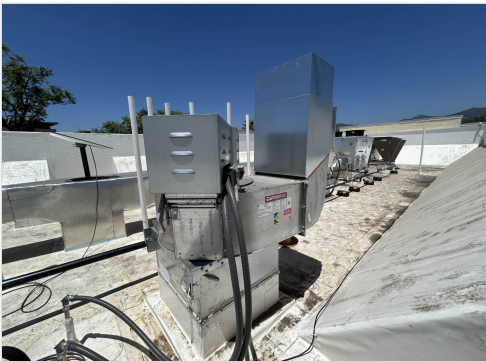
Unit Data - PHOTO LOG

Asset: KEF1

Test Data		
	Design	Actual
CFM	1600	1660
Fan RPM	1338	1015
Fan Rotation	-	CW
Motor RPM	-	1015
System SetPt	-	35HZ
RL Voltage	-	89@VFD
RL Amperage	-	3.8 @VFD
Total ESP	1.8"	0.73"
Fan Inlet SP	-	-0.73"
Fan Discharge SP	-	ATMS

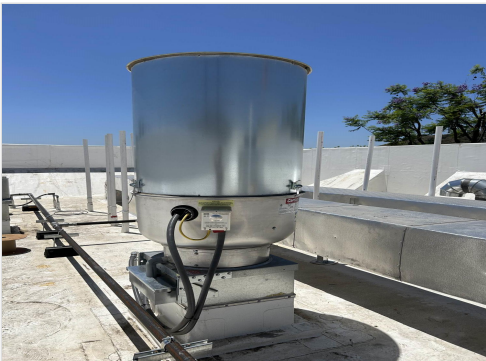
Unit Data - PHOTO LOG

Asset: KEF2

Test Data		
	Design	Actual
CFM	775	733
Fan RPM	1449	900
Fan Rotation	-	CCW
Motor RPM	-	900
System SetPt	-	50%
RL Voltage	-	116
RL Amperage	-	1.3
Total ESP	1.0"	0.30"
Fan Inlet SP	-	-0.30"
Fan Discharge SP	-	ATMS

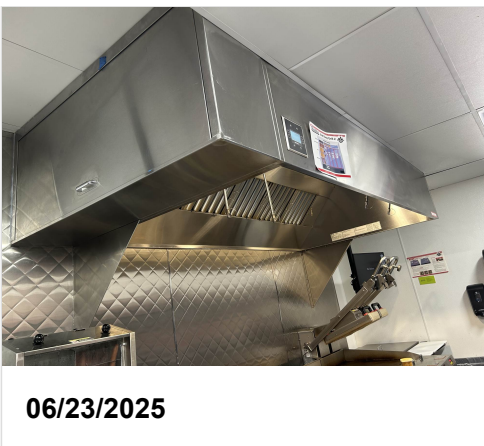
Unit Data - PHOTO LOG

Asset: HD1

Test Data Exhaust		
	Design	Actual
Filter Type	CAPTRATE SOLO	BAFFLED
Filter Size 1	16X16	16X16
Filter Qty 1	5	5
Filter AK factor size 1	1.62	1.62
Filter Total AK Area	8.1	8.1
Filter1 FPM	-	184
Filter2 FPM	-	204
Filter3 FPM	-	238
Filter4 FPM	-	214
Filter5 FPM	-	186
Filter Ave FPM(corr)	-	205
CFM	1600	1660
