Report: TAB Report
Function: Test, Adjust, & Balance
Date: 09/03/2025
Completed By: National TAB

PROJECT
KURA SUSHI EDISON, NJ

Project: KURA SUSHI EDISON, NJ

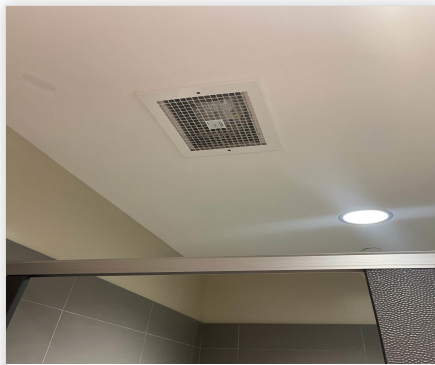
Issue Name : EF-1 EF-2 EF-3 Underperforming
Description : Restroom exhaust fans are underperforming and have positive pressure, pushing any stink out. Recommend looking for obstructions in duct. All fans are between 40-50 CFM. Design capacity is at least 120 CFM.
Created By : National TAB **Assigned To :** National TAB - Dan Hertenstein
Status : Open
Priority : High **Asset Tag :**
Originated Date : 09/02/2025 - John Barresi - National TAB

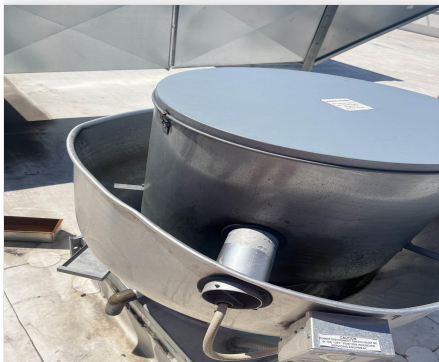
Issue Name : KEF-1 Damage
Description : Exhaust fan shroud is dented in a couple spots. Wobbles on curb.
Created By : National TAB **Assigned To :** National TAB - Dan Hertenstein
Status : Open
Priority : Low **Asset Tag :**
Originated Date : 09/02/2025 - John Barresi - National TAB

KEF1 was shaking in base

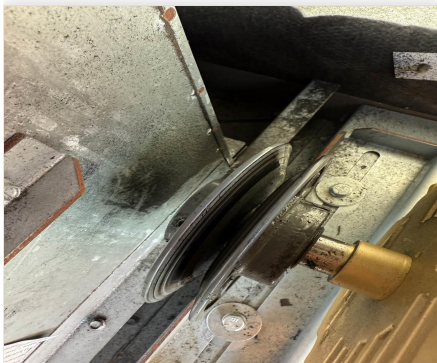
Issue Name : RTU-1 Motor Sheave Seized
Description : Motor sheave is seized and unable to be readjusted. Target CFM/TON is 350-400. Currently the unit is operating at 334 CFM/TON. Recommend replacing pulley and speeding the unit up by 10%.
Created By : National TAB **Assigned To :** National TAB - Dan Hertenstein
Status : Open
Priority : **Medium** **Asset Tag :**
Originated Date : 09/03/2025 - John Barresi - National TAB

Notes:
[1] RTU MOTOR SHEAVE WAS RUSTED. UNABLE TO ACHEIVE 350-400 CFM/TON TARGET

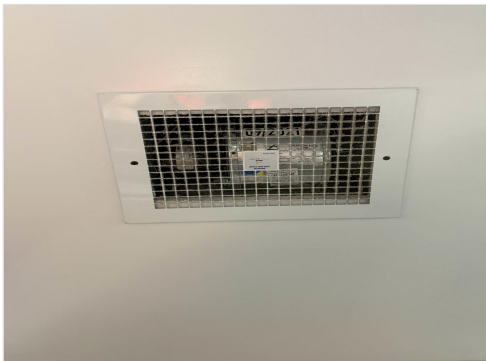
Asset: EF1

Unit Data		
	Design	Actual
MFG	UNKNOWN	PENNBARY
Model Num	UNKNOWN	Z6H
Serial Num	-	J21AE23559
Type	-	CEILING

Test Data		
	Design	Actual
CFM	150	43

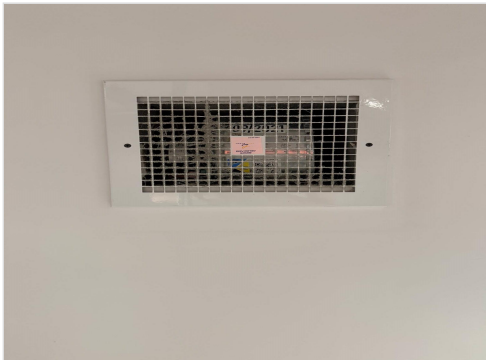
Asset: EF2

Unit Data		
	Design	Actual
MFG	UNKNOWN	PENNBARY
Model Num	UNKNOWN	Z6H
Serial Num	-	J21AE23564
Type	-	CEILING

Test Data		
	Design	Actual
CFM	150	37

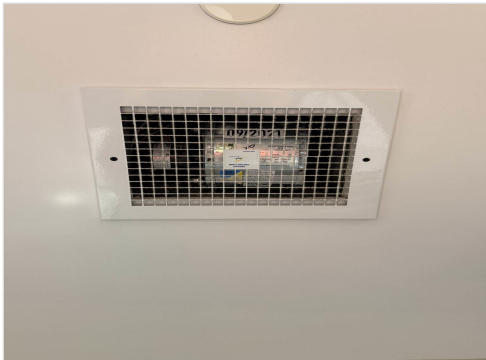
Asset: EF3

Unit Data		
	Design	Actual
MFG	NA	PENNBARY
Model Num	NA	Z6H
Serial Num	-	J21AE23552
Type	-	CEILING

Test Data		
	Design	Actual
CFM	150	31

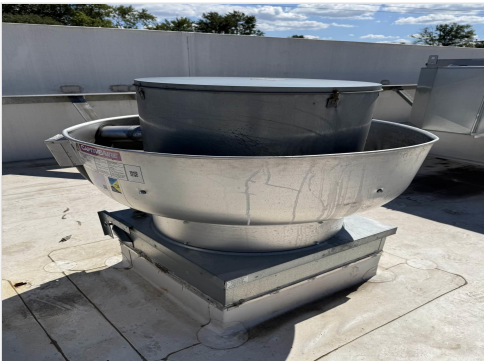
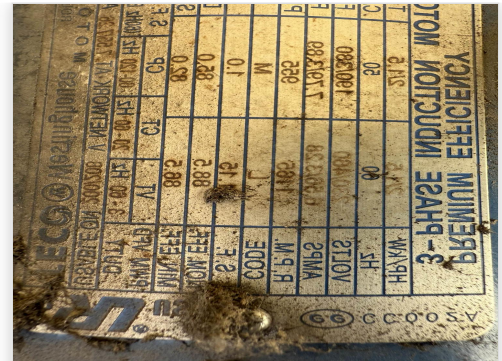
Asset: KEF1

Unit Data		
	Design	Actual
MFG	UNKNOWN	CAPTIVEAIRE
Model Num	UNKNOWN	DU180HFA
Serial Num	-	5528880
Type	-	EXHAUST
Configuration	-	VERTICAL

Test Data		
	Design	Actual
CFM	2375	2265
Fan RPM	-	1229
Fan Rotation	-	CCW
Motor RPM	-	1229
System SetPt	-	66.3HZ
RL Voltage	-	188 VFD
RL Amperage	-	6.6 VFD
Total ESP	-	1.36"
Fan Inlet SP	-	-1.36"
Fan Discharge SP	-	ATM

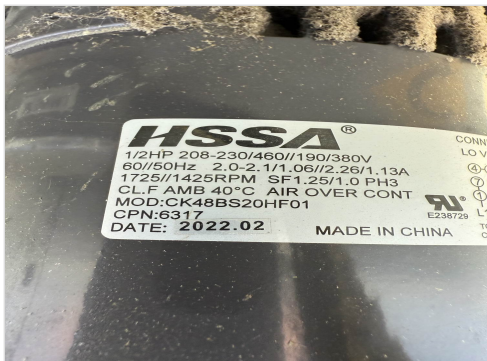
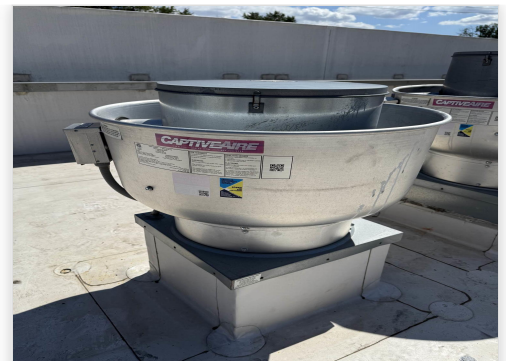
Asset: KEF2

Unit Data		
	Design	Actual
MFG	UNKNOWN	CAPTIVEAIRE
Model Num	UNKNOWN	DU50HFA
Serial Num	-	5528880
Type	-	EXHAUST
Configuration	-	VERTICAL

Test Data		
	Design	Actual
CFM	1375	1312
Fan RPM	-	1262
Fan Rotation	-	CCW
Motor RPM	-	1262
System SetPt	-	43.9 HZ
RL Voltage	-	168 VFD
RL Amperage	-	2.0 VFD
Total ESP	-	0.56"
Fan Inlet SP	-	-0.56"
Fan Discharge SP	-	ATM

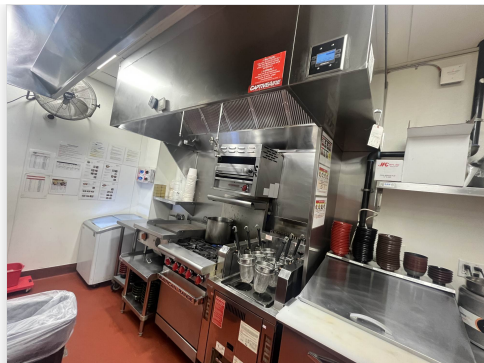
Asset: HD T1-1

Unit Data		
	Design	Actual
MFG	UNKNOWN	CAPTIVE AIRE
Model Num	UNKNOWN	4824 ND-2
Job / Serial Num	-	552880
Type	-	TYPE I CANOPY
Hood length	-	84"
Hood Width	-	48"

Test Data Exhaust		
	Design	Actual
Filter Type	-	CAPTRATE SOLO
Filter Size 1	-	16X16
Filter Qty 1	-	5
Filter AK factor size 1	-	1.62
Filter Total AK Area	-	8.1
Filter1 FPM	-	177
Filter2 FPM	-	194
Filter3 FPM	-	190
Filter4 FPM	-	203
Filter5 FPM	-	188
Filter Ave FPM(corr)	-	190
CFM	1330	1539

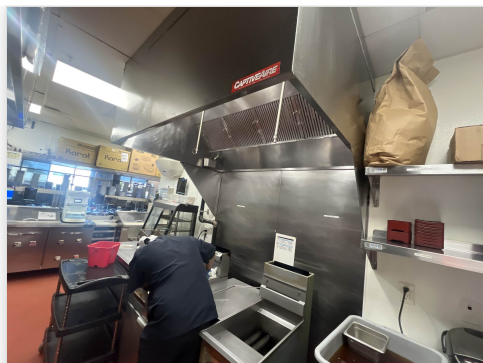
Asset: HD T1-2

Unit Data		
	Design	Actual
MFG	UNKNOWN	CAPTIVE AIRE
Model Num	UNKNOWN	4824 ND-2
Job / Serial Num	-	5528880
Type	-	TYPE I CANOPY
Hood length	-	66"
Hood Width	-	48"

Test Data Exhaust		
	Design	Actual
Filter Type	-	CAPTRATE SOLO
Filter Size 1	-	16X16
Filter Qty 1	-	4
Filter AK factor size 1	-	1.62
Filter Total AK Area	-	6.48
Filter1 FPM	-	115
Filter2 FPM	-	112
Filter3 FPM	-	113
Filter4 FPM	-	108
Filter Ave FPM(corr)	-	112
CFM	1045	726

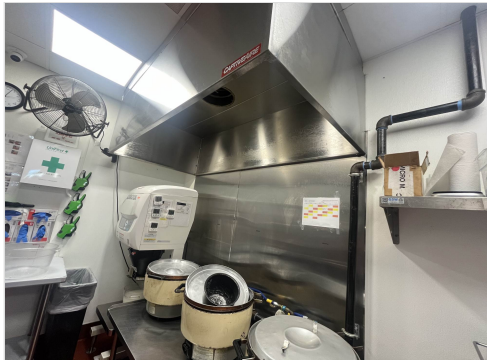
Asset: HD T2-1

Unit Data		
	Design	Actual
MFG	UNKNOWN	CAPTIVE AIRE
Model Num	UNKNOWN	4224 VHB
Serial Num	-	5528880
Type	-	TYPE II CANOPY
Hood length	-	84"
Hood Width	-	42"

Test Data		
	Design	Actual
Exhaust CFM	917	991

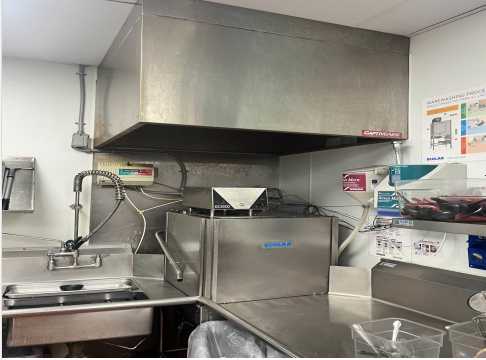
Asset: HD T2-2

Unit Data		
	Design	Actual
MFG	UNKNOWN	CAPTIVE AIRE
Model Num	UNKNOWN	4224 VHB
Serial Num	-	5528880
Type	-	TYPE II CANOPY
Hood length	-	42"
Hood Width	-	42"

Test Data		
	Design	Actual
Exhaust CFM	458	321
