**Report: TAB Report**  
**Function: Test, Adjust, & Balance**  
**Date: 01/11/2026**  
**Completed By: National TAB**

**01-05-26 Wawa #5462 Jacksonville, FL**

7142 COMMONWEALTH AVE

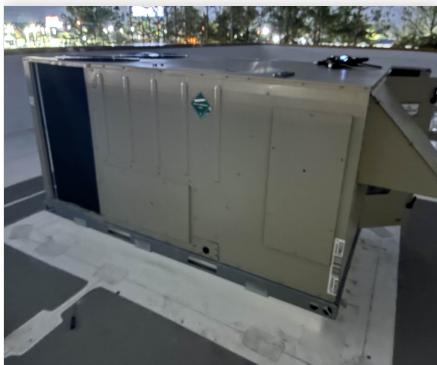
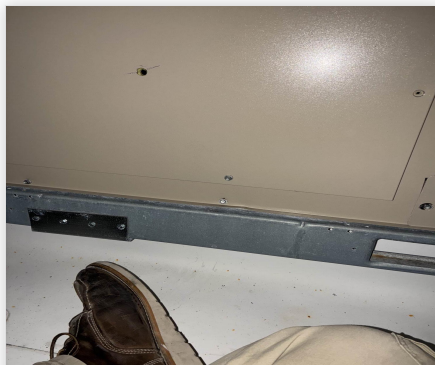
**Issue Name :** Curb Leak - All RTUs  
**Description :** All RTUs have a curb leak in the location shown. It is moderate on RTU3, and less noticeable on RTUs 1 and 2  
**Created By :** National TAB                      **Assigned To :** National TAB - Dan Hertenstein  
**Status :** Open  
**Priority :** High                                      **Asset Tag :**  
**Originated Date :** 01/08/2026 - Jackson Gunnels - National TAB

- **02/04/2026 National TAB - Jackson Gunnels**
  - Caulk installed on units 1 and 3, air is still able to exit through gaps in the caulk.

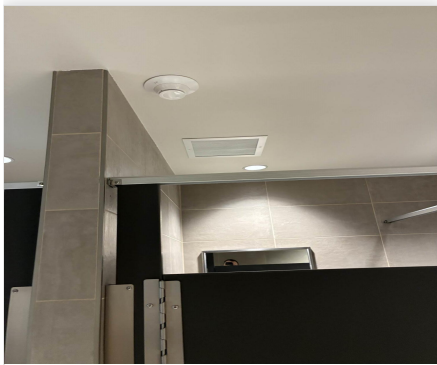
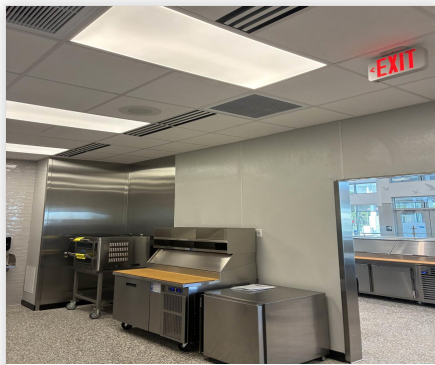
**Issue Name :** EF-1 Dampers  
**Description :** Could not locate dampers for women’s restroom and one of the back of house exhausts. Unable to fully balance grills on this unit.  
**Created By :** National TAB                      **Assigned To :** National TAB - Dan Hertenstein  
**Status :** Closed  
**Priority :** Urgent                                      **Asset Tag :**  
**Originated Date :** 01/07/2026 - Jackson Gunnels - National TAB

- **02/04/2026 National TAB - Jackson Gunnels**
  - Dampers located, issue resolved.

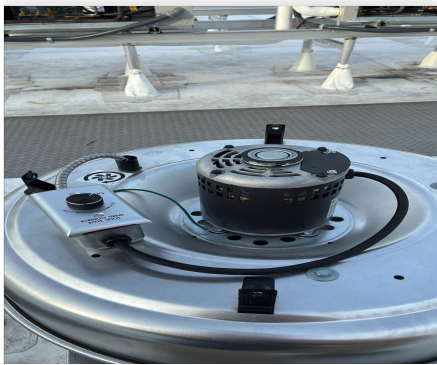
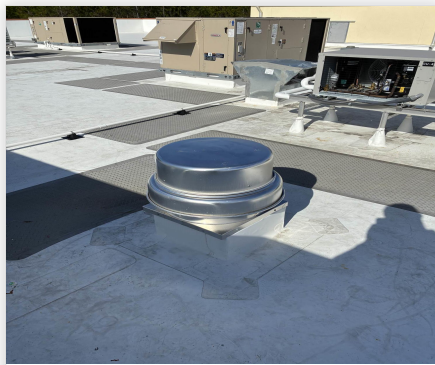
**Issue Name :** EF-1 Total Flow  
**Description :** EF1 at max flow only provides %92 design flow. Approximately 70 cfm total change from lowest to maximum setting on speed controller.  
**Created By :** National TAB                      **Assigned To :** National TAB - Dan Hertenstein  
**Status :** Closed  
**Priority :** Urgent                                      **Asset Tag :**  
**Originated Date :** 01/08/2026 - Jackson Gunnels - National TAB

- **02/04/2026 National TAB - Jackson Gunnels**
  - Further diffuser balancing resulted in greater total flow from EF-1, now at %95 of design, issue resolved.

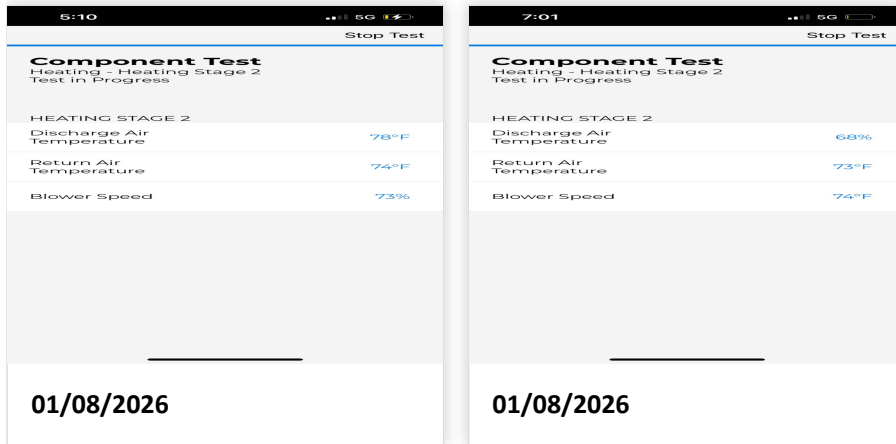
**Issue Name :** RTUs 1 and 3 Heating  
**Description :** Unable to confirm heating functionality on RTUs 1 and 3. Unit 1 EAT/LAT 78/74, unit 3 EAT/LAT 74/73.  
**Created By :** National TAB      **Assigned To :** National TAB - Dan Hertenstein  
**Status :** Closed  
**Priority :** Urgent      **Asset Tag :**  
**Originated Date :** 01/08/2026 - Jackson Gunnels - National TAB

- **02/04/2026 National TAB - Jackson Gunnels**
  - Confirmed heating functionality on both units. Unit 1 EAT/LAT 72/80 Unit 3 EAT/LAT 80/71. Return temperatures began increasing at 80 degrees.

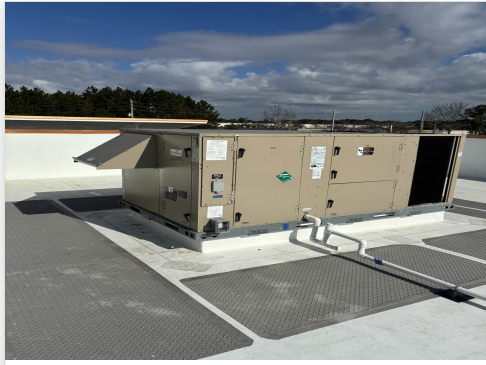
# Unit Data - PHOTO LOG

Unit Data		
	Design	Actual
MFG	LENNOX	LENNOX
Serial Num	-	5624H04158
Model Num	LCT092H4E	LCT092H4EG1Y
Type	RTU	RTU
Configuration	VERTICAL	VERTICAL
Num OA Filters 1	-	1
OA Filter Size 1	-	23X14
Num Final Filter 1	-	4
Final Filter Size 1	-	20X25X2

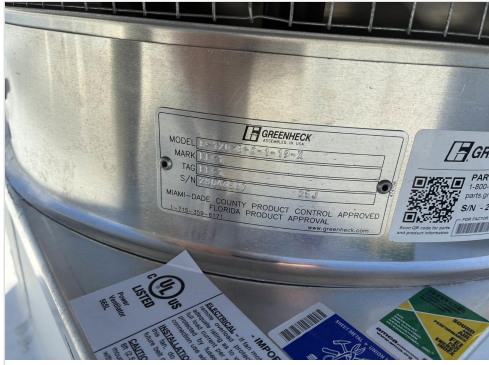
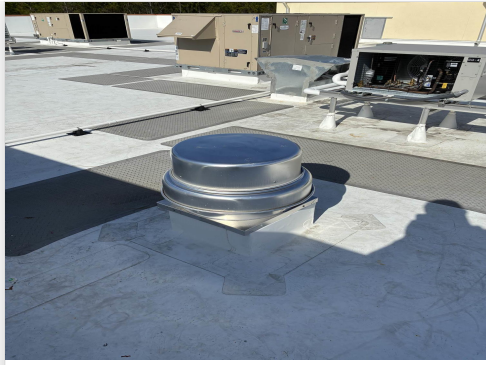
# Unit Data - PHOTO LOG

Unit Data		
	Design	Actual
<b>MFG</b>	GREENHECK	GREENHECK
<b>Model Num</b>	G-120	G-120-B-6-1-19-X
<b>Serial Num</b>	-	28046587
<b>Type</b>	DOWNBLAST	CENTRIFUGAL
<b>Configuration</b>	VERTICAL	DOWNBLAST

Notes:  
Speed controller at maximum setting.

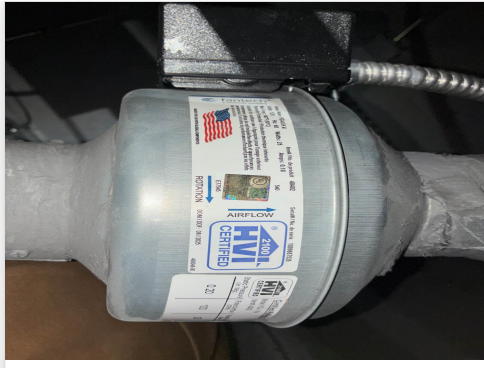
## Unit Data - PHOTO LOG

Unit Data		
	Design	Actual
MFG	GREENHECK	FANTECH
Model Num	CSP-B110	40402
Serial Num	-	1009657535
Type	INLINE	INLINE
Configuration	VERTICAL	HORIZONTAL
