PlanGrid Task Report - Jun 26, 2025

Prepared by Dale Wheeler

Jun 26, 2025

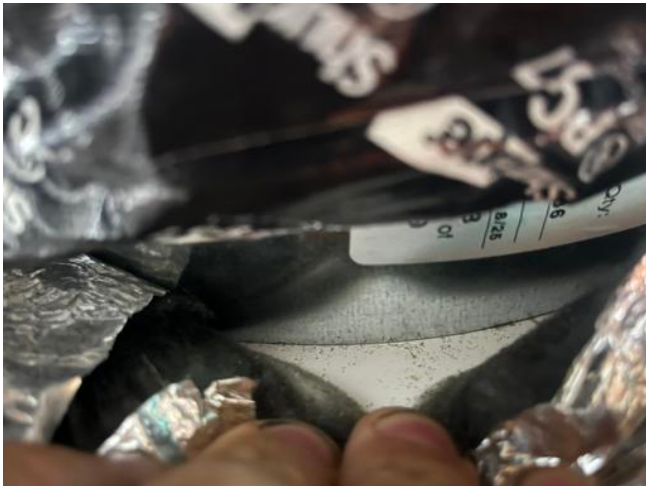
IMG_8104

#40 [DUCT 499] [NEW] CRITICAL (MISC) – [AC1 - MASTIC]

AC1 mastic not installed at diffuser collars for all supply grills, also ensure that all hard duct joint connections are sealed with mastic.

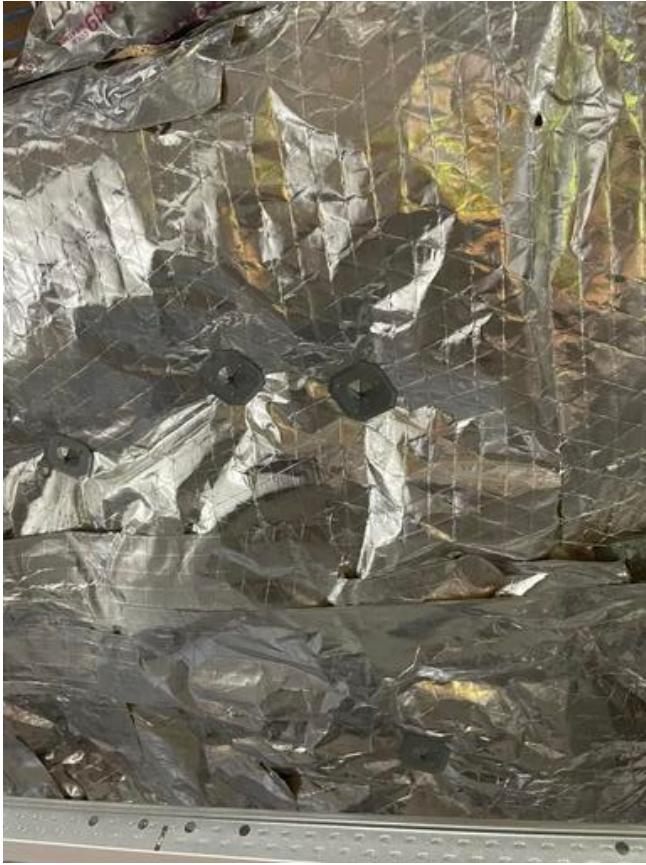
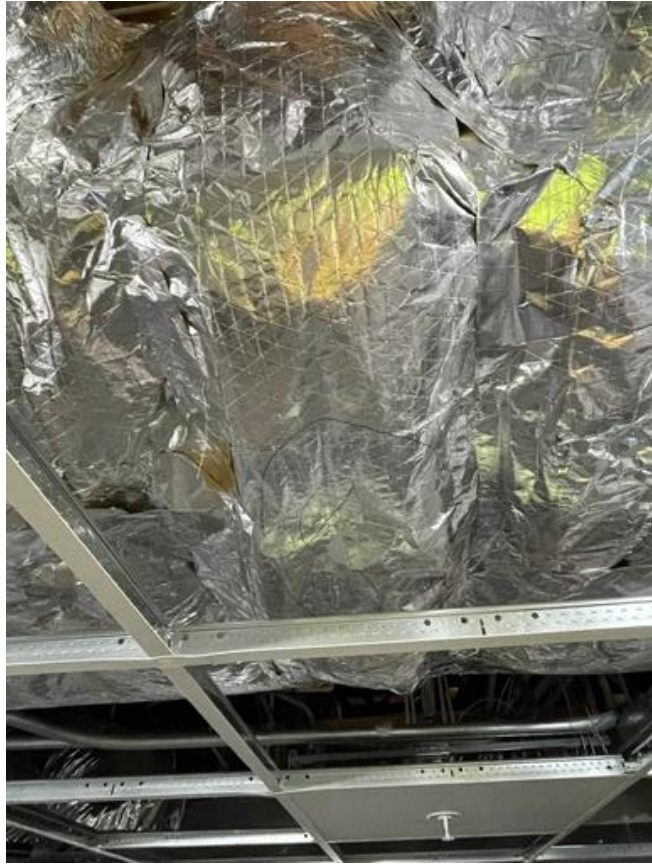
#39 [DUCT 501] [NEW] Insulation stick pins.

More stick pins are needed to ensure duct does not sag. Existing stick pins need to be taped over.

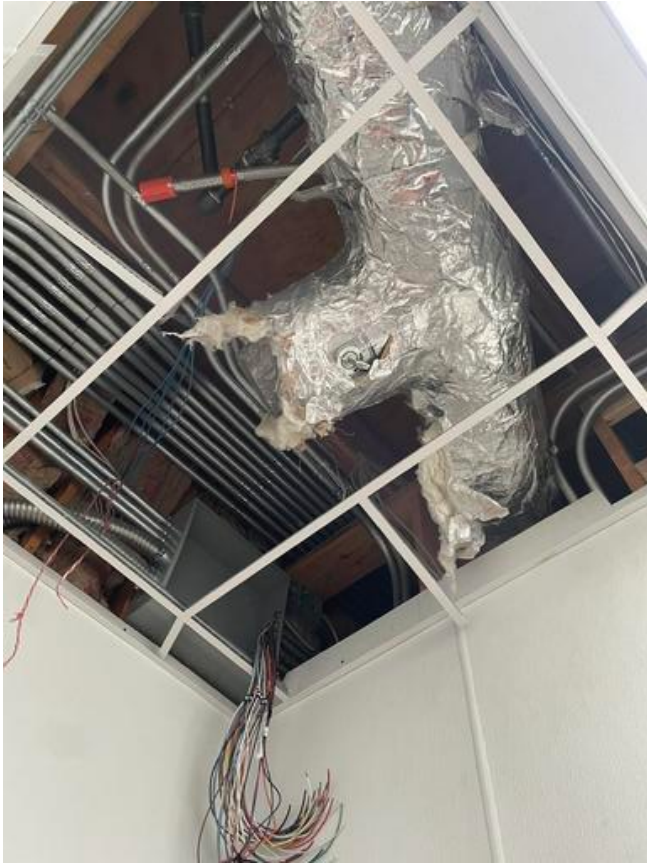
IMG_7031

#38 [DUCT 498] [NEW] CRITICAL (DESIGN) – [MISSING DIFFUSERS]

AC-2, diffuser 1 is not installed. For diffuser 2 there is a large gap in the duct work allowing air to escape the duct.

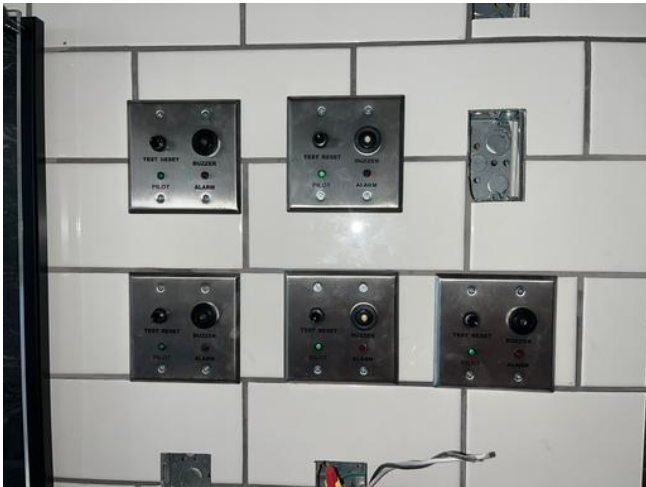
20250624_144327_photo

#37 [CNTL 004] [NEW] CRITICAL – Annunciators not powered.

AC1, AC2, AC3, AC4, AC5
annunciators are not labeled
or energized.

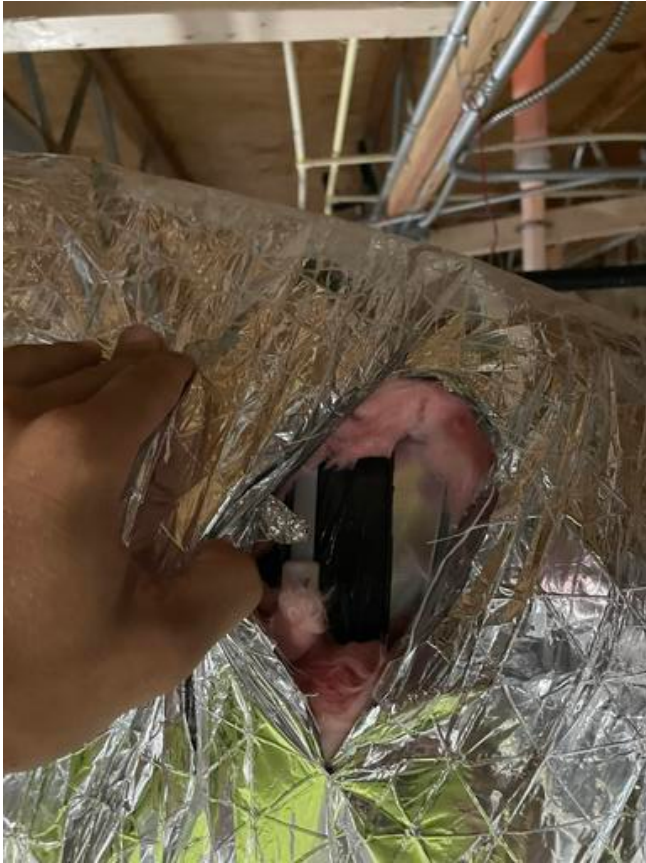
IMG_6994

#36 [DUCT 006] [NEW] CRITICAL – Flex duct installation.

AC1 supply grills were spot checked and Inner flex cores was banded but not taped. Recommend all supply grills be check / verified band and tape were used.

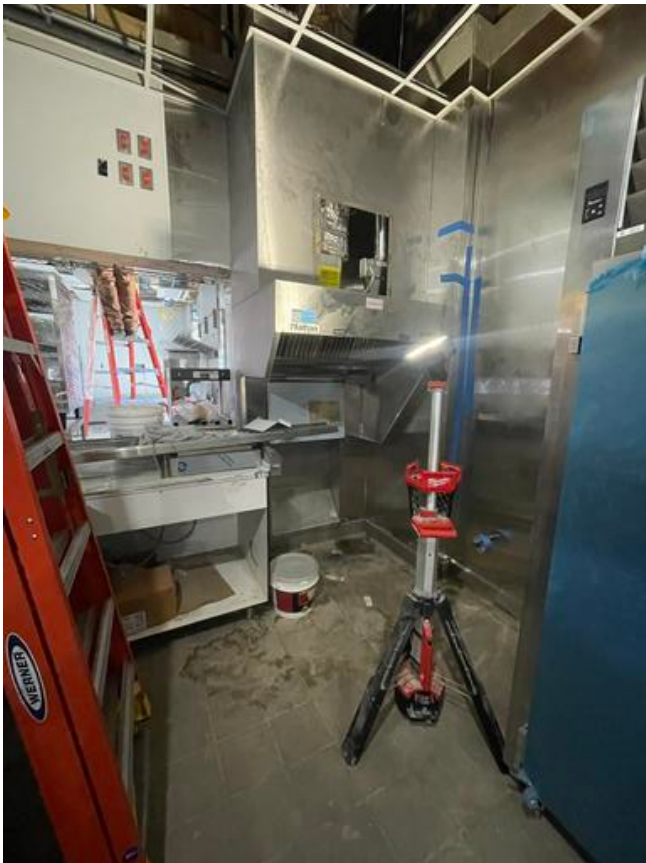
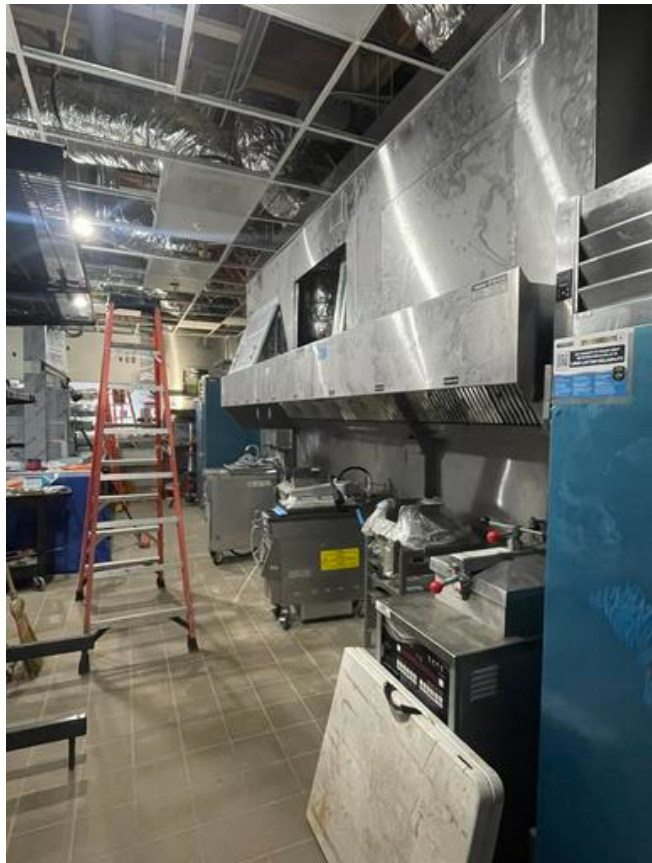
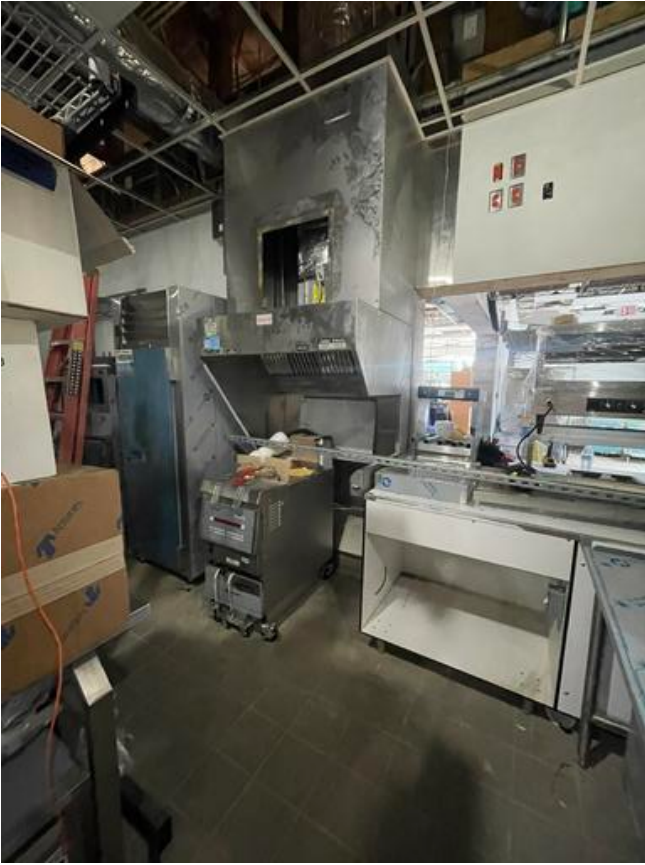
#34 [EXHA 499] [NEW] CRITICAL (MISC) – [HOODS AND FANS NOT POWERED]

Hoods and exhaust fans are not energized.

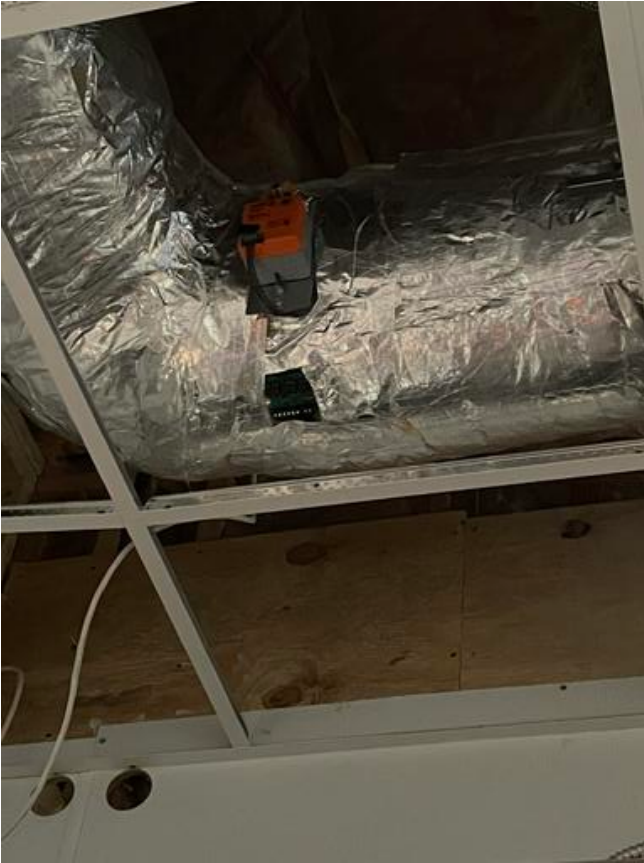
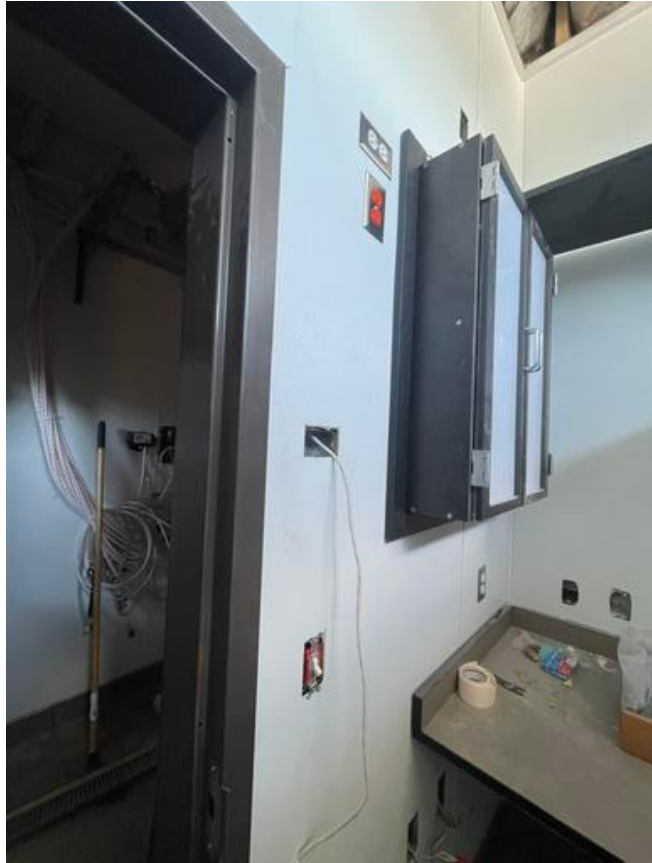
#33 [CNTL 001] [NEW] CRITICAL – MECHANICAL DAMPER.

AC1 mechanical damper
office damper is not
powered, and thermostat is
not installed.

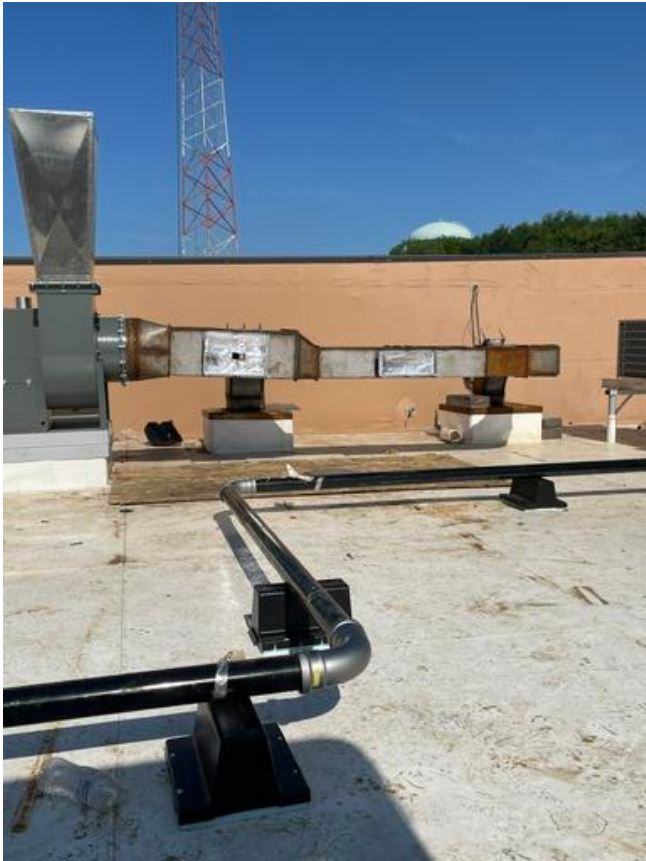
IMG_7030

#30 [EXHA 509] [NEW] Grease exhaust duct is not painted.

EF-1 & EF-2 grease duct on rooftop is not painted.

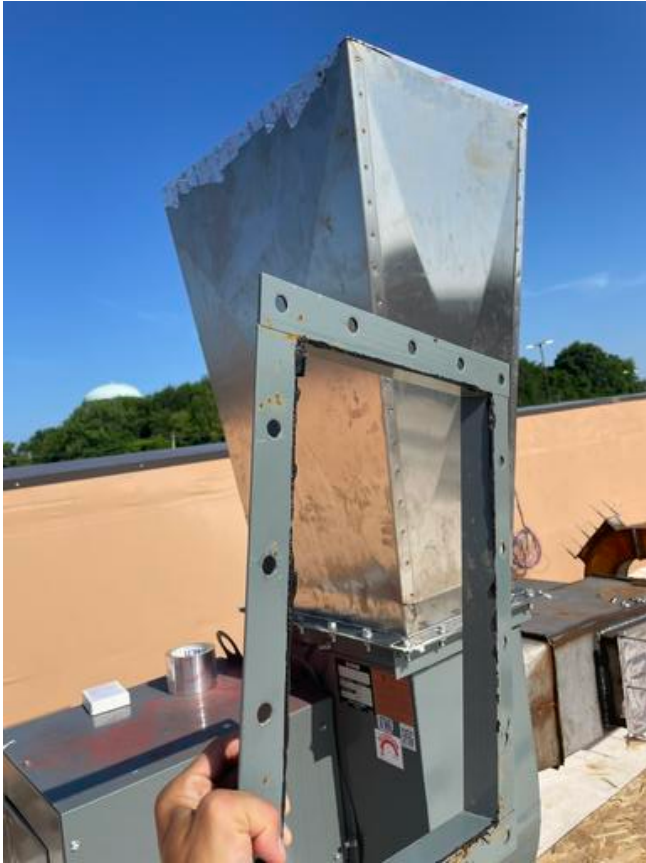
20250624_094604_photo

#29 [EXHA 506] [NEW] Exhaust fan discharge nozzle.

EF-1 & EF-2 factory
discharge flange is not
installed.

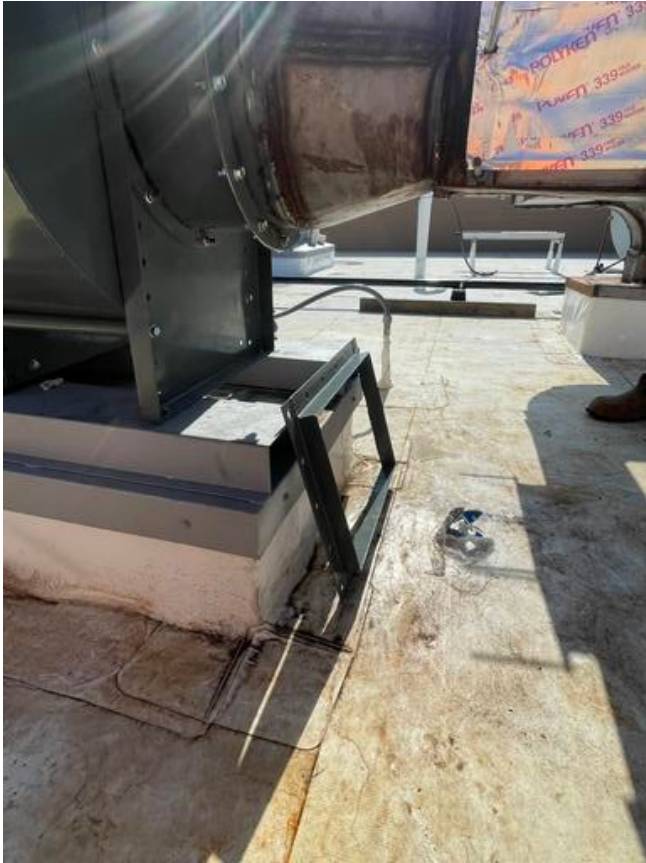
IMG_7027

#28 [EXHA 508] [NEW] Exhaust fan G2 Drip Guard.

EF1 & EF-2 PVC drain & G2
grease guards are not
installed.

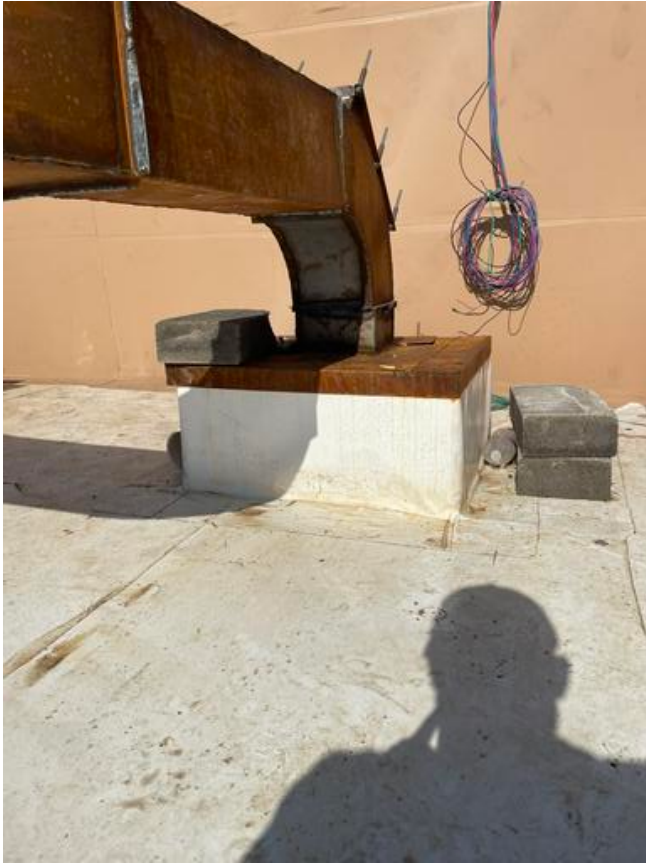
20250624_093605_photo

#27 [EXHA 511] [NEW] Grease exhaust duct curb cap.

EF1 & EF2 grease duct curb cap is to be screwed at all four corners to curb.

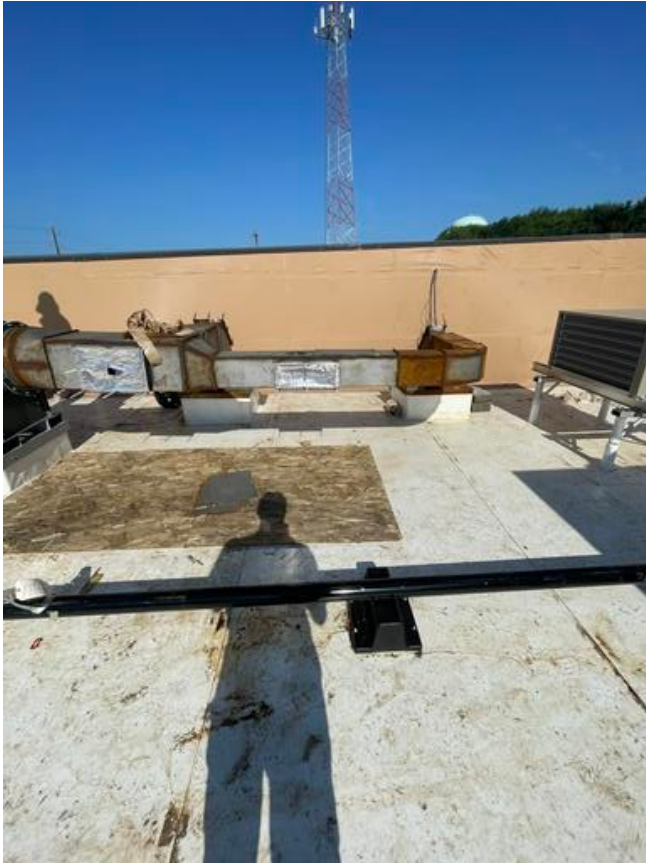
IMG_7025

#26 [EXHA 510] [NEW] Grease exhaust duct is not supported.

EF-1 & EF-2 grease ducts
support stands are not
installed.

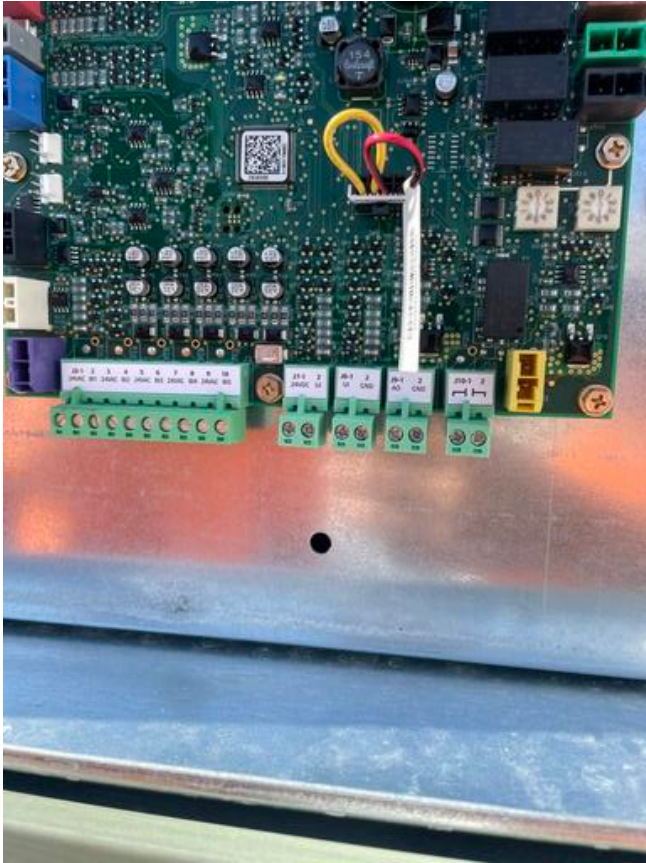
IMG_7023

#23 [CNTL 017] [NEW] CRITICAL Thermostat terminations incorrect.

AC-1, 2, 3, 4, 5 terminal D-1 wire is not landed at terminal J-18 inside each unit.

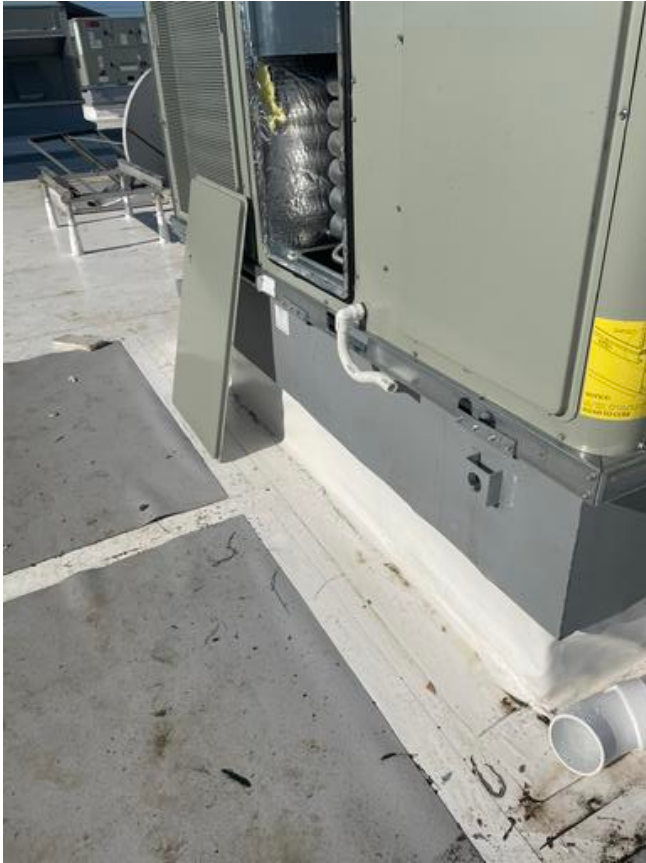
IMG_7021

#22 [UNIT 517] [NEW] Condensate piping construction.

AC1, 2, 3, 4, 5 condensate line and p-traps are not installed.

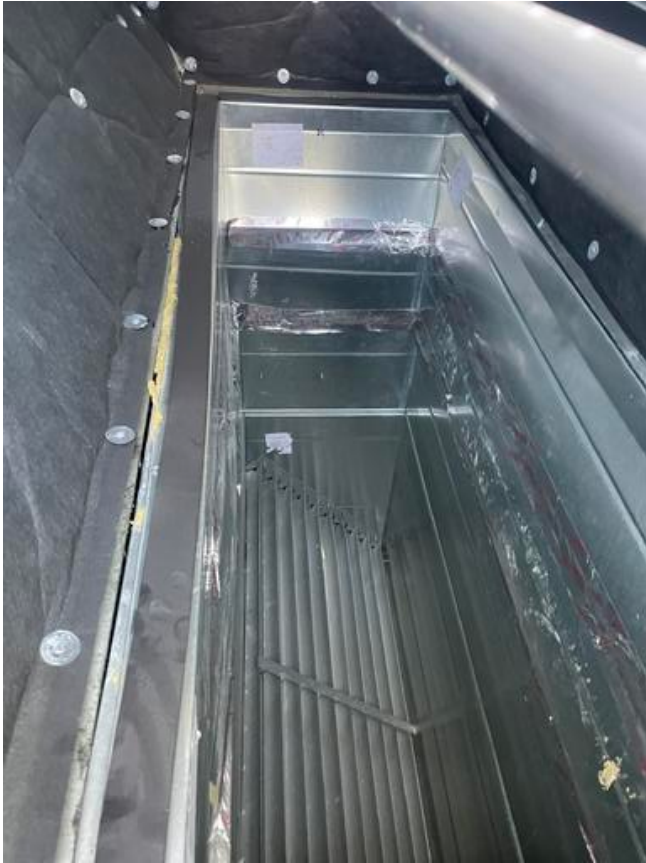
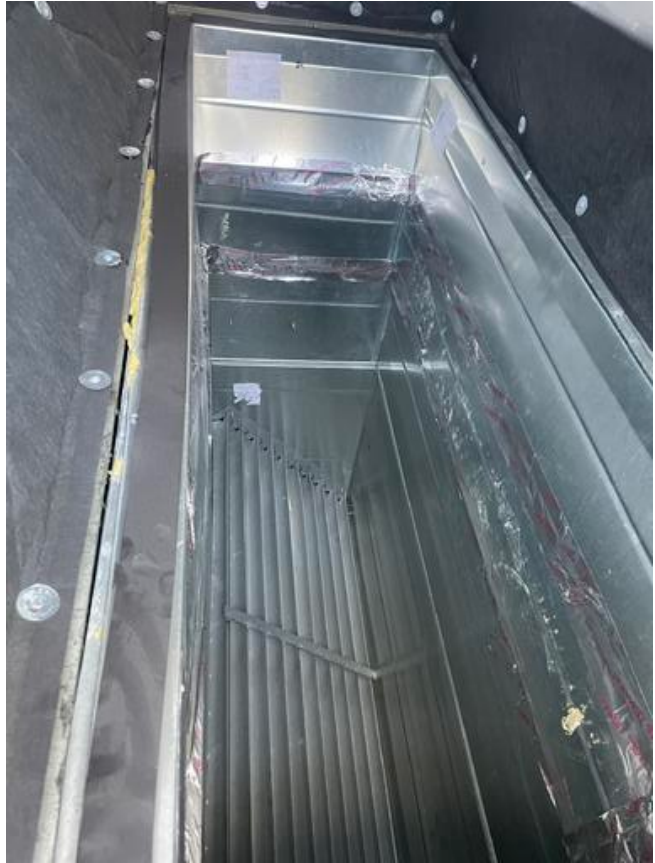
#21 [DUCT 005] [NEW] CRITICAL – Duct leaks observed.

AC-1 new ductwork is not aligned with opening at curb of unit. Can see directly into space. Unit unable to be balanced till issue is resolved.

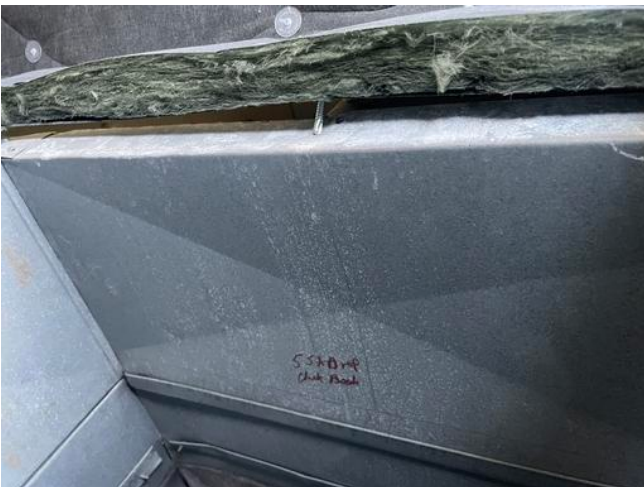
IMG_7015

#20 [DUCT 005] [NEW] CRITICAL – Duct leaks observed.

AC-2, 3, 4, 5 existing supply ductwork does not meet flush with bottom of rooftop unit allowing supply air to escape through the gaps. Units are unable to be balanced till ductwork issue is resolved.

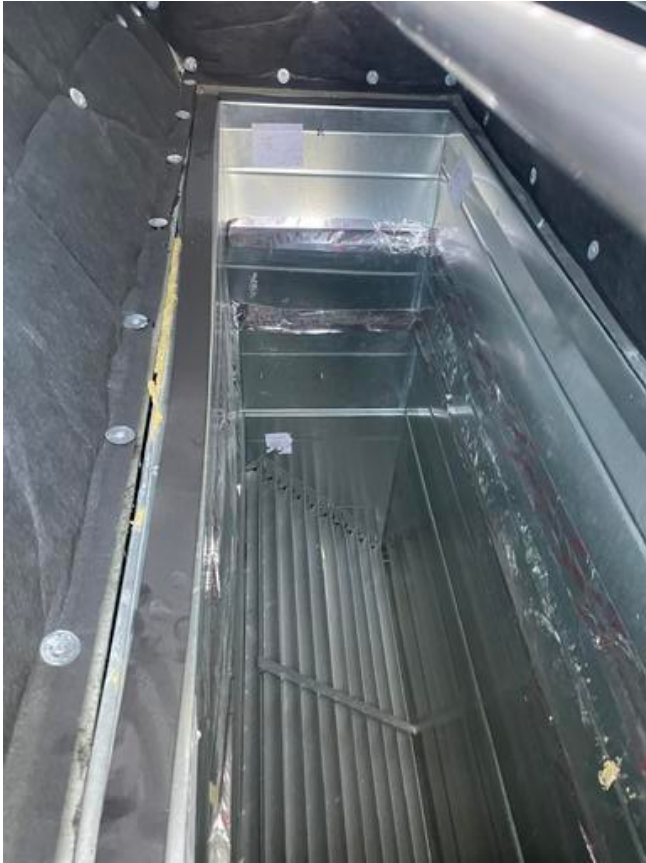
IMG_7020

#19 [UNIT 504] [NEW] Equipment Fresh Air Tempering.

AC-1, 2, 3, 4, 5 fresh air tempering kits are not installed.

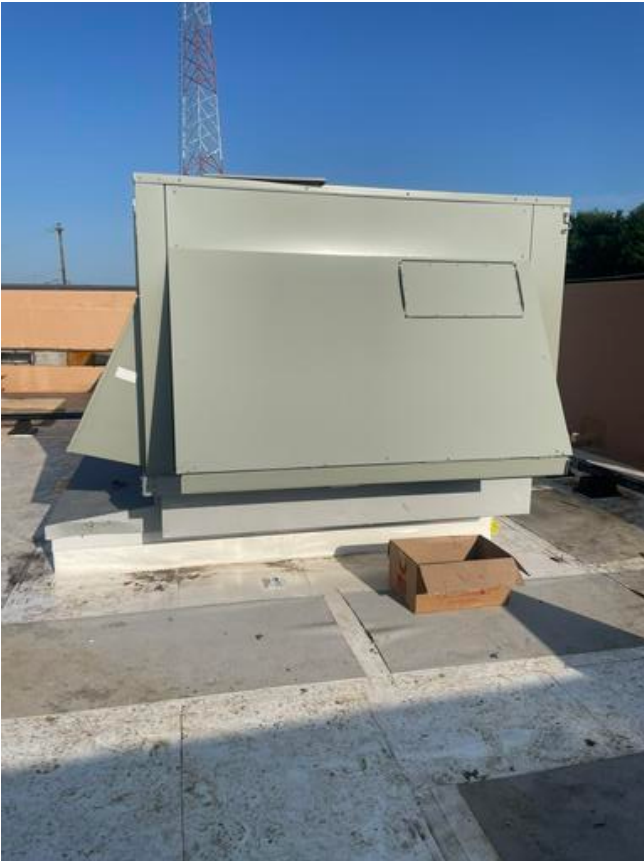
IMG_7013

#18 [UNIT 521] [NEW] Equipment is missing specified options.

AC-1, 2, 3, 4, 5 power exhaust is not installed.

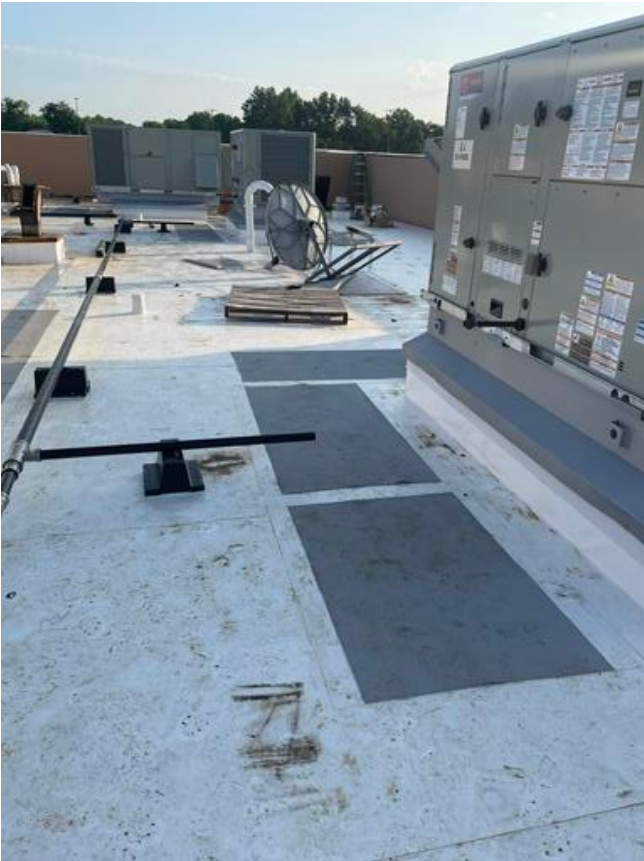
IMG_7012

#17 [UNIT 514] [NEW] Equipment gas piping.

AC-1, 2, 3, 4, 5 gas piping is not completed.

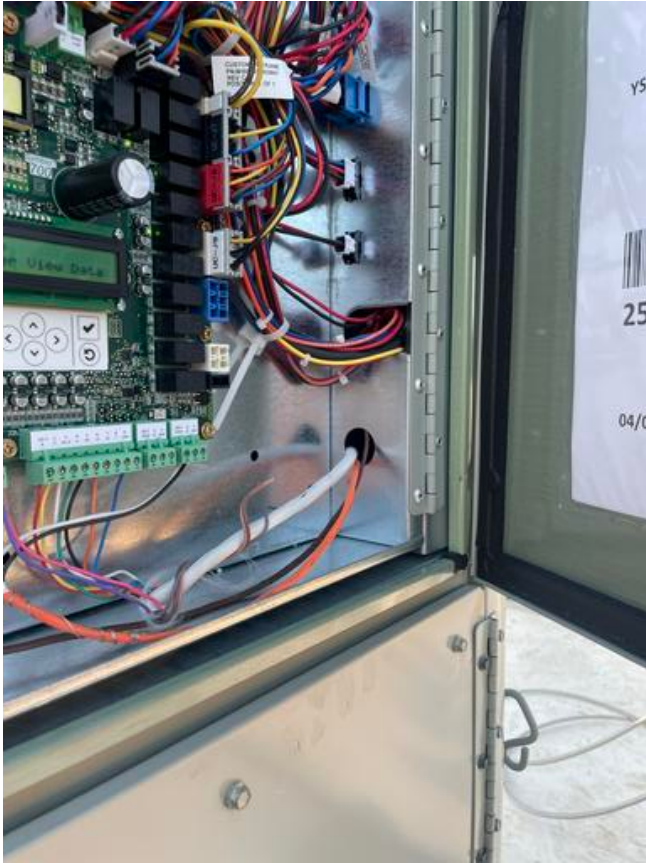
IMG_7011

#16 [UNIT 514] [NEW] Equipment gas piping.

AC-1, 2, 3, 4, 5 grommets need to be installed around penetrations for low voltage wiring.

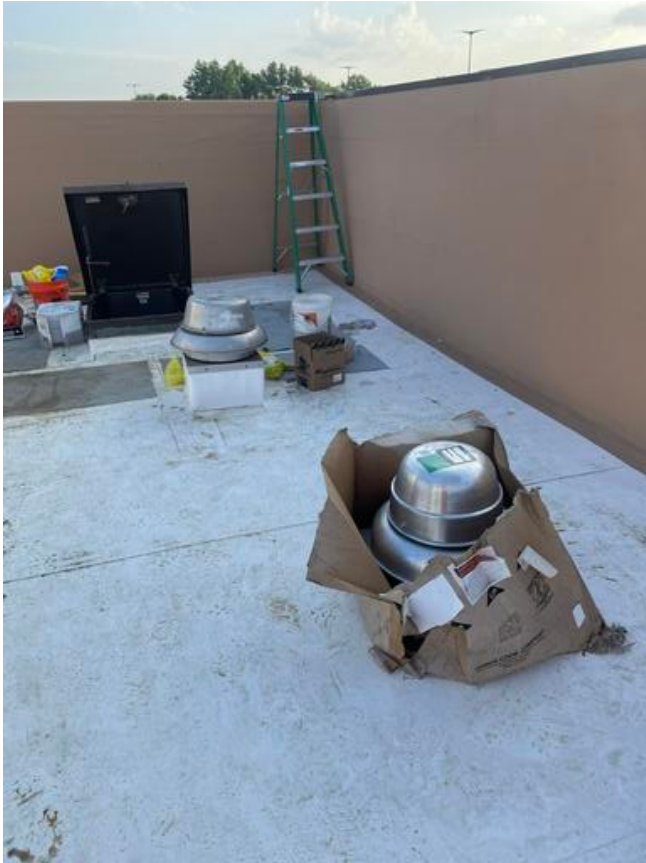
20250624_074015_photo

#15 [EXHA 007] [NEW] CRITICAL – Restroom fan not powered.

New EF-3 has not been attached to curb or powered at this time.

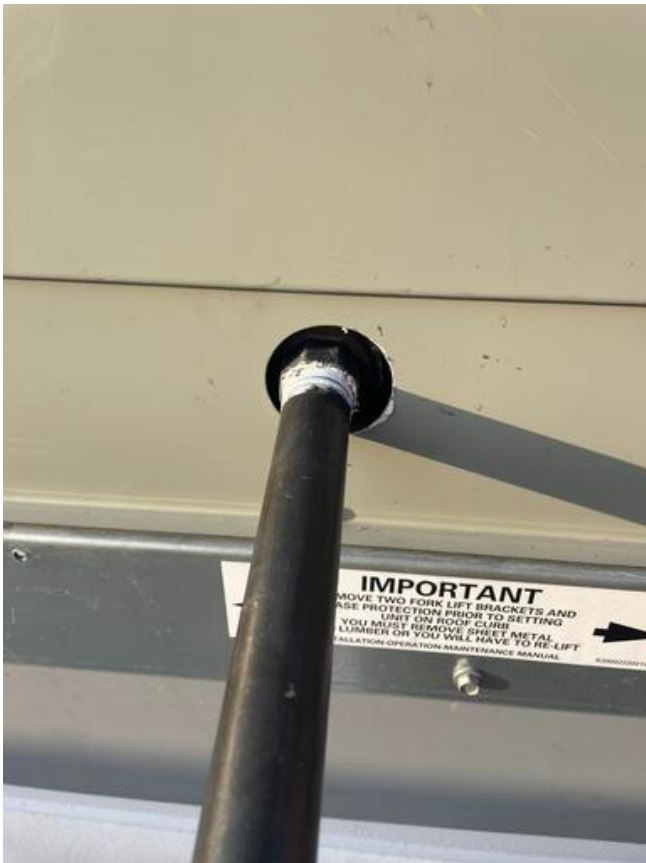
IMG_7008

#14 [UNIT 510] [NEW] Gas inlet grommet.

AC-1 gas pipe grommet is not installed.

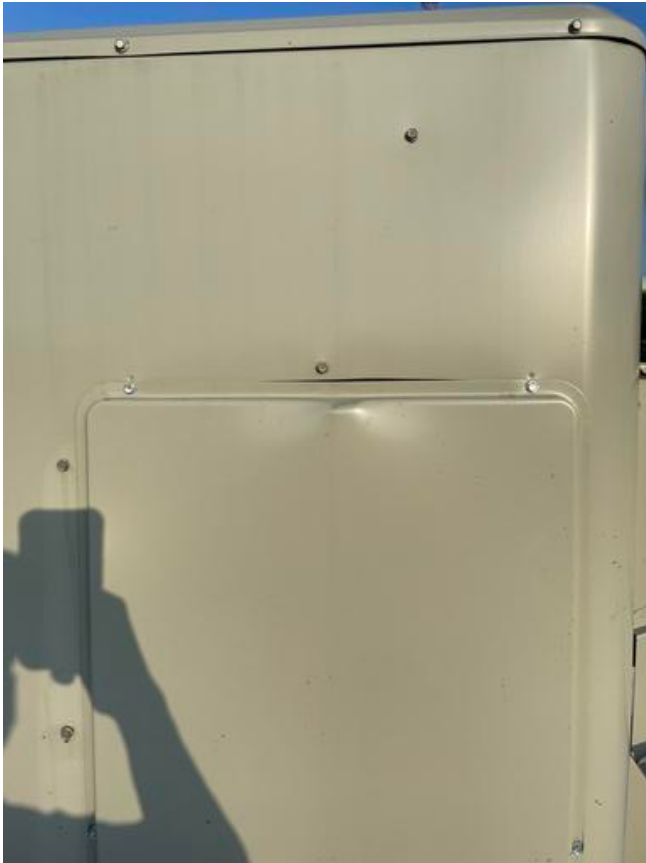
IMG_7007

#13 [UNIT 513] [NEW] Equipment is damaged.

AC-2 exterior is damaged.

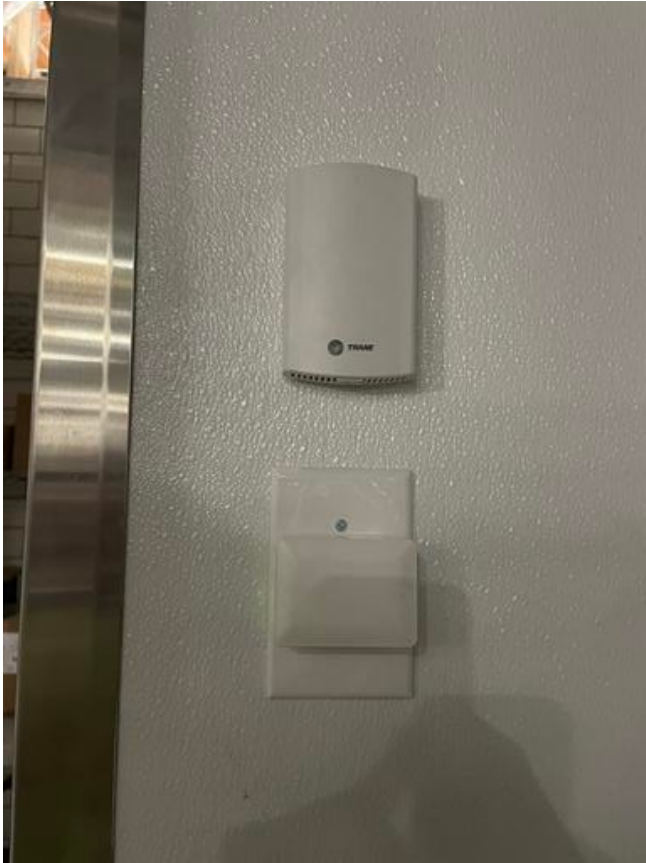
IMG_7005

#12 [CNTL 508] [NEW] Controls labeling.

AC-1, 2, 3, 4, 5 temp and humidity sensors are not labeled.

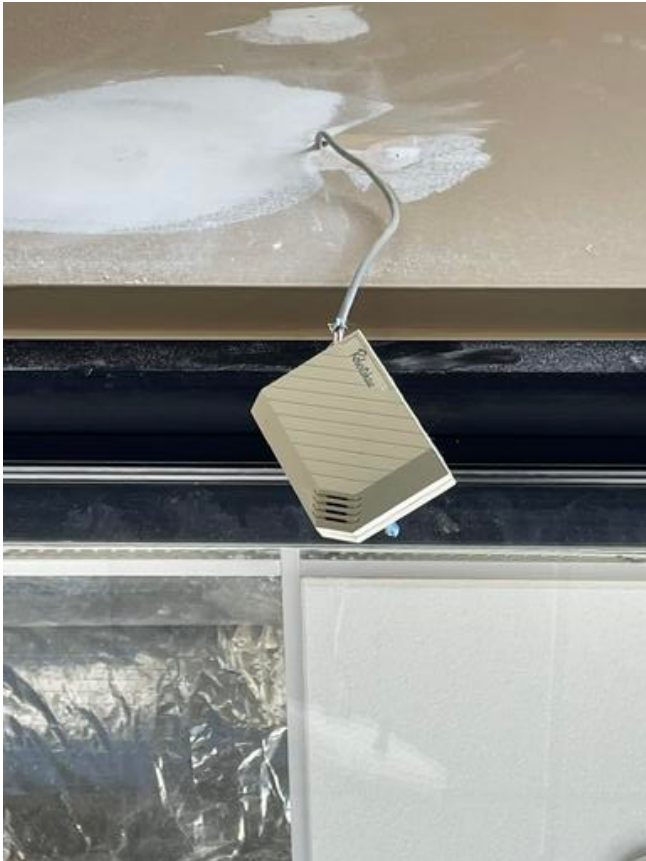
IMG_7004

#11 [CNTL 505] [NEW] New sensors not installed

AC-5 temp and humidity sensors not installed.

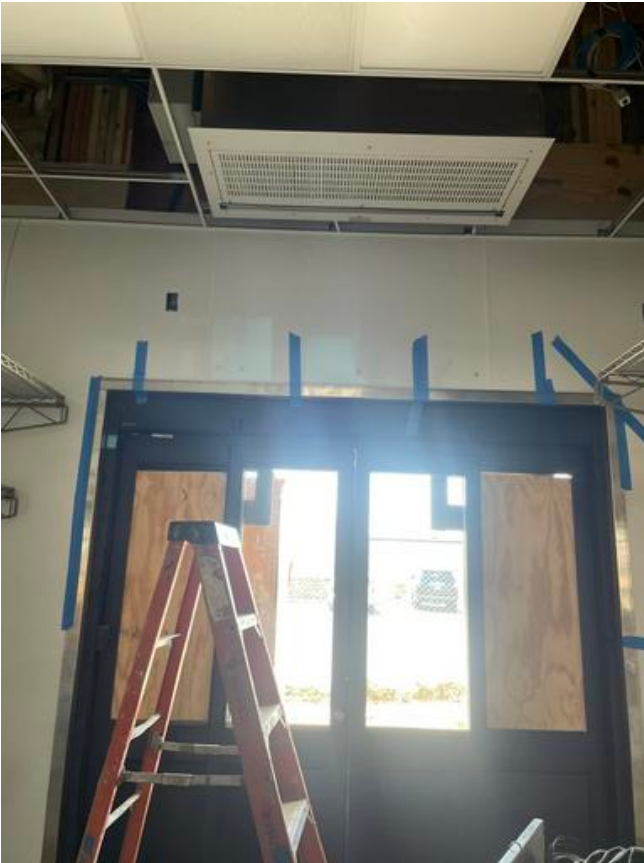
IMG_7044

#10 [CURT 501] [NEW] Air curtain power.

AD-1, 2, 3 are not energized.

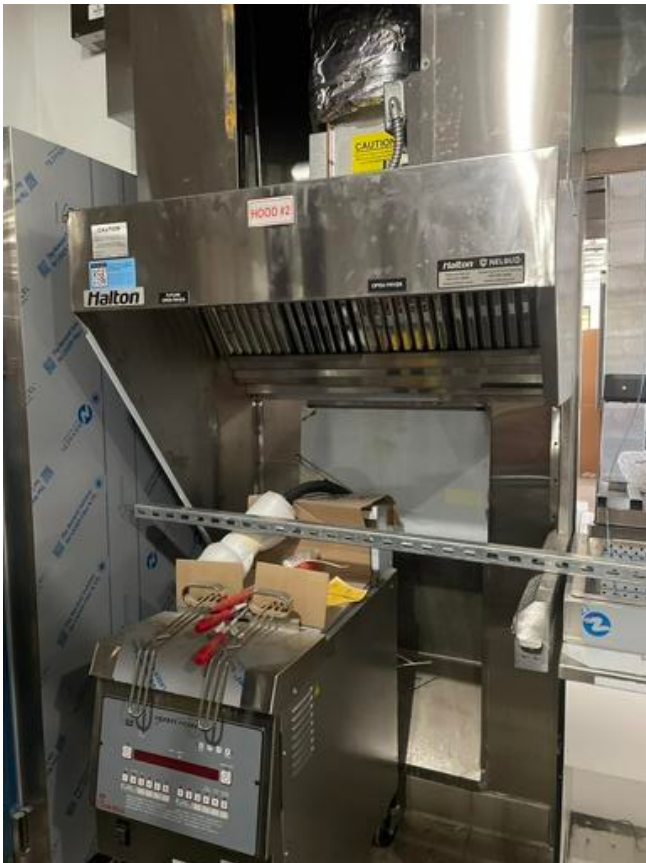
20250624_153314_photo

#9 [HOOD 512] [NEW] Grease cup.

Hood 2 grease cup is not installed.

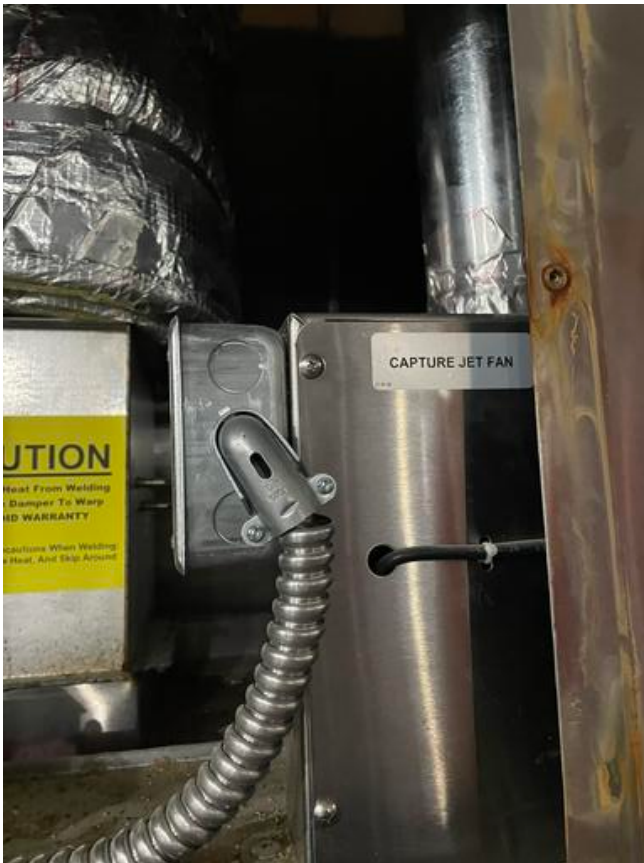
IMG_7002

#8 [HOOD 499] [NEW] CRITICAL (MISC) – [CAPTURE JET NOT POWERED]

Capture jet fans not powered

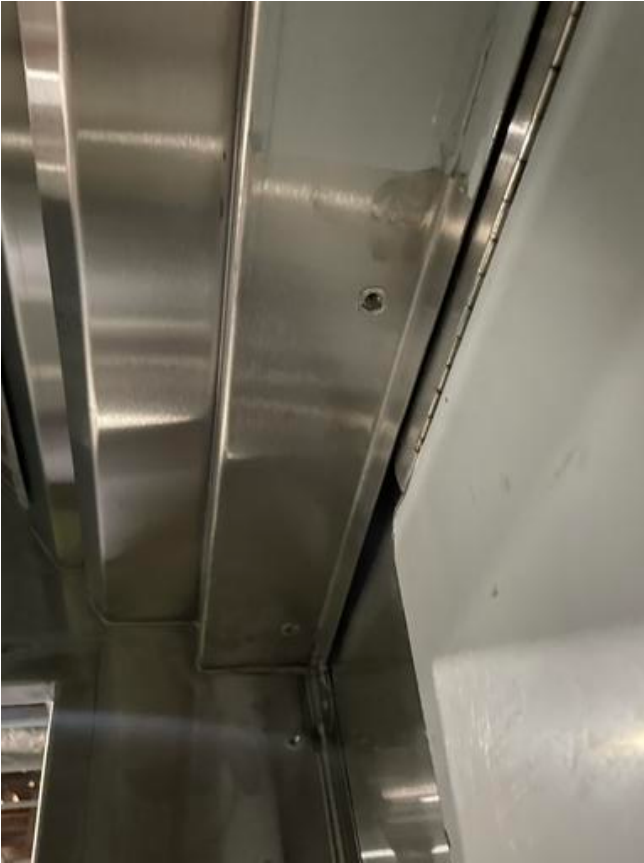
IMG_6998

#6 [HOOD 505] [NEW] Hood shipping brackets.

Gusset bracket holes need screws installed.

Side bracket holes unoccupied

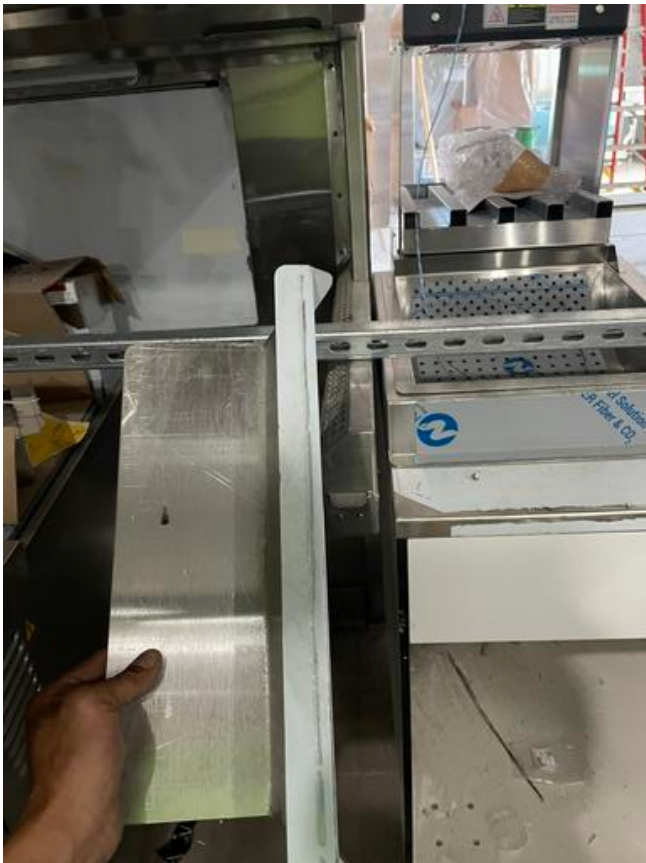
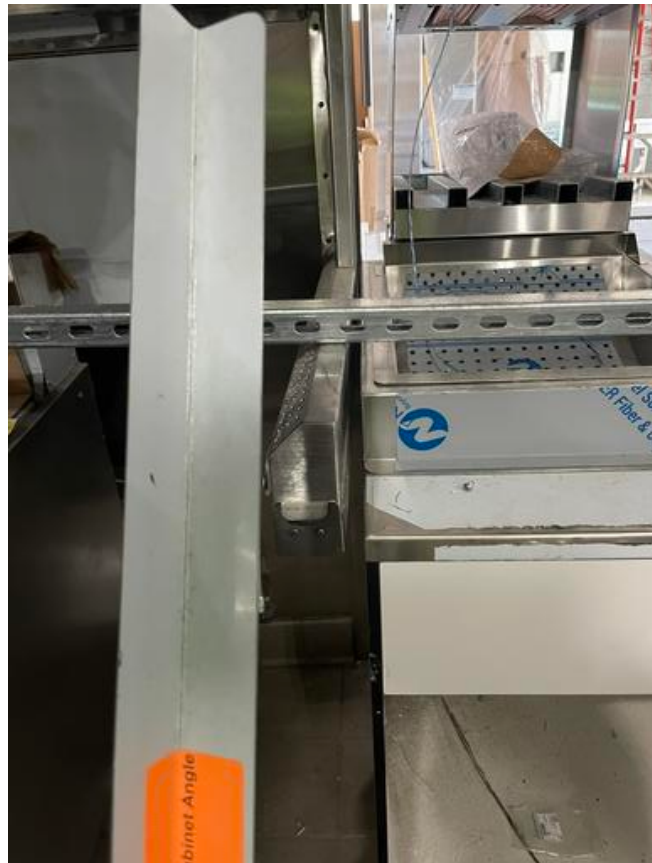
#5 [HOOD 508] [NEW] Sidejet arm angle bracket.

Hood 2 and hood 3 side arm brackets are not installed.

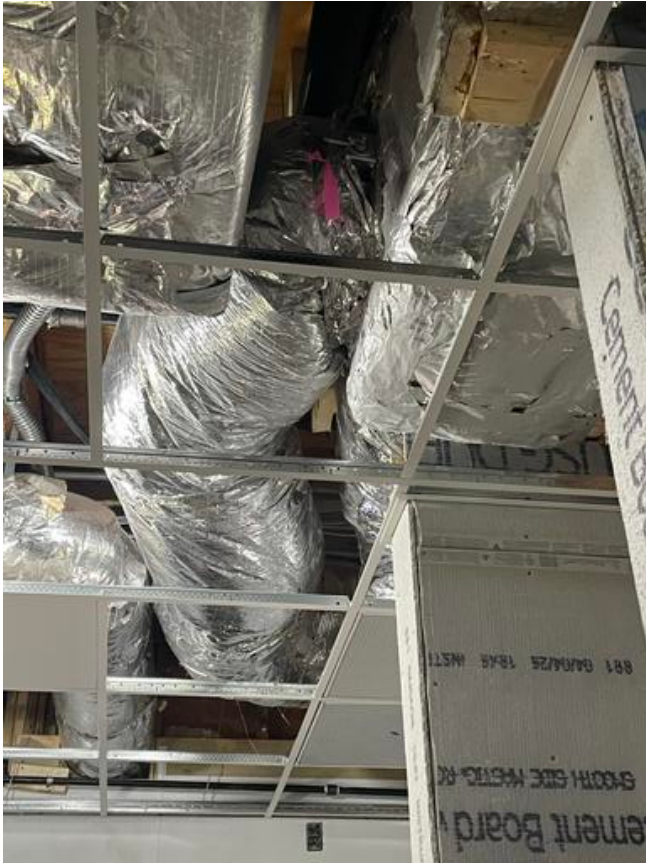
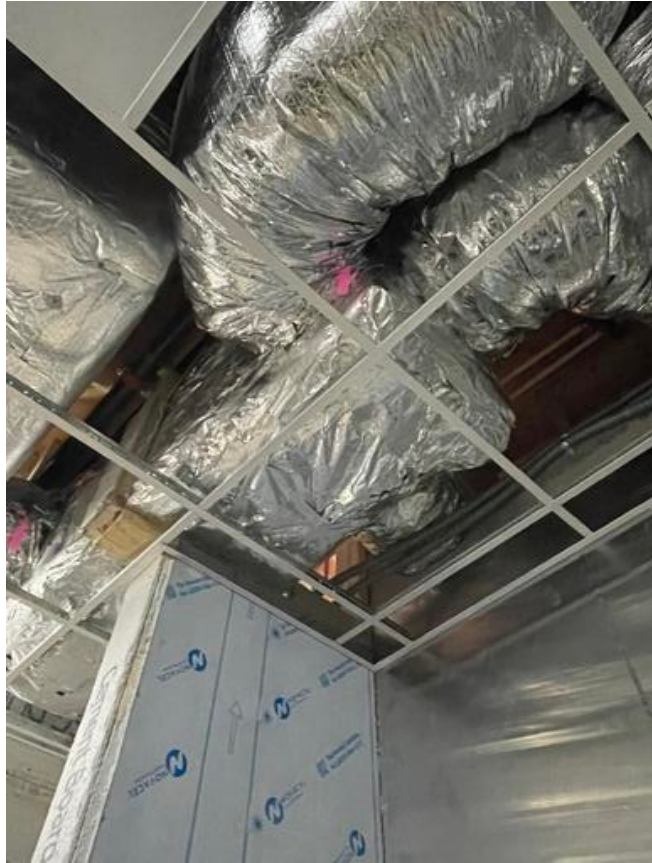
#4 [DUCT 008] [NEW] CRITICAL – Start collar damper orientation.

AC-1 return diffuser damper handles are located on the sides of the duct and should be located on the bottom of the duct.

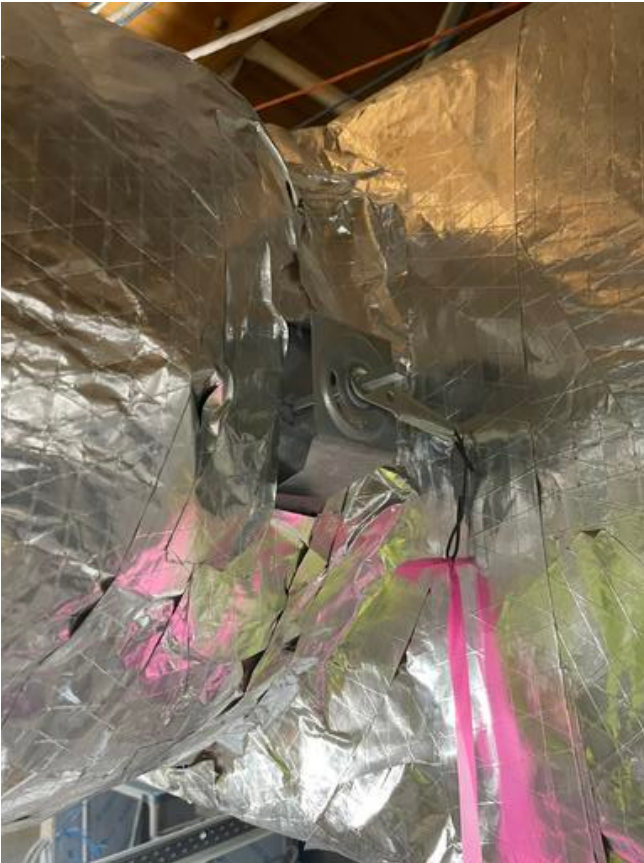
IMG_6993

#3 [DUCT 010] [NEW] CRITICAL – Damper(s) missing hardware.

Damper is missing
necessary hardware.

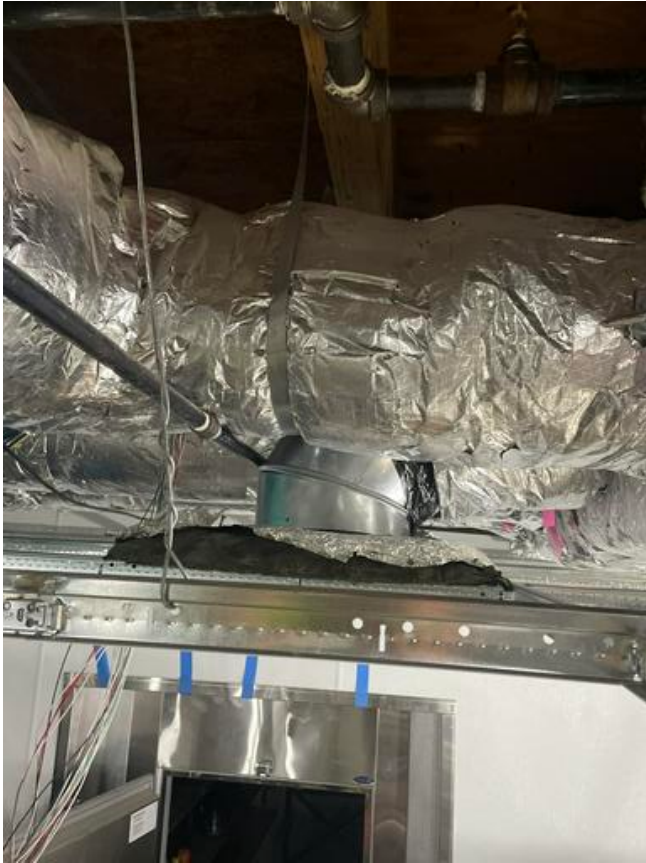
20250623_134655_photo

#2 [DUCT 507] [NEW] Ductwork is not fully insulated.

AC1 has exposed sheet metal & and insulation seems that are not taped also no insulation vapor barrier around diffuser tops.
