Report: Renew  
Date: 3/17/2022

**PROJECT**  
**FREDDY'S - DERBY, KS (DERBY) - RENEW 4FB (4)**

2100 N ROCK RD, SUITE 1000  
DERBY, KS 67037

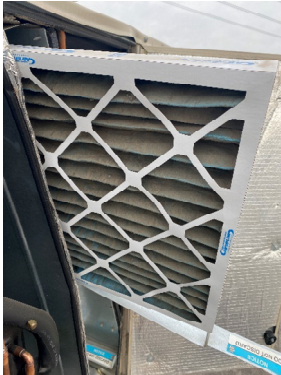
RTU-1 (DINING)  
DIRTY EVAPORATOR FILTERS

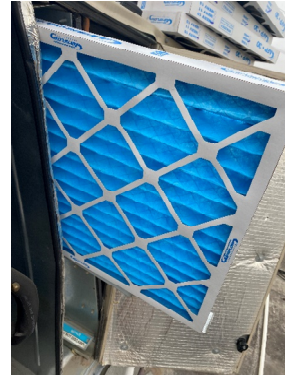
RTU-1 (DINING)  
CLEAN EVAPORATOR FILTERS

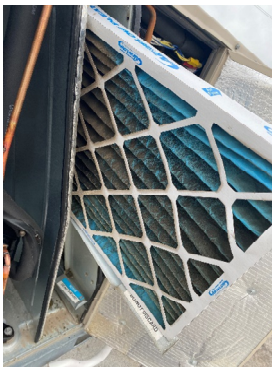
RTU-2 (KITCHEN)  
DIRTY EVAPORATOR FILTERS

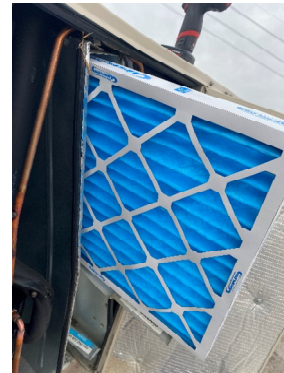
RTU-2 (KITCHEN)  
CLEAN EVAPORATOR FILTERS

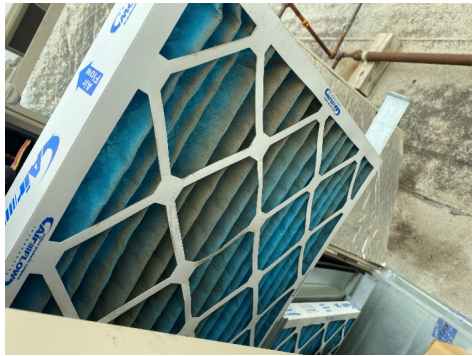
RTU-3 (DINING)  
DIRTY EVAPORATOR FILTERS

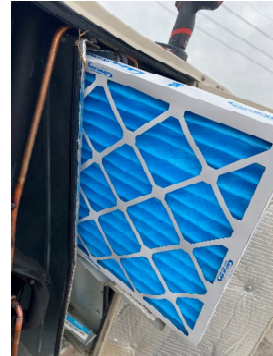
RTU-3 (DINING)  
DIRTY EVAPORATOR FILTERS

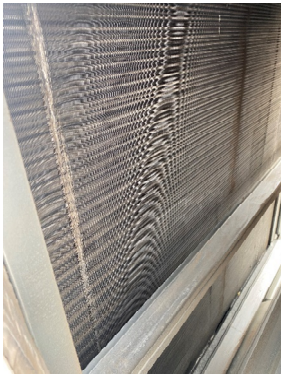
RTU-1 (DINING)  
DIRTY EVAPORATOR

RTU-1 (DINING)  
TO COLD TO CLEAN

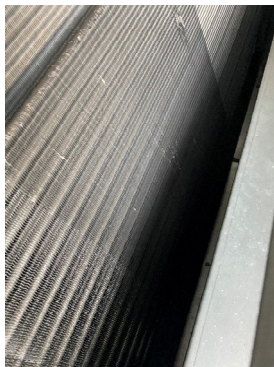
RTU-2 (KITCHEN)  
DIRTY EVAPORATOR

RTU-2 (KITCHEN)  
TO COLD TO CLEAN

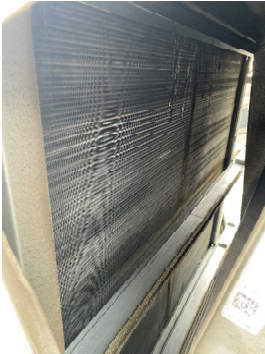
RTU-3 (DINING)  
DIRTY EVAPORATOR

RTU-3 (DINING)  
TO COLD TO CLEAN

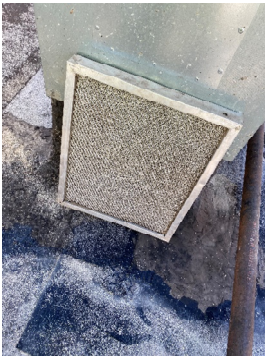
MAU-2 (HOODS 3)  
DIRTY OUTSIDE AIR FILTERS

MAU-2 (HOODS 3)  
TO COLD TO CLEAN

MAU: The intake filters had slight dirt accumulation. They were washed.

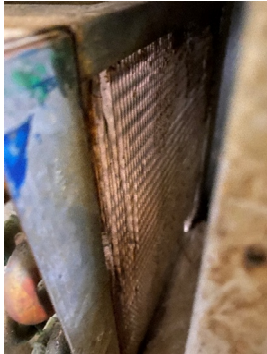
DXC-2 (MEAT COOLER 1)  
DIRTY CONDENSER FILTER

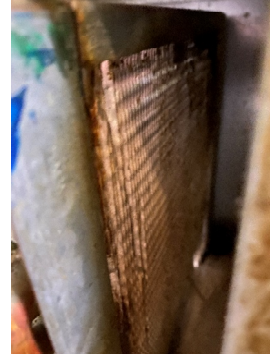
DXC-2 (MEAT COOLER 1)  
CLEAN CONDENSER FILTER

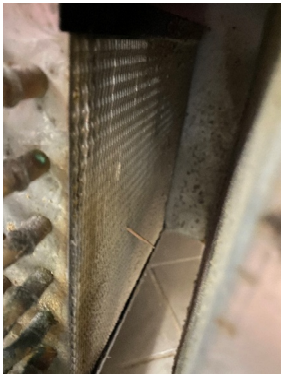
DXC-3 (MEAT COOLER 2)  
DIRTY CONDENSER

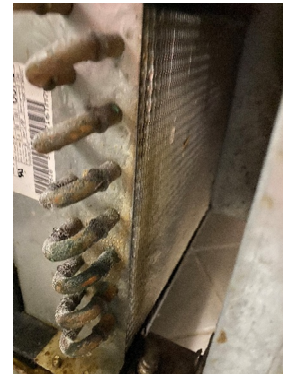
DXC-3 (MEAT COOLER 2)  
CLEAN CONDENSER

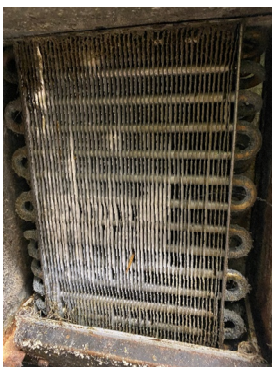
DXC-4 (PREP TABLE 1)  
DIRTY CONDENSER

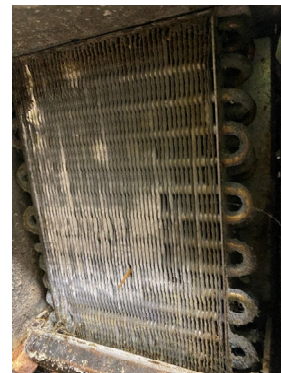
DXC-4 (PREP TABLE 1)  
CLEAN CONDENSER

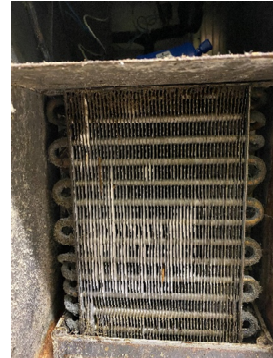
DXC-5 (PREP TABLE 2)  
CLEAN CONDENSER

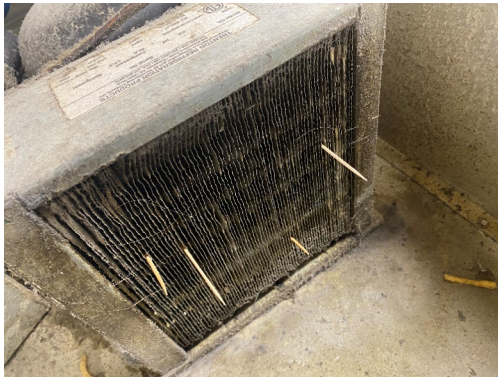
DXC-6 (FRYER FREEZER)  
DIRTY CONDENSER

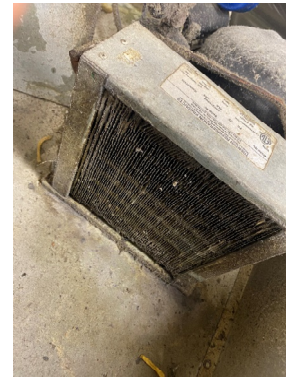
DXC-6 (FRYER FREEZER)  
CLEAN CONDENSER

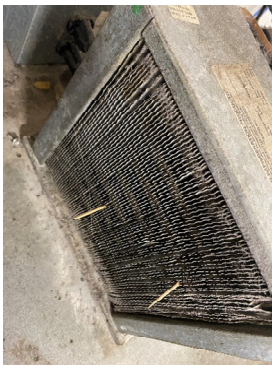
DXC-7 (SUNDAE PREP)  
DIRTY CONDENSER

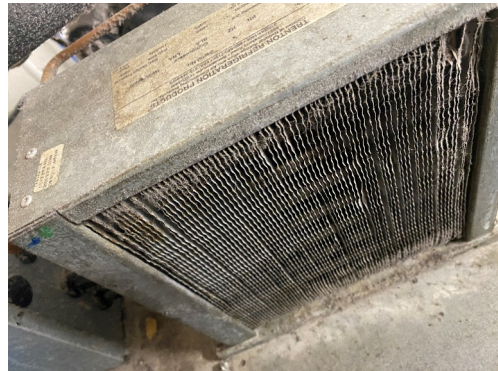
DXC-7 (SUNDAE PREP)  
CLEAN CONDENSER

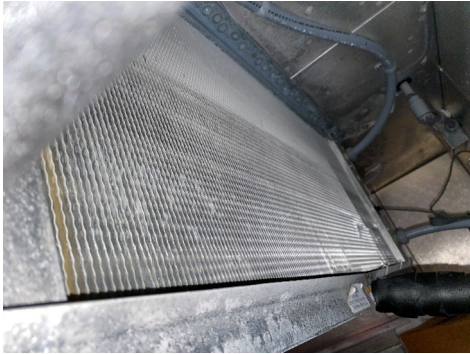
DXC-1 (WALK-IN FREEZER)  
DIRTY EVAPORATOR

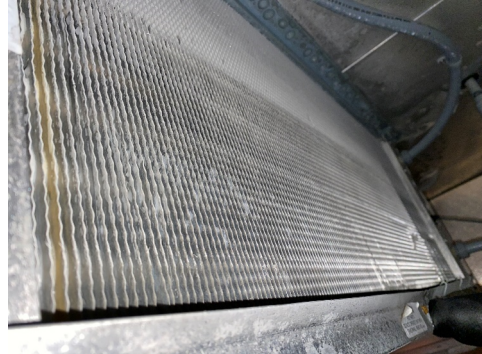
DXC-1 (WALK-IN FREEZER)  
CLEAN EVAPORATOR

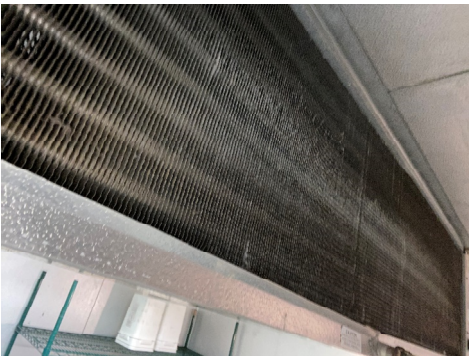
DXC-1 (WALK-IN COOLER)  
DIRTY EVAPORATOR

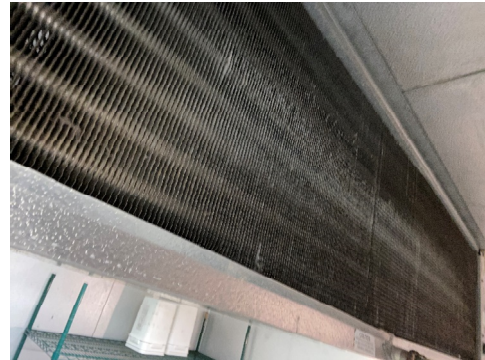
DXC-1 (WALK-IN COOLER)  
CLEAN EVAPORATOR
