Report: TAB REPORT
Function: Test, Adjust, & Balance
Date: 07/26/2024

PROJECT
07-15-24 FREDDY'S - MANASSAS, VA

Project: 07-15-24 FREDDY'S - MANASSAS, VA

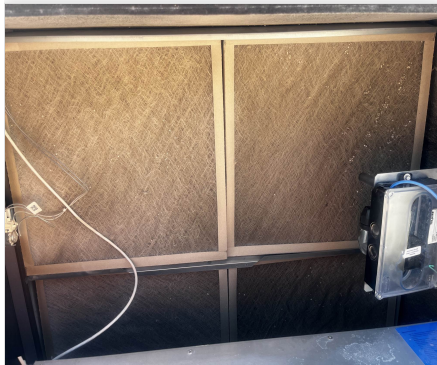
Issue Name : RTU-1: Construction filters are dirty and need to be replaced
Description : RTU-1 construction filters are dirty. Recommend installing pleated filters with a MERV rating of 8 or higher prior to store's opening.
Created By : National TAB **Assigned To :** National TAB - David Annan
Status : Open
Priority : Medium **Asset Tag :**
Originated Date : 07/28/2024 - David Annan - National TAB

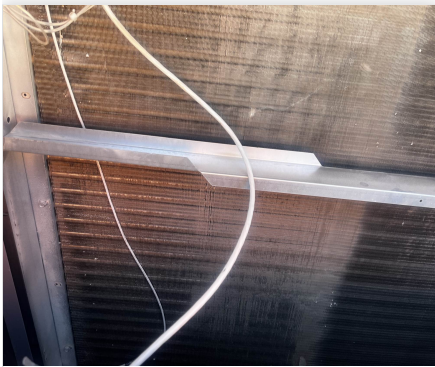
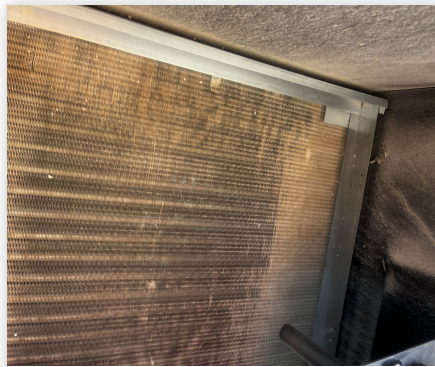
Issue Name : RTU-1: Evaporator Coils are dirty
Description : RTU-1 evaporator coils are dirty. Recommend having the coils washed.
Created By : National TAB **Assigned To :** National TAB - David Annan
Status : Open
Priority : High **Asset Tag :**
Originated Date : 07/28/2024 - David Annan - National TAB
