Report: TAB REPORT
Function: Test, Adjust, & Balance
Date: 07/26/2024

PROJECT
07-15-24 FREDDY'S - MANASSAS, VA

Project: 07-15-24 FREDDY'S - MANASSAS, VA

Table Of Contents

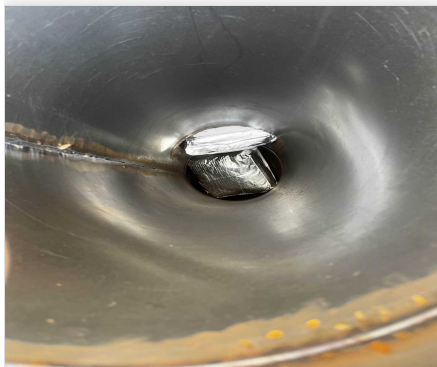
Issue Name : KEF-1: Debris is blocking airflow in grease duct
Description : There is debris lodged in the grease duct restricting airflow. Could not get fan to design. Recommend having Mechanical remove the debris.
Created By : National TAB **Assigned To :** National TAB - David Annan
Status : Open
Priority : Urgent **Asset Tag :**
Originated Date : 07/28/2024 - David Annan - National TAB

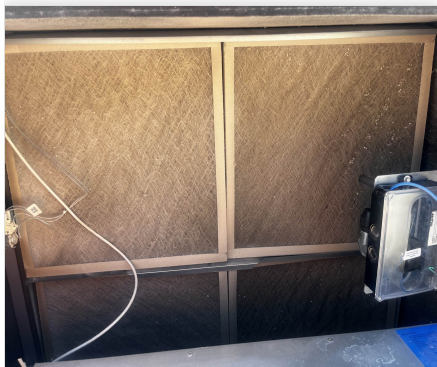
Issue Name : RTU-1: Construction filters are dirty and need to be replaced
Description : RTU-1 construction filters are dirty. Recommend installing pleated filters with a MERV rating of 8 or higher prior to store's opening.
Created By : National TAB **Assigned To :** National TAB - David Annan
Status : Open
Priority : Medium **Asset Tag :**
Originated Date : 07/28/2024 - David Annan - National TAB

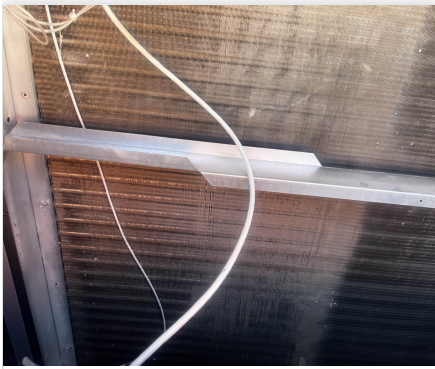
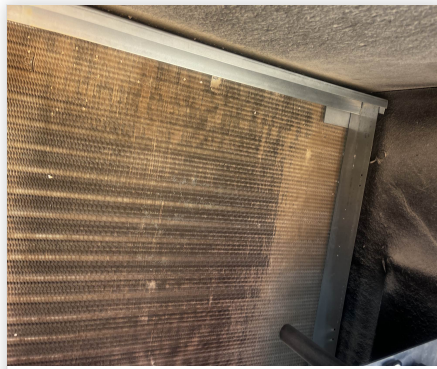
Issue Name : RTU-1: Evaporator Coils are dirty
Description : RTU-1 evaporator coils are dirty. Recommend having the coils washed.
Created By : National TAB **Assigned To :** National TAB - David Annan
Status : Open
Priority : High **Asset Tag :**
Originated Date : 07/28/2024 - David Annan - National TAB
