**Report: TAB Report
Function: Test, Adjust, & Balance
Date: 11/14/2022**

**11-07 WALGREENS #3507 - PORT NECHES,
TX**

Project: 11-07 WALGREENS #3507 - PORT NECHES, TX

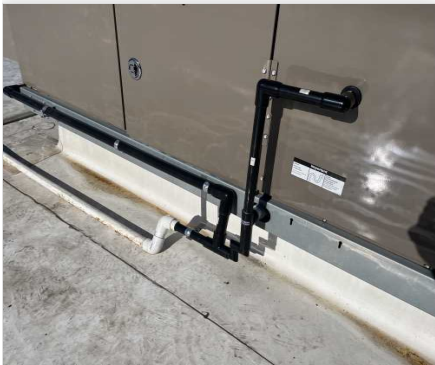
Image_2022_11_13T2102...

Issue Name : COSTGARD

Description : RTU-1 COSTGARD IS LEAKING AT CONNECTION TO UNIT. DRAIN IS NOT VENTED, NOT SUPPORTED AT SUCTION SECTION. DRAIN RUNS ONTO ROOF. FAN DISCHARGE PIPE HAS COME LOOSE FROM GROMMET.

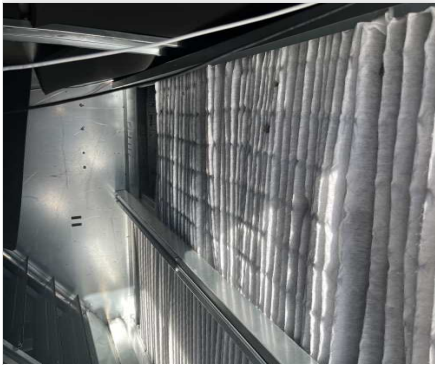
Image_2022_11_13T2102...

Issue Name : RTU-1

Description : RTU-1 EVAP FILTERS DO NOT ADEQUATELY COVER COIL.
