**National TAB  
1329 E. KEMPER ROAD  
SUITE 4210  
CINCINNATI, OH 45246**

**Report: TAB Report  
Function: Test, Adjust, & Balance  
Date: 11/14/2022**

**11-07 WALGREENS #3507 - PORT NECHES,  
TX**

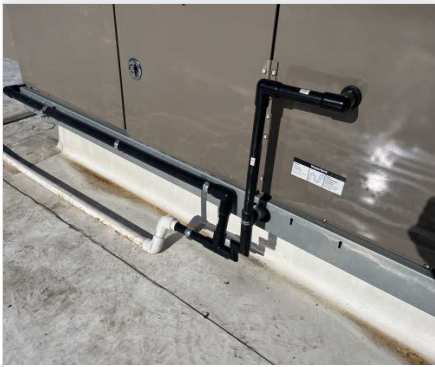
Image\_2022\_11\_13T2102...

**Issue Name :** COSTGARD

**Description :** RTU-1 COSTGARD IS LEAKING AT CONNECTION TO UNIT. DRAIN IS NOT VENTED, NOT SUPPORTED AT SUCTION SECTION. DRAIN RUNS ONTO ROOF. FAN DISCHARGE PIPE HAS COME LOOSE FROM GROMMET.
