Report: TAB REPORT
Function: Test, Adjust, & Balance
Date: 03/24/2025
Completed By: National TAB

PROJECT
03-24-25 CHIPOTLE #4941 DUNCAN, NC

Project: 03-24-25 CHIPOTLE #4941 DUNCAN, NC

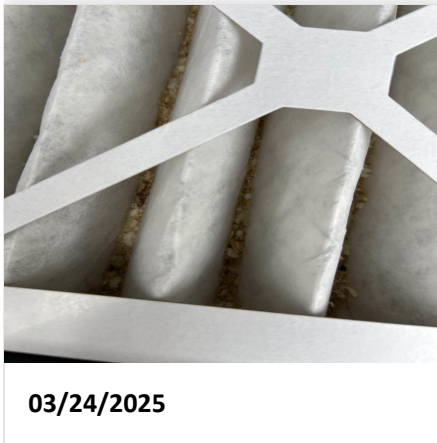
Issue Name : Final filters dirty.
Description : Filters on both RTU's are dirty, recommend replacement.
Created By : National TAB **Assigned To :** National TAB - Brianna Biggs
Status : Open
Priority : Medium **Asset Tag :**
Originated Date : 03/24/2025 - Jearod Ferrette - National TAB

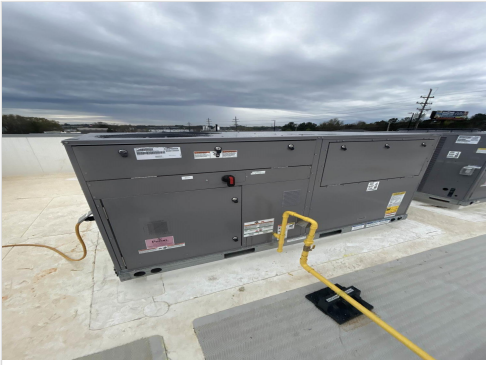
Unit Data - PHOTO LOG

Asset: RTU1

General		Actual
Fan Rotation Correct		YES
Unit Filters Clean		NO
Condensate Drain Installed		YES

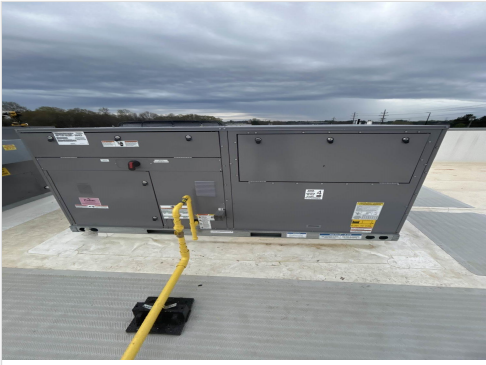
Unit Data - PHOTO LOG

Asset: RTU2

General	
	Actual
Fan Rotation Correct	YES
Unit Filters Clean	NO
Condensate Drain Installed	YES

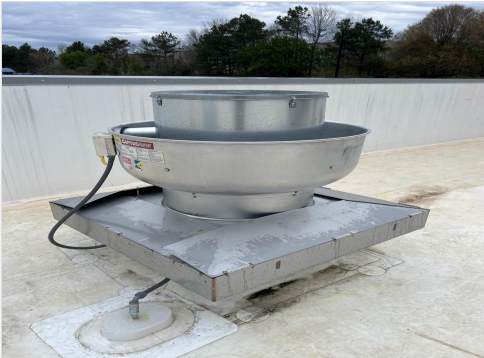
Unit Data - PHOTO LOG

Asset: EF1

Test Data		
	Design	Actual
CFM	2550	2536
Fan RPM	-	DD/48.3
Fan Rotation	-	CCW
Motor RPM	-	DD/48.3
System SetPt	-	48.3HZ
RL Voltage	-	88 VFD
RL Amperage	-	4.8 VFD
Total ESP	1.20"	0.55"
Fan Inlet SP	-	-0.55"
Fan Discharge SP	-	ATMO

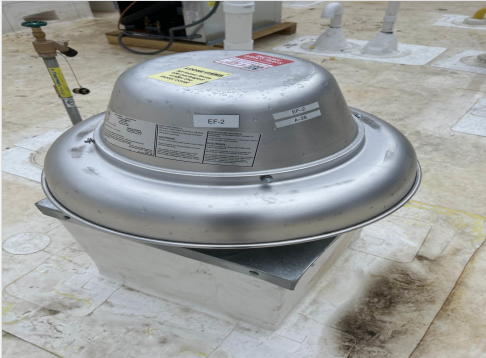
Unit Data - PHOTO LOG

Asset: EF2

Test Data		
	Design	Actual
CFM	150	148
Fan RPM	1304	1251
Fan Rotation	-	CCW
Motor RPM	-	1251
System SetPt	-	65P
RL Voltage	-	115V
RL Amperage	-	0.80
Total ESP	0.600"	0.40"
Fan Inlet SP	-	-0.40"
Fan Discharge SP	-	ATMO

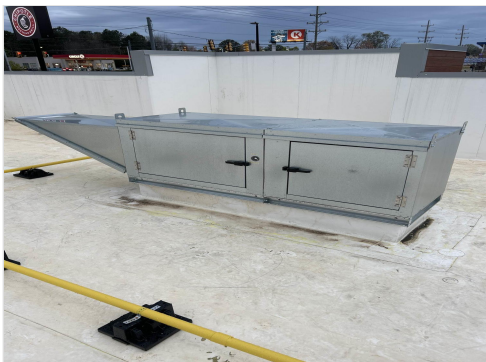
Unit Data - PHOTO LOG

Asset: MUA 1

Test Data		
	Design	Actual
CFM	1300	1319
SF RPM	1557	DD/53.4
Motor RPM	-	DD/53.4
SF System SetPt	-	53.4HZ
RL Voltage	-	145 VFD
RL Amperage	-	2.5 VFD

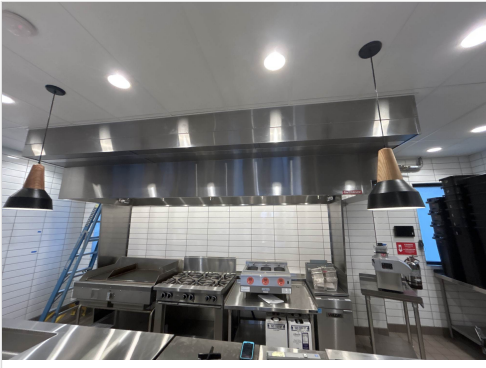
Unit Data - PHOTO LOG

Asset: HD1

Test Data Exhaust		
	Design	Actual
Filter Type	CAPTRATE SOLO FILTER	CAPTRATE SOLO FILTER
Filter Size 1	16X16	16X16
Filter Qty 1	9	9
Filter AK factor size 1	1.62	1.62
Filter Total AK Area	14.58	14.58
Filter1 FPM	-	161
Filter2 FPM	-	170
Filter3 FPM	-	177
Filter4 FPM	-	181
Filter5 FPM	-	191
Filter6 FPM	-	185
Filter7 FPM	-	168
Filter8 FPM	-	169
Filter9 FPM	-	165
Filter Ave FPM(corr)	-	174
CFM	2550	2536
