Report: TAB Report
Function: Test, Adjust, & Balance
Date: 11/18/2025
Completed By: National TAB

11-17-25 CHIPOTLE # 5643 Winona, MN

Project: 11-17-25 CHIPOTLE # 5643 Winona, MN

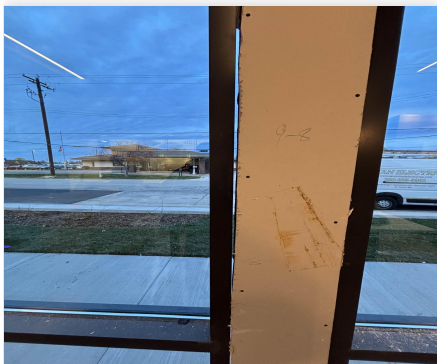
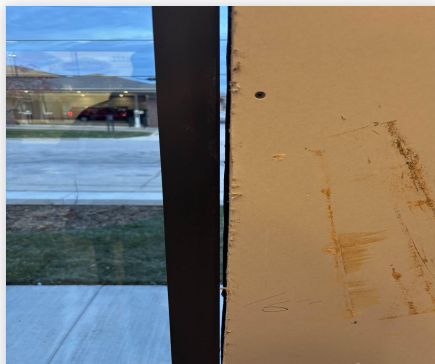
Issue Name : INFO ONLY: Building Pressure Measurement
Description : Dining room window installation is incomplete. Gaps in window frame, building is not sealed. As a result, a reliable building pressure measurement could not be taken. Net airflow measured positive, anticipate positively pressurized space once building is sealed.
Created By : National TAB **Assigned To :** National TAB - Michael McDonnell
Status : Open
Priority : Urgent **Asset Tag :**
Originated Date : 11/18/2025 - Michael McDonnell - National TAB

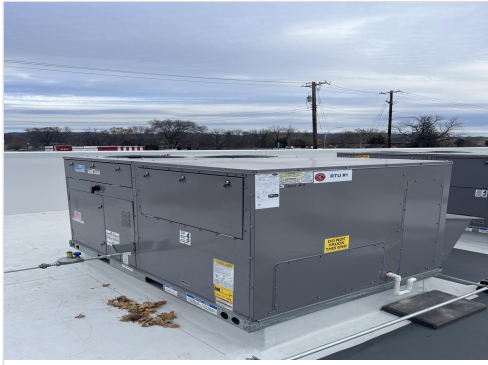
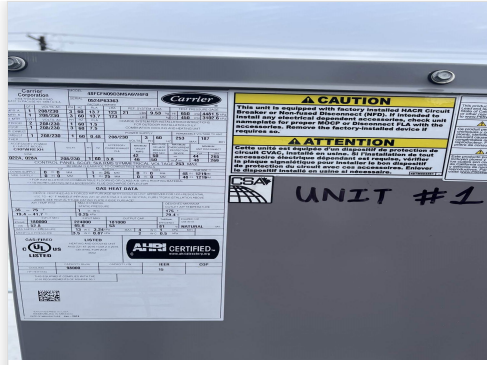
Unit Data - PHOTO LOG

Unit Data		
	Design	Actual
MFG	CARRIER	CARRIER
Serial Num	-	0524P63363
Model Num	48FCFN09D3M5	48FCFN09D3M5
Type	RTU	RTU
Configuration	VERTICAL	VERTICAL
Num OA Filters 1	-	1
OA Filter Size 1	-	35X19
Num Final Filter 1	-	4
Final Filter Size 1	-	20X20X2

Notes:
[1] CONSTRUCTION FILTERS INSTALLED.

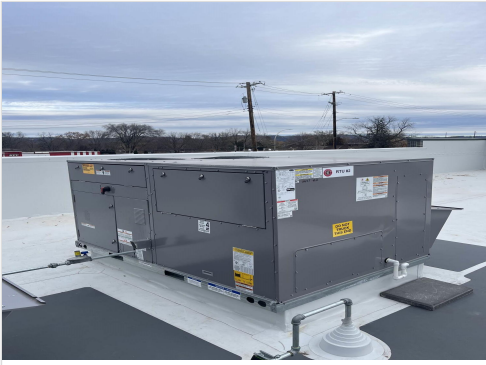
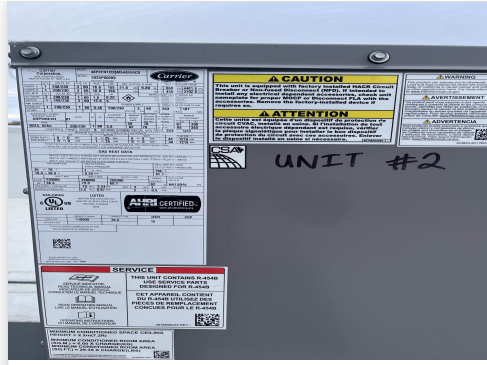
Unit Data - PHOTO LOG

Unit Data		
	Design	Actual
MFG	CARRIER	CARRIER
Serial Num	-	2925P60289
Model Num	48FCFN12D3M5	48FEFN12D3
Type	RTU	RTU
Configuration	VERTICAL	VERTICAL
Num OA Filters 1	-	1
OA Filter Size 1	-	35X19
Num Final Filter 1	-	4
Final Filter Size 1	-	16X20X4

Notes:
[1] UNIT HAS 4" THICK FINAL FILTERS.

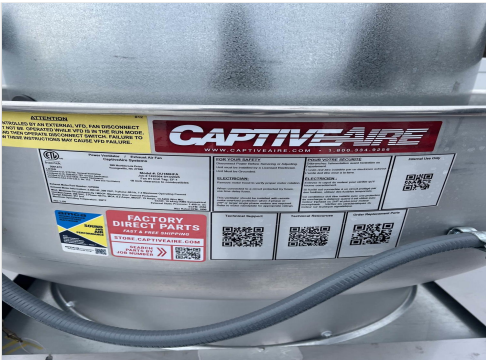
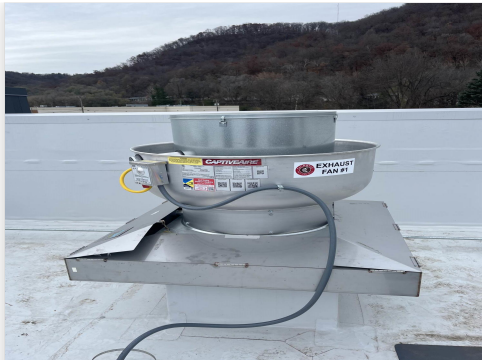
Unit Data - PHOTO LOG

Unit Data		
	Design	Actual
MFG	CAPTIVE-AIRE	CAPTIVE-AIRE
Model Num	DU180HFA	DU180HFA
Serial Num	-	7425364
Type	UPBLAST	UPBLAST
Configuration	VERTICAL	VERTICAL

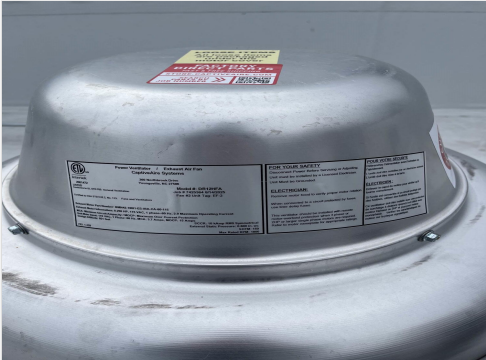
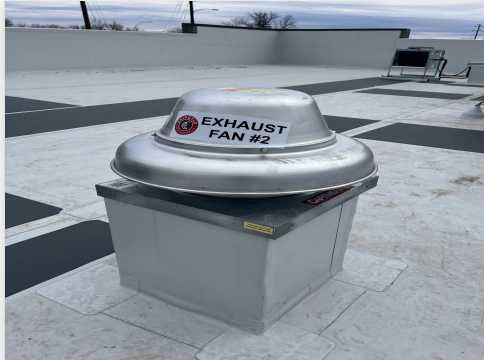
Unit Data - PHOTO LOG

Unit Data		
	Design	Actual
MFG	CAPTIVE-AIRE	CAPTIVE-AIRE
Model Num	DR12HFA	DR12HFA
Serial Num	-	7425364
Type	DOWNBLAST	DOWNBLAST
Configuration	VERTICAL	VERTICAL

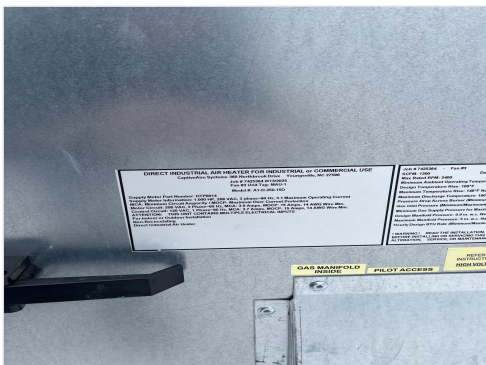
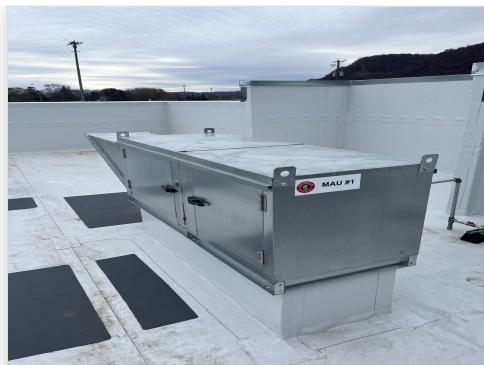
Unit Data - PHOTO LOG

Unit Data		
	Design	Actual
MFG	CAPTIVE-AIRE	CAPTIVE-AIRE
Model Num	A1-D.250-15D	A1-D.250-15D
Serial Num	-	7425364
Type	MAU	MAU
Configuration	VERTICAL	VERTICAL

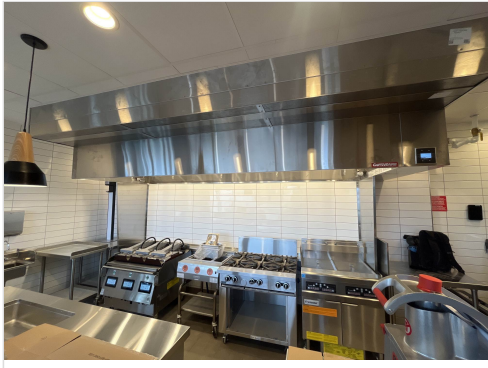
Unit Data - PHOTO LOG

Unit Data		
	Design	Actual
MFG	CAPTIVE-AIRE	CAPTIVE-AIRE
Model Num	5424 ND-2-ACPSP-F	5424 ND-2-ACPSP-F
Job / Serial Num	-	7425364
Type	TYPE 1 CANOPY	TYPE 1
Hood length	153"	153"
Hood Width	54"	54"
Supply Plenum Type	-	ACPSP
Supply Plenum Width	9"	9"
Supply Plenum Length	165"	165"
