**Report: TAB Report**  
**Function: Test, Adjust, & Balance**  
**Date: 10/01/2025**  
**Completed By: National TAB**

## 09-22-25 Firebirds Chesterfield, VA

Project: 09-22-25 Firebirds Chesterfield, VA

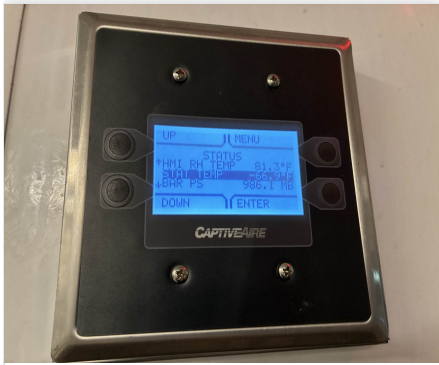
**Issue Name :** DOAS - 1 Temperature Sensor Malfunctioning  
**Description :** DOAS - 1 temperature sensor not reading properly. It causes the unit to shutdown on an overheat fault.  
**Created By :** National TAB                      **Assigned To :** National TAB - Antonio Flores-De La Cruz  
**Status :** Open  
**Priority :** Urgent                                      **Asset Tag :**  
**Originated Date :** 09/24/2025 - Alex Bauer - National TAB

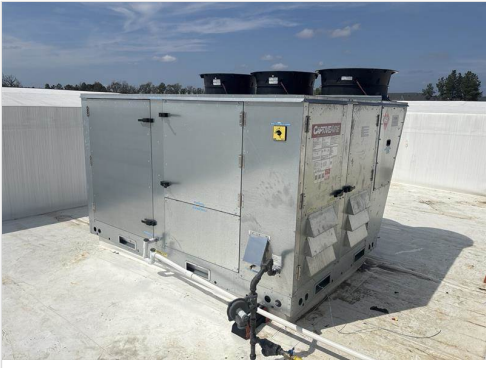
Asset: DOAS1

Test Data		
	Design	Actual
SF CFM	4000	4135
SF RPM	-	1108
RA CFM	300	263
OA CFM	3700	3872
RL Voltage	-	210/211/210
RL Amperage	-	10.5
SF Rotation	-	CCW
SF System SetPt	-	38 Hz
RA Damper Position	-	2%
Min OA Damper Position	-	98%
Min OA Damper Type	-	DOAS

Performance Data		
	Design	Actual
MA Plenum SP	-	-0.19"
Fan Suction SP	-	-0.91"
Fan Discharge SP	-	0.46"
Total ESP	0.50"	0.65"
Fan Total SP	-	1.37"

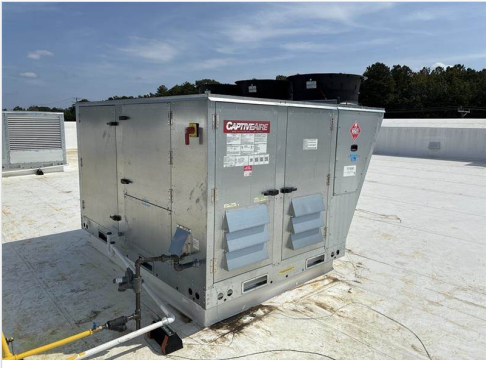
Asset: RTU1

Test Data		
	Design	Actual
SF CFM	4000	3947
SF RPM	-	913
RA CFM	2050	2066
OA CFM	1850	1881
RL Voltage	-	210/211/210
RL Amperage	-	10.3/10.2/10.3
SF Rotation	-	CCW
SF System SetPt	-	47 Hz
RA Damper Position	-	5.2 V / 52%
Min OA Damper Position	-	4.8 V / 48%
Min OA Damper Type	-	ECONOMIZER

TOTAL FLOW WAS SET DUE TO SGRD 1-9 AND 1-10 DAMPERS BEING ABOVE HARD CEILING. MANUAL DAMPERS FOR BRANCHES WAS NOT INSTALLED PER THE DRAWINGS AND UNABLE TO LIMIT FLOW IN BRANCH SERVING SGRD 1-4 TO 1-8

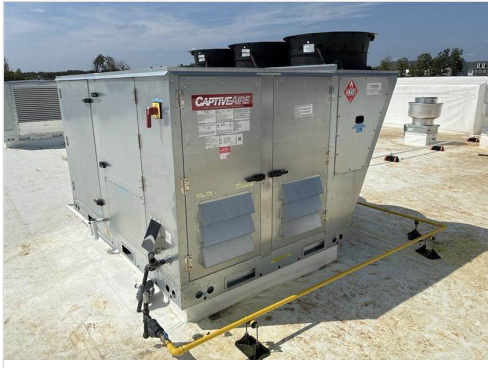
Asset: RTU2

Test Data		
	Design	Actual
SF CFM	3900	4145
SF RPM	-	913
RA CFM	2050	2267
OA CFM	1850	1878
RL Voltage	-	210/211/210
RL Amperage	-	10.2/10.1/10.2
SF Rotation	-	CCW
SF System SetPt	-	47 Hz
RA Damper Position	-	4.5 V / 45%
Min OA Damper Position	-	5.5 V / 50%
Min OA Damper Type	-	ECONOMIZER

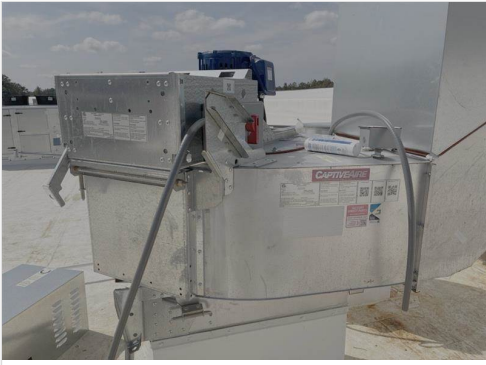
Asset: KEF3

Test Data		
	Design	Actual
CFM	3360	3217
Fan RPM	-	1045
Fan Rotation	-	CCW
Motor RPM	-	1045
RL Voltage	-	210/211/210
RL Amperage	-	11.3/11.2/11.3
Suction ESP	-	-1.35"
Discharge ESP	-	ATM
Total ESP	1.60"	1.35"

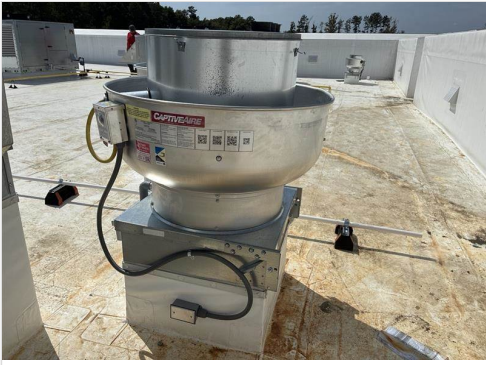
Asset: KEF-H4

Test Data		
	Design	Actual
CFM	2340	2209
Fan RPM	-	911
Fan Rotation	-	CCW
Motor RPM	-	911
System SetPt	-	46.7 Hz
RL Voltage	-	210/211/210
RL Amperage	-	4.5/4.4/4.5
Total ESP	1.60"	1.36"
Fan Inlet SP	-	-1.36"
Fan Discharge SP	-	ATM

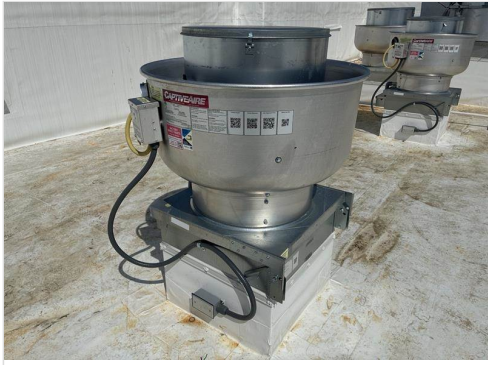
Asset: KEF-HL1

Test Data		
	Design	Actual
CFM	1425	1327
Fan RPM	-	957
Fan Rotation	-	CCW
Motor RPM	-	957
System SetPt	-	33.3 Hz
RL Voltage	-	210/211/210
RL Amperage	-	1.7
Total ESP	1.40"	0.79"
Fan Inlet SP	-	-0.79"
Fan Discharge SP	-	ATM

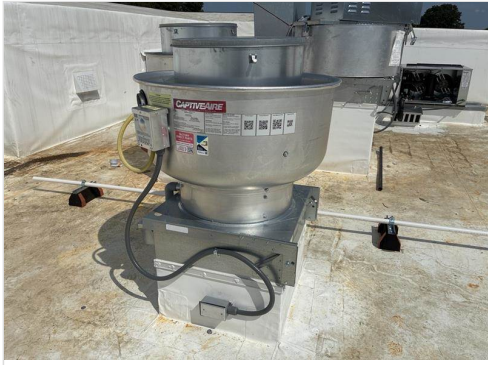
Asset: KEF-HR1

Test Data		
	Design	Actual
CFM	1425	1327
Fan RPM	-	957
Fan Rotation	-	CCW
Motor RPM	-	957
System SetPt	-	33.3 Hz
RL Voltage	-	210/211/210
RL Amperage	-	1.7
Total ESP	1.40"	0.68"
Fan Inlet SP	-	-0.68"
Fan Discharge SP	-	ATM

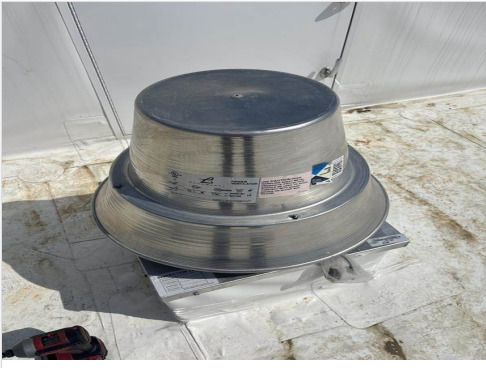
Asset: TEF1

TEF-1 IS NOT WIRED AND OPERATIONAL

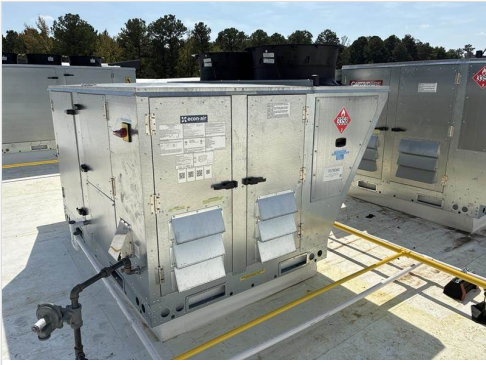
Gas Heat		
	Design	Actual
<b>Heater Operates (y/n)</b>	-	N
<b>Flame Status (pass/fail)</b>	-	FAIL
<b>Inlet Air Temp SetPt</b>	55	55
<b>Discharge Air Temp SetPt</b>	60	60
<b>Air Flow Switch SP Actual</b>	-	N/A
