Report: TAB Report
Function: Test, Adjust, & Balance
Date: 10/22/2025
Completed By: National TAB

PROJECT
10-13-25 QT #1128 INMAN, SC

National TAB

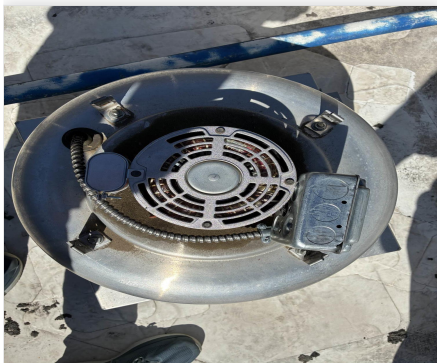
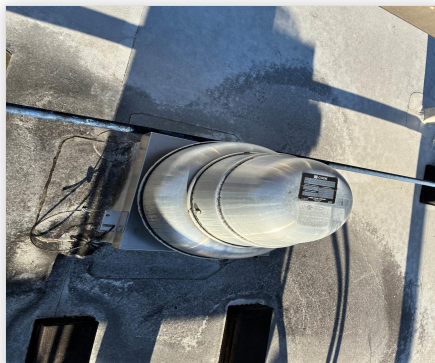
Issue Name : EF-1 speed controller not working
Description : EF-1's speed controller does not work, airflow cannot be decreased and is above design.
Created By : National TAB **Assigned To :** National TAB - Brianna Biggs
Status : Open
Priority : Urgent **Asset Tag :** EF1
Originated Date : 10/15/2025 - Christian Moller - National TAB

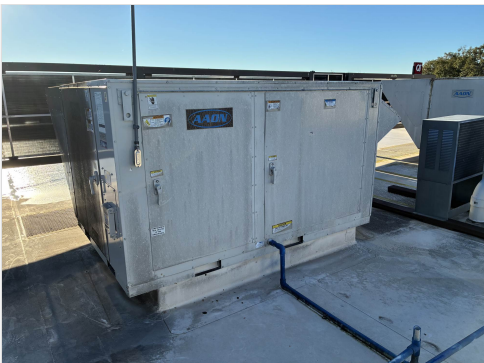
Asset: RT-3

Test Data		
	Design	Actual
SF CFM	4200	4429
OA CFM (Hoods On)	800	862
OA CFM (Hoods Off)	350	370
RL Voltage	-	207/207/208
RL Amperage	-	7.8/8.2/8.0
VFD Max SetPt	-	40Hz
VFD Min SetPt	-	24Hz
OA Damper Position (Hoods On)	-	30%
OA Damper Position (Hoods Off)	-	25%
