Report: TAB Report
Function: Test, Adjust, & Balance
Date: 10/22/2025
Completed By: National TAB

PROJECT
10-13-25 QT #1128 INMAN, SC

9620 ASHEVILLE HWY

Project: 10-13-25 QT #1128 INMAN, SC

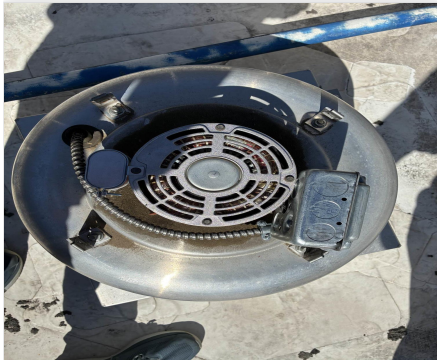
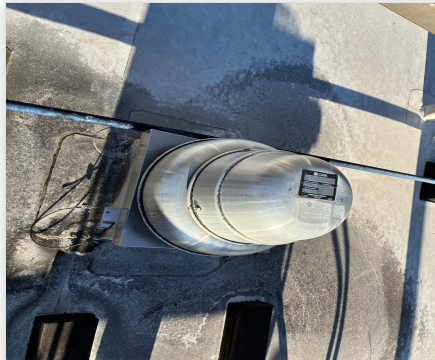
Issue Name : EF-1 speed controller not working
Description : EF-1's speed controller does not work, airflow cannot be decreased and is above design.
Created By : National TAB **Assigned To :** National TAB - Brianna Biggs
Status : Open
Priority : Urgent **Asset Tag :** EF1
Originated Date : 10/15/2025 - Christian Moller - National TAB

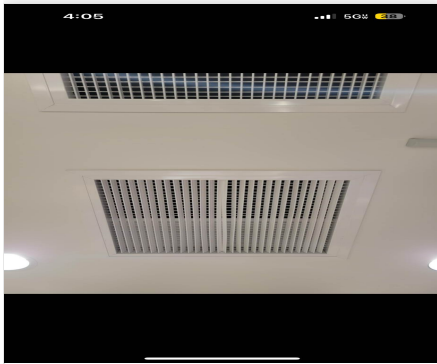
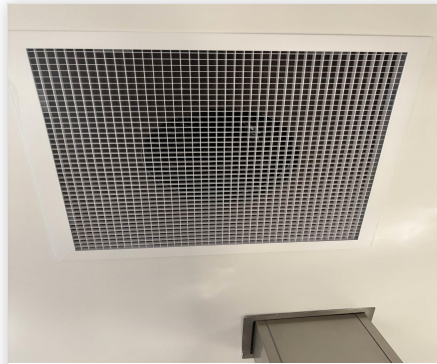
Issue Name : RTU 3 cook line diffusers no deflection blades
Description : Per the GC the diffusers ordered to replace the cook line SGRD's for RTU 3 are not being installed with the deflection blades. These are needed to mitigate drafting.
Created By : National TAB **Assigned To :** National TAB - Brianna Biggs
Status : Open
Priority : High **Asset Tag :** RT-3
Originated Date : 10/17/2025 - Christian Moller - National TAB

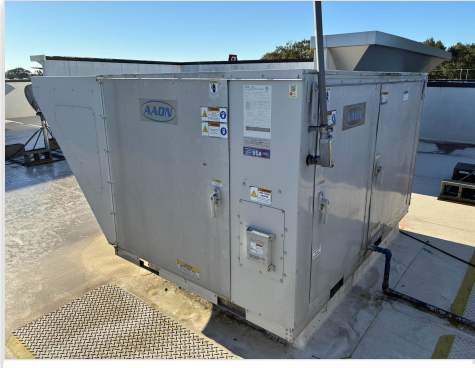
Asset: RT-1

Unit Data		
	Design	Actual
MFG	NA	AAON
Serial Num	-	201702-ANEK15207
Model Num	NA	RN-013-8-0-152
Num OA Filters 1	-	1
OA Filter Size 1	-	45X25

Test Data		
	Design	Actual
SF CFM	4200	4387
OA CFM (Hoods On)	800	737
OA CFM (Hoods Off)	350	375
RL Voltage	-	205/206/206
RL Amperage	-	7.2/6.6/7.2
VFD Max SetPt	-	38,6Hz
VFD Min SetPt	-	24Hz
OA Damper Position (Hoods On)	-	20%
OA Damper Position (Hoods Off)	-	23%

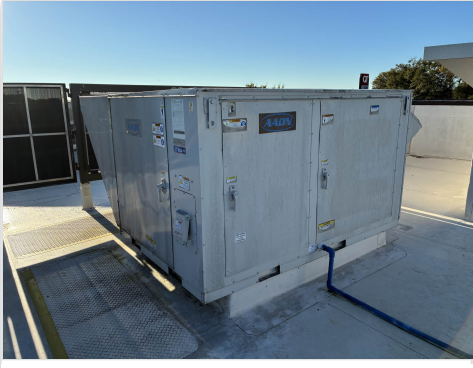
Asset: RT-2

Unit Data		
	Design	Actual
MFG	NA	AAON
Serial Num	-	201702-ANEK15208
Model Num	NA	RN-013-8-0-152
Num OA Filters 1	-	1
OA Filter Size 1	-	45X25

Test Data		
	Design	Actual
SF CFM	4200	4179
OA CFM (Hoods On)	800	739
OA CFM (Hoods Off)	350	372
RL Voltage	-	208/212/207
RL Amperage	-	5.3/6.3/6.0
VFD Max SetPt	-	35.6Hz
VFD Min SetPt	-	24Hz
OA Damper Position (Hoods On)	-	21%
OA Damper Position (Hoods Off)	-	21%

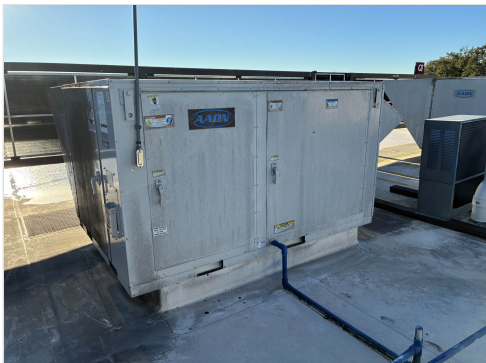
Asset: RT-3

Unit Data		
	Design	Actual
MFG	NA	AAON
Serial Num	-	201702-ANEK15209
Model Num	NA	RN-013-8-0-152
Num OA Filters 1	-	1
OA Filter Size 1	-	45X25

Test Data		
	Design	Actual
SF CFM	4200	4429
OA CFM (Hoods On)	800	862
OA CFM (Hoods Off)	350	370
RL Voltage	-	207/207/208
RL Amperage	-	7.8/8.2/8.0
VFD Max SetPt	-	40Hz
VFD Min SetPt	-	24Hz
OA Damper Position (Hoods On)	-	30%
OA Damper Position (Hoods Off)	-	25%

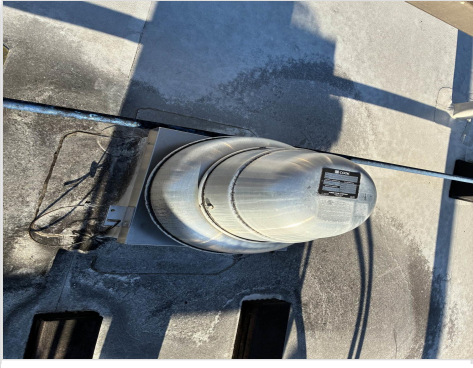
Asset: EF1

Unit Data		
	Design	Actual
MFG	NA	COOK
Model Num	NA	120 ACE 120C13D 33
Serial Num	-	050SG76777- 00/0002101
Type	-	UPBLAST
Configuration	-	VERTICAL

Test Data		
	Design	Actual
CFM	225	280
Fan Rotation	-	CCW
System SetPt	-	SPEED CONTROLLER / MEDIUM SPEED
RL Voltage	-	110
RL Amperage	-	0.98
Total ESP	-	0.30"
Fan Inlet SP	-	-0.30"
Fan Discharge SP	-	ATM

Speed controller does not work.

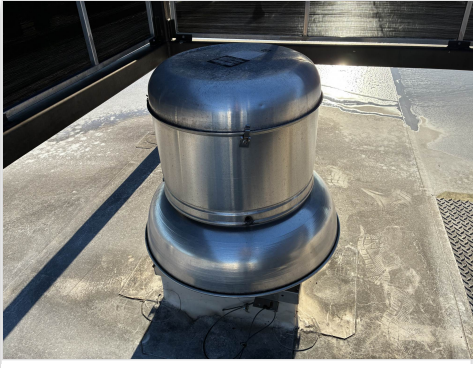
Asset: EF2

Unit Data		
	Design	Actual
MFG	NA	COOK
Model Num	NA	90 ACEH 90C15DH
Serial Num	-	050SG16777 00/0000701
Type	-	UPBLAST
Configuration	-	VERTICAL

Test Data		
	Design	Actual
CFM	525	549
Fan Rotation	-	CCW
System SetPt	-	SPEED CONTROLLER / MEDIUM SPEED
RL Voltage	-	111
RL Amperage	-	2.4
Total ESP	-	0.13"
Fan Inlet SP	-	-0.13"
Fan Discharge SP	-	ATM

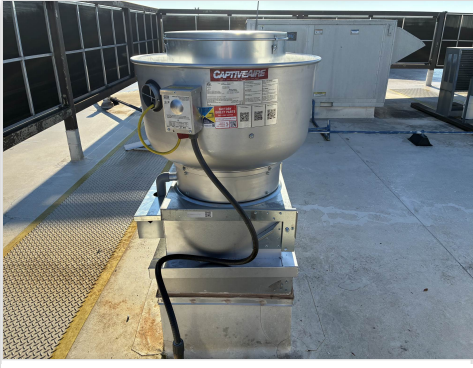
Asset: EF3

Unit Data		
	Design	Actual
MFG	NA	CAPTIVEAIRE
Model Num	NA	DU50HFA
Serial Num	-	7644869
Type	UPBLAST	UPBLAST
Configuration	VERTICAL	VERTICAL

Test Data		
	Design	Actual
CFM	1350	1360
Fan Rotation	-	CCW
System SetPt	-	HMI/55.8Hz
RL Voltage	-	207
RL Amperage	-	2.8
Total ESP	-	NR
Fan Inlet SP	-	NR
Fan Discharge SP	-	ATM

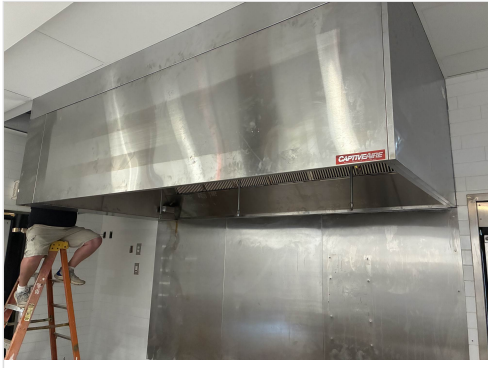
Asset: HD1

Unit Data		
	Design	Actual
MFG	CAPTIVEAIRE	CAPTIVEAIRE
Model Num	6030ND-2-F	6030ND-2-F
Job / Serial Num	-	7644869
Type	-	TYPE I CANOPY
Hood length	-	122"
Hood Width	-	60"

Test Data Exhaust		
	Design	Actual
Filter Type	-	BAFFLE FILTERS
Filter Size 1	-	16X20
Filter Qty 1	-	6
Filter AK factor size 1	-	2.08
Filter Total AK Area	-	12.48
Filter1 FPM	-	99
Filter2 FPM	-	115
Filter3 FPM	-	116
Filter4 FPM	-	107
Filter5 FPM	-	108
Filter6 FPM	-	111
Filter Ave FPM(corr)	-	109
CFM	1350	1360
