Report: TAB Report
Function: Test, Adjust, & Balance
Date: 10/22/2025
Completed By: National TAB

PROJECT
10-13-25 QT #1128 INMAN, SC

Project: 10-13-25 QT #1128 INMAN, SC

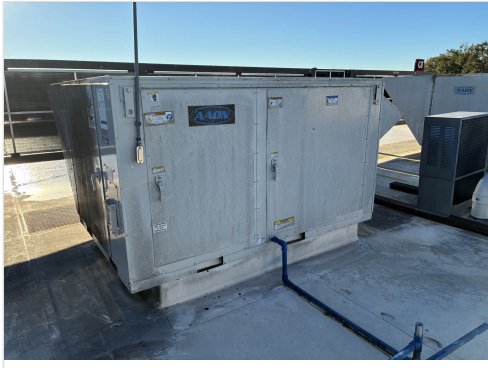
Unit Data - PHOTO LOG

Unit Data	
	Actual
MFG	AAON
Serial Num	201702-ANEK15209
Model Num	RN-013-8-0-152
Num OA Filters 1	1
OA Filter Size 1	45X25
