**Report: TAB Report**  
**Function: Test, Adjust, & Balance**  
**Date: 11/07/2024**  
**Completed By: National TAB**

**PROJECT**  
**11-04-24 FREDDY'S - LANCASTER, PA**

2347 Lincoln Highway East

Lancaster, PA 17602

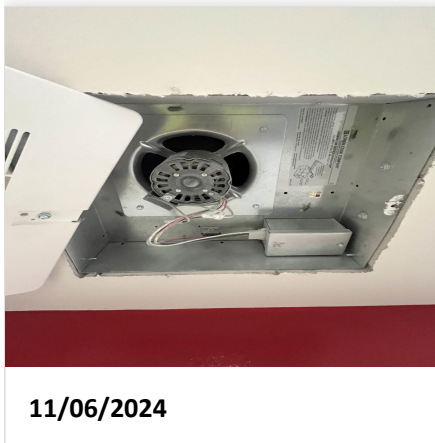
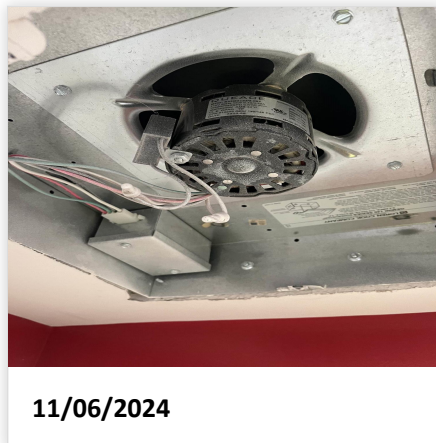
**Issue Name :** EF-1/EF-2 high on flow  
**Description :** EF-1/EF-2 restroom exhaust fans are high on flow at 99/75 and 97/75CFM. NTi rewired the exhaust fans for lowest speed settings and this is the lowest possible CFM achieved. Could not reduce further.  
**Created By :** National TAB                      **Assigned To :** National TAB - Dylan Crisman  
**Status :** Open  
**Priority :** Medium                                      **Asset Tag :**  
**Originated Date :** 11/06/2024 - Dylan Crisman - National TAB

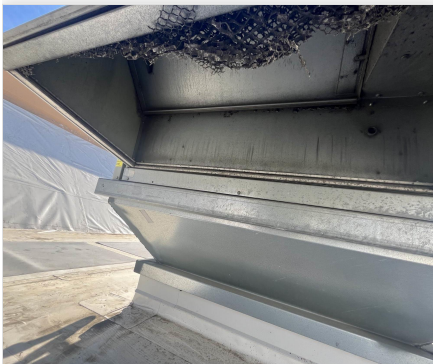
**Issue Name :** RTU-1/RTU-2 missing OA filter  
**Description :** RTU-1/RTU-2 OA Mesh filters are missing. Recommend replacing with correct size Mesh filters.  
**Created By :** National TAB                      **Assigned To :** National TAB - Dylan Crisman  
**Status :** Open  
**Priority :** Low    **Asset Tag :**  
**Originated Date :** 11/06/2024 - Dylan Crisman - National TAB

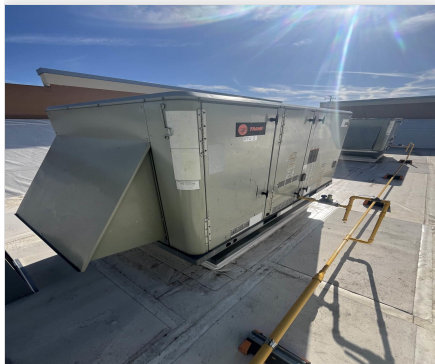
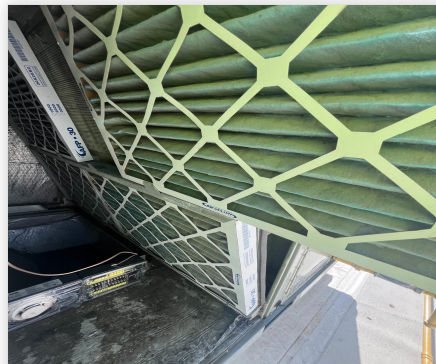
**Issue Name :** RTU-2 Final Filters Dirty  
**Description :** RTU-2 final filters are dirty, recommend replacing with clean correct size (4 20x25x2) merv 8 rated pleated filters  
**Created By :** National TAB                      **Assigned To :** National TAB - Dylan Crisman  
**Status :** Open  
**Priority :** Low    **Asset Tag :**  
**Originated Date :** 11/06/2024 - Dylan Crisman - National TAB

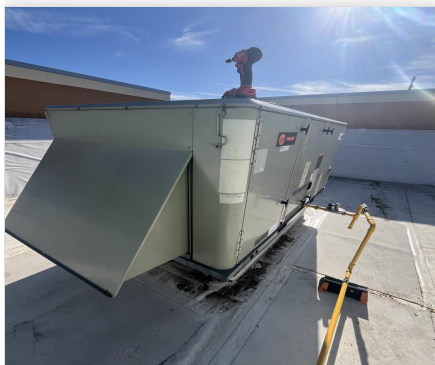
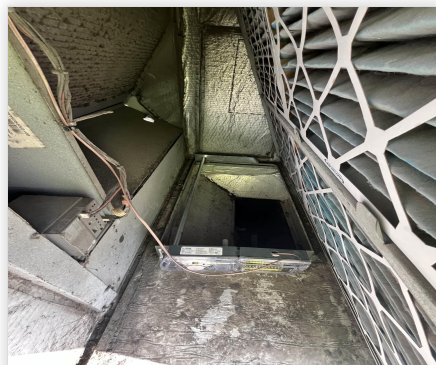
**Issue Name :** RTU-3 economizer not functional  
**Description :** RTU-3 economizer is not functional, when changing potentiometer setpoints on economizer box there is no change in damper position. Recommend mechanical troubleshoot and diagnose to correct this problem. Damper has been Manually set.  
**Created By :** National TAB                      **Assigned To :** National TAB - Dylan Crisman  
**Status :** Open  
**Priority :** High                                      **Asset Tag :**  
**Originated Date :** 11/06/2024 - Dylan Crisman - National TAB

RTU-1/RTU-2 Economizers work. RTU-3 economizer not functional, issue created.

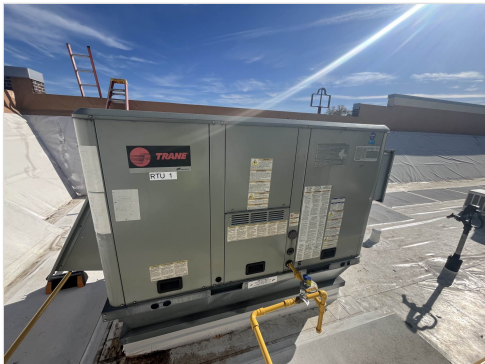
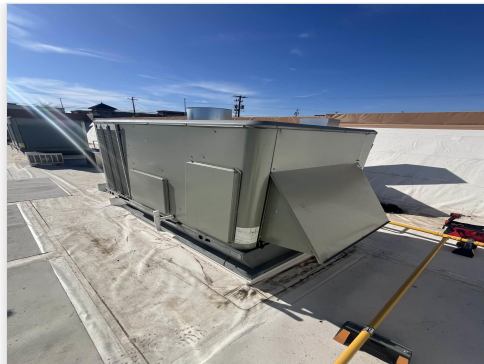
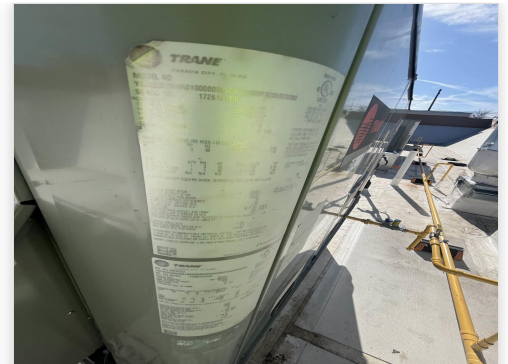
Unit Data		
	Design	Actual
MFG	CAPTIVEAIRE	TRANE
Serial Num	-	172612640L
Model Num	CASRTU3- I.400-18-15T	YSC060G3RHA0100
Type	RTU	RTU
Configuration	VERTICAL	VERTICAL
Num OA Filters 1	-	1
OA Filter Size 1	-	NA
Num Final Filter 1	-	2
Final Filter Size 1	-	20X35X2

Motor Data		
	Design	Actual
Motor MFG	-	US-MOTORS
Frame	-	NL
Horsepower	-	1.0
Motor Rpm	-	NL
Phase	3	3
Rated Voltage	208	208
Rated Amperage	-	6.9

Test Data		
	Design	Actual
SF CFM	2000	1869
RA CFM	1500	1357
OA CFM	500	512
RL Voltage	-	216/213/215
RL Amperage	-	4.8/4.8/4.7
SF Rotation	-	CW
SF System SetPt	-	HIGH SPEED
RA Damper Position	-	80%
Min OA Damper Position	-	20%
Min OA Damper Type	-	ECONOMIZER
OA Enthalpy Setpt	-	E

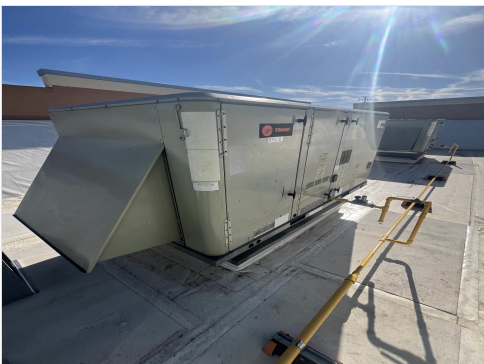
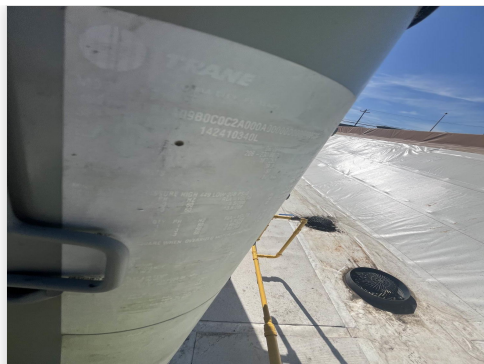
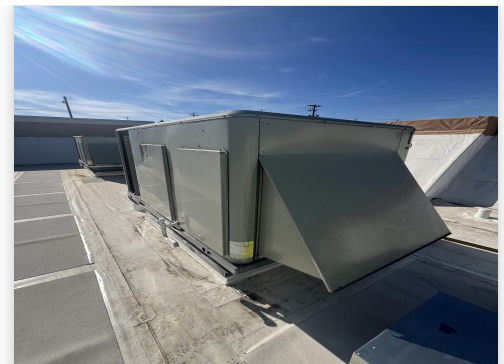
Test Data		
	Design	Actual
SF CFM	3000	2928
SF RPM	-	713
RA CFM	1950	1853
OA CFM	1050	1075
RL Voltage	-	215/216/217
RL Amperage	-	2.7/2.7/2.6
SF Rotation	-	CW
SF System SetPt	-	3 TURNS OPEN
Min OA Damper Position	-	1.25" OPEN
Min OA Damper Type	-	ECONOMIZER
OA Enthalpy Setpt	-	E

General	
	Actual
Fan Rotation Correct	YES
Unit Filters Clean	NO
Condensate Drain Installed	YES

**Issue Name :** RTU-2/RTU-3 motor sheave seized  
**Description :** RTU-2/RTU-3 motor sheaves are seized, unable to free to make speed adjustment on units. Unable to increase airflow. Recommend mechanical inspect and possibly replace motor sheaves.  
**Created By :** National TAB                      **Assigned To :** National TAB - Dylan Crisman  
**Status :** Open  
**Priority :** [Medium](#)                                      **Asset Tag :**  
**Originated Date :** 11/06/2024 - Dylan Crisman - National TAB

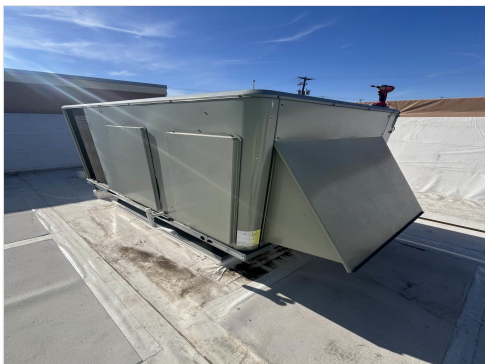
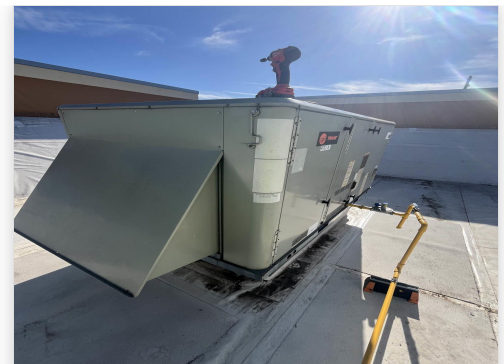
Test Data		
	Design	Actual
SF CFM	3000	2877
SF RPM	-	712
RA CFM	1950	1785
OA CFM	1050	1092
RL Voltage	-	215/216/215
RL Amperage	-	3.1/3.2/3.2
SF Rotation	-	CW
SF System SetPt	-	3 TURNS OPEN
Min OA Damper Position	-	1.5" OPEN
Min OA Damper Type	-	ECONOMIZER
OA Enthalpy Setpt	-	E

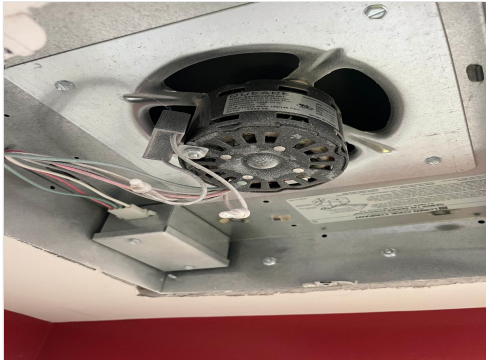
IMG\_6060\_1320240225.j..

Test Data		
	Design	Actual
<b>CFM</b>	75	99
<b>Fan RPM</b>	-	NA
<b>Fan Rotation</b>	-	CCW
<b>Motor RPM</b>	-	NA
<b>System SetPt</b>	-	LOW SPEED
<b>RL Voltage</b>	-	113
<b>RL Amperage</b>	-	0.3
<b>Total ESP</b>	1/4"	NA
<b>Fan Inlet SP</b>	-	NA
<b>Fan Discharge SP</b>	-	ATM

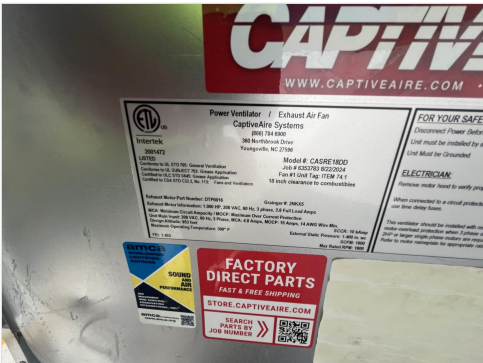
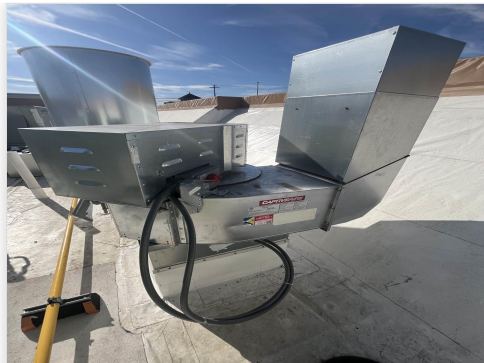
Test Data		
	Design	Actual
CFM	1600	1612
Fan RPM	-	883
Fan Rotation	-	CCW
Motor RPM	-	883
System SetPt	-	46.1Hz
RL Voltage	-	101V@VFD
RL Amperage	-	2.4@VFD
Total ESP	1.500"	NA
Fan Inlet SP	-	NA
Fan Discharge SP	-	ATM

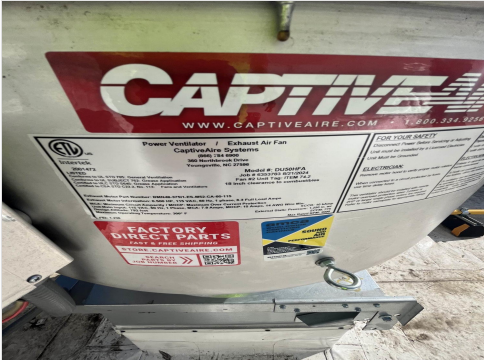
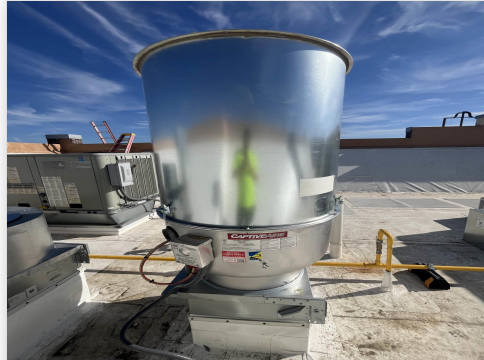
Test Data		
	Design	Actual
CFM	-	782
Fan RPM	-	1008
Fan Rotation	-	CCW
Motor RPM	-	1008
System SetPt	-	56%
RL Voltage	-	124.5
RL Amperage	-	2.7
Total ESP	-	0.78"
Fan Inlet SP	-	-0.78"
Fan Discharge SP	-	ATM

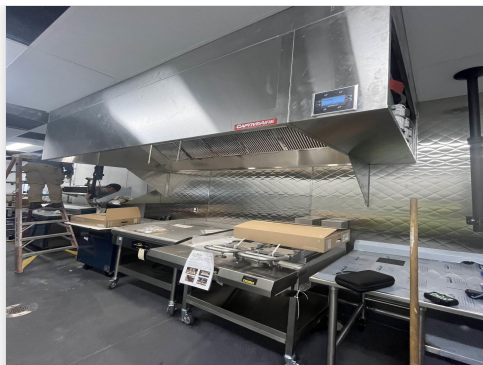
Unit Data		
	Design	Actual
MFG	CAPTIVEAIRE	CAPTIVEAIRE
Model Num	5424 ND-2	5424 ND-2
Job / Serial Num	-	6353783
Type	TYPE I CANOPY	TYPE I CANOPY
Hood length	96"	96"
Hood Width	54"	54"

Test Data Exhaust		
	Design	Actual
Filter Type	CAPTRATE SOLO FILTER	CAPTRATE SOLO
Filter Size 1	16X16	16x16
Filter Qty 1	5	5
Filter AK factor size 1	1.62	1.62
Filter Total AK Area	8.1	8.1
Filter1 FPM	-	193
Filter2 FPM	-	220
Filter3 FPM	-	200
Filter4 FPM	-	196
Filter5 FPM	-	187
Filter Ave FPM(corr)	-	199
CFM	1600	1612

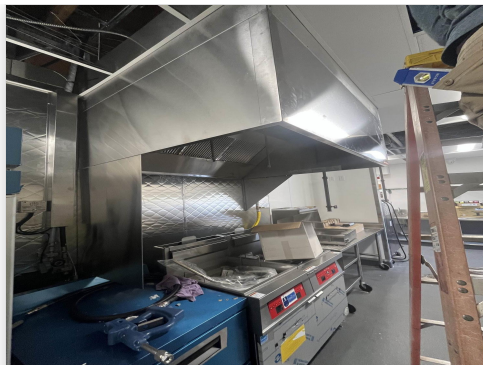
Unit Data		
	Design	Actual
MFG	CAPTIVEAIRE	CAPTIVEAIRE
Model Num	5424 ND-2	5424 ND-2
Job / Serial Num	-	6353783
Type	TYPE I CANOPY	TYPE I CANOPY
Hood length	81"	60"
Hood Width	54"	54"

Test Data Exhaust		
	Design	Actual
Filter Type	CAPTRATE SOLO FILTER	CAPTRATE SOLO
Filter Size 1	16X16	16x16
Filter Qty 1	5	3
Filter AK factor size 1	1.62	1.62
Filter Total AK Area	8.1	4.86
Filter1 FPM	-	163
Filter2 FPM	-	165
Filter3 FPM	-	155
Filter Ave FPM(corr)	-	161
CFM	775	782
