Report: TAB REPORT
Function: Test, Adjust, & Balance
Date: 05/23/2024

05-20-24 FREDDY'S - EDMOND, OK (REVIVE)

1925 E 2ND ST

EDMOND, OK 73003

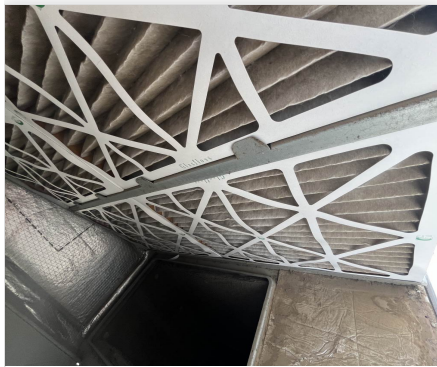
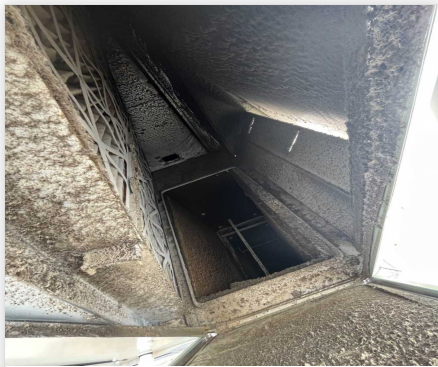
IMG_4189
05/22/2024

Issue Name : RTU-1/RTU-2/RTU-3 final filters dirty
Description : Final filters for all 3 RTUs are dirty. Recommend replacing with correct 20x25x2 merv 8 rated pleated filters. RTU-1 kitchen unit OA section is very dirty, recommend cleaning.
Created By : National TAB **Assigned To :** National TAB - Dylan Crisman
Status : Open
Priority : Low **Asset Tag :**
Originated Date : 05/22/2024 - Dylan Crisman - National TAB

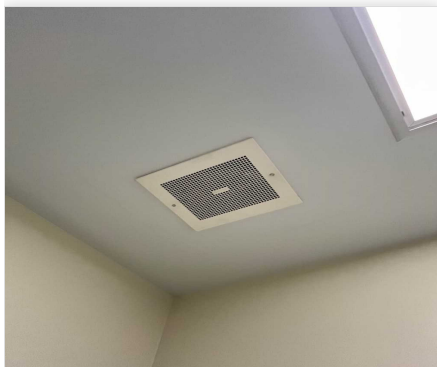
IMG_4201
05/23/2024

Issue Name : Women's RR Exhaust fan
Description : Women's RR ceiling Exhaust fan is spinning backwards, read very low negative (-11CFM) to a slightly positive reading. Recommend mechanical contractor flip rotation on fan.
Created By : National TAB **Assigned To :** National TAB - Dylan Crisman
Status : Open
Priority : Low **Asset Tag :**
Originated Date : 05/23/2024 - Dylan Crisman - National TAB
