Report: TAB REPORT
Function: Test, Adjust, & Balance
Date: 10/03/2023

PROJECT
09-25-23 FREDDY'S BURLESON, TX

Project: 09-25-23 FREDDY'S BURLESON, TX

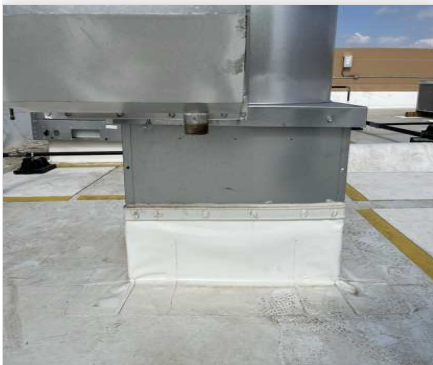
KEF_1_GREASE_TRAP_ISS..
09/25/2023

Issue Name : KEF GREASE TRAPS NOT INSTALLED
Description : KEF-1, KEF-2 AND KEF-3 DO NOT HAVE THEIR GREASE TRAPS INSTALLED ON THE ROOF.
Created By : National TAB **Assigned To :** National TAB - Will Turnbough
Status : Open
Originated Date : 09/25/2023 - Bayley Morvant - National TAB
