**Report: TAB REPORT
Function: Test, Adjust, & Balance
Date: 10/03/2023**

**PROJECT
09-25-23 FREDDY'S BURLESON, TX**

Project: 09-25-23 FREDDY'S BURLESON, TX

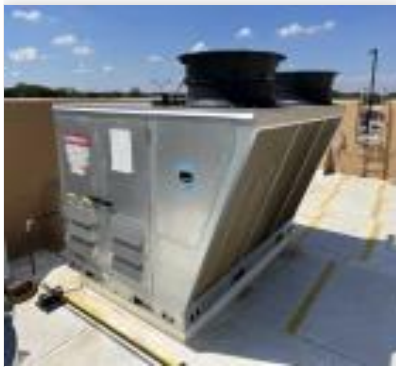
DOAS_1
09/26/2023

THIS IS DOAS-1

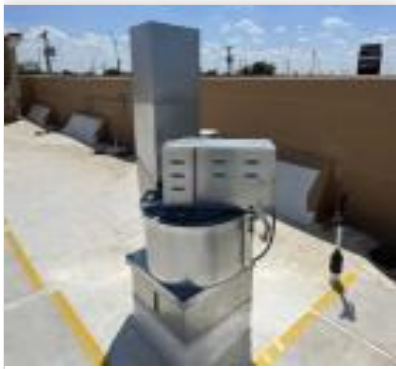
KEF_1
09/26/2023

KEF-1 PICTURED HERE

KEF-2 HAS HINGE KIT BUT KEF-1 ONLY HAS A HINGE KIT ON THE FAN MOTOR AND FAN, NOT ON THE WHOLE FAN HOUSING. KEF-3 IS THE DISH HOOD FAN, BUT ALSO DOES NOT HAVE A HINGE KIT INSTALLED.

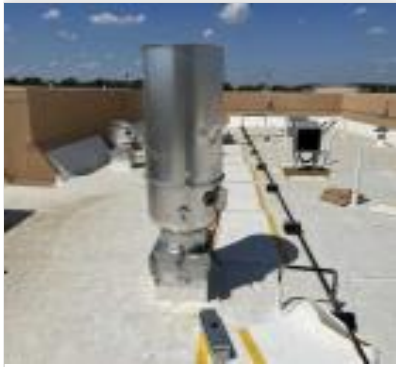
KEF_2
09/26/2023

KEF-2 PICTURED HERE

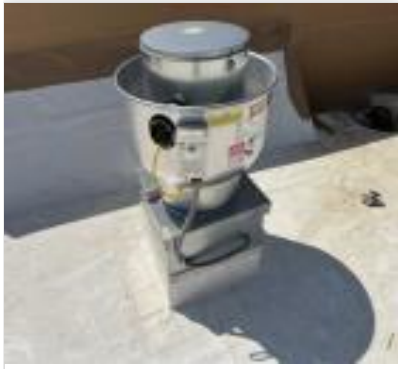
KEF_3
09/26/2023

KEF-3 PICTURED HERE

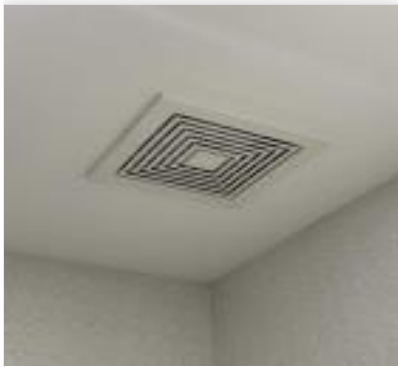
EF_1
09/26/2023

EF-1 PICTURED HERE

*1 NO SPEED CONTROLLER INSTALLED.

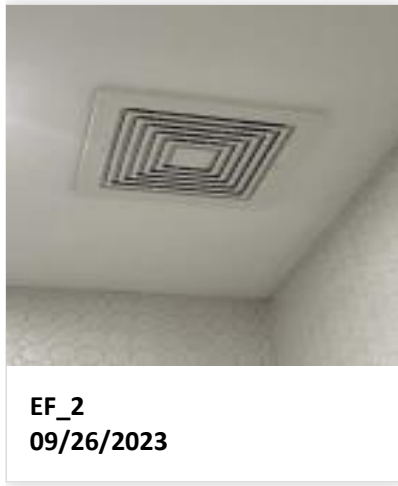
EF-2 PICTURED HERE

Notes:
 *1 NO SPEED CONTROLLER INSTALLED. FAN IS OPERATING AT 77% OF DESIGN.
 *2 NO ACCESS TO DISCHARGE DUCT DUE TO SHEET ROCK CEILING.
